STAR ONLINE PUBLICATION

Case Number: S2108000190

Symptom/Vehicle Issue: Temperature Gauge Running Hot, Engine Cooling Warning Lamp On, Cluster Chime For The Condition, Radiator Cooling Fan Does Not Turn On

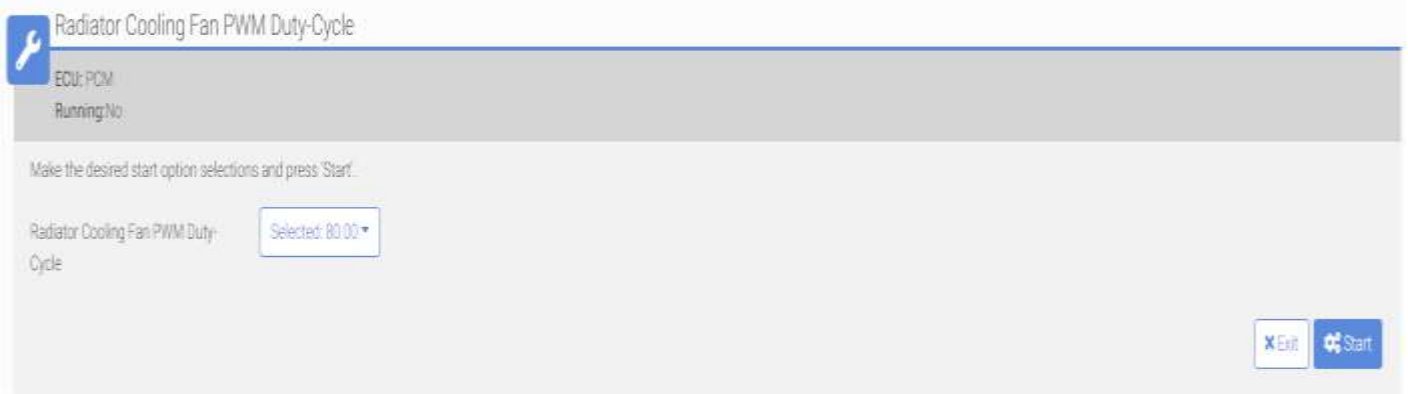
Fig 1

Customer Complaint/Technician Observation: Owner complains temperature gauge runs hot and or cooling lamp is on and the cluster warning chime sounds for a run hot condition. Technician observed the vehicle is running hot and the cooling fan is not turning on.

Repair Procedure: Use the scan tool PCM, Actuators, Radiator Cooling Fan PWM Duty Cycle, select 80% duty cycle to actuate and test the fan, while moving the wires of the involved fan circuits to locate any connection issues. Inspect the G904A ground location, clean and secure the ground location as needed, no parts are required Fig 1, 2 .
