## STAR ONLINE PUBLICATION

**Case Number:** S2108000072

**Symptom/Vehicle Issue:** MIL (Malfunction Indicator Lamp) On, DTC P0073 Ambient Air Temperature Sensor Circuit High, B1029-12 External Temperature Sensor-Circuit Short To Battery

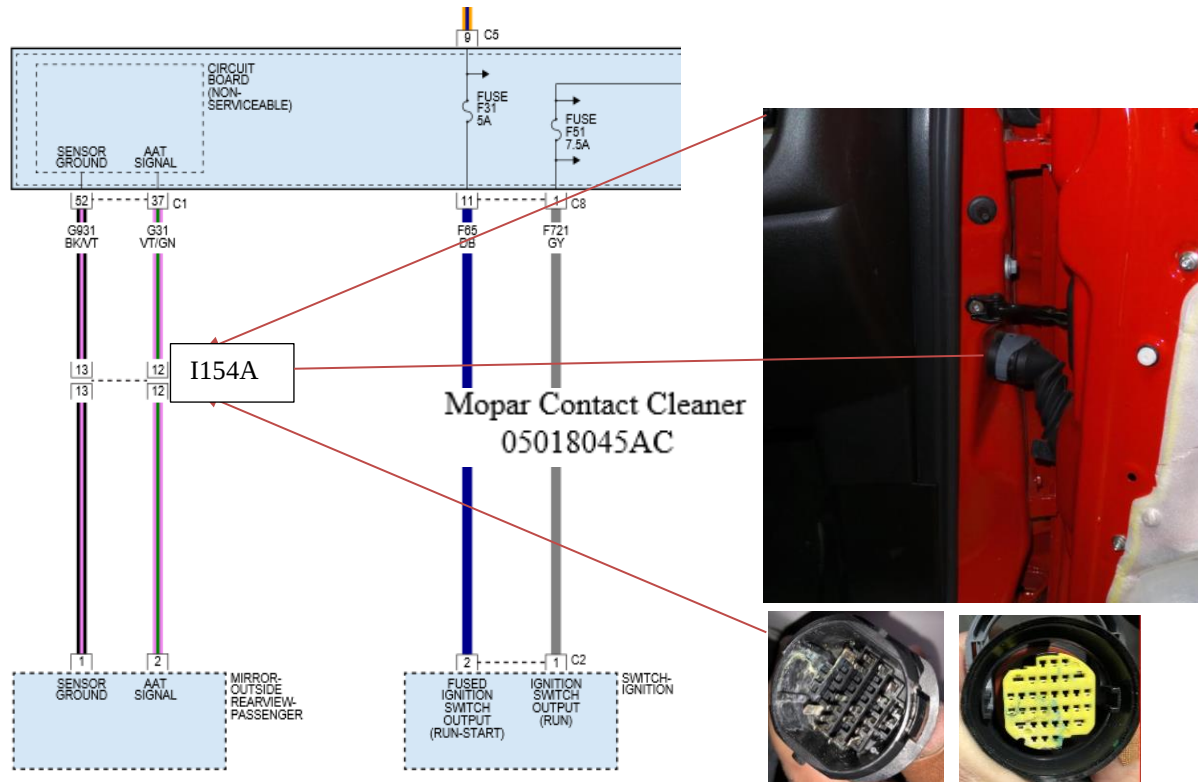
**Customer Complaint/Technician Observation:** Owner complaint, MIL lamp on. Technician observed DTC P0073 Ambient Air Temperature Sensor Circuit High, B1029-12 External Temperature Sensor- Circuit Short To Battery.

**Repair Procedure:** Inspect I154A, the A pillar door connector, for signs of corrosion, TPO (terminals pushed out), bent or spread terminals. Clean and secure as needed no parts required.
