STAR ONLINE PUBLICATION

Case Number: S2108000106 REV. A

Symptom/Vehicle Issue: Power Windows, Door Locks, Mirrors, Operate Intermittently, Driver Door Ajar Warning Lamp On, Stop Start Feature Disabled

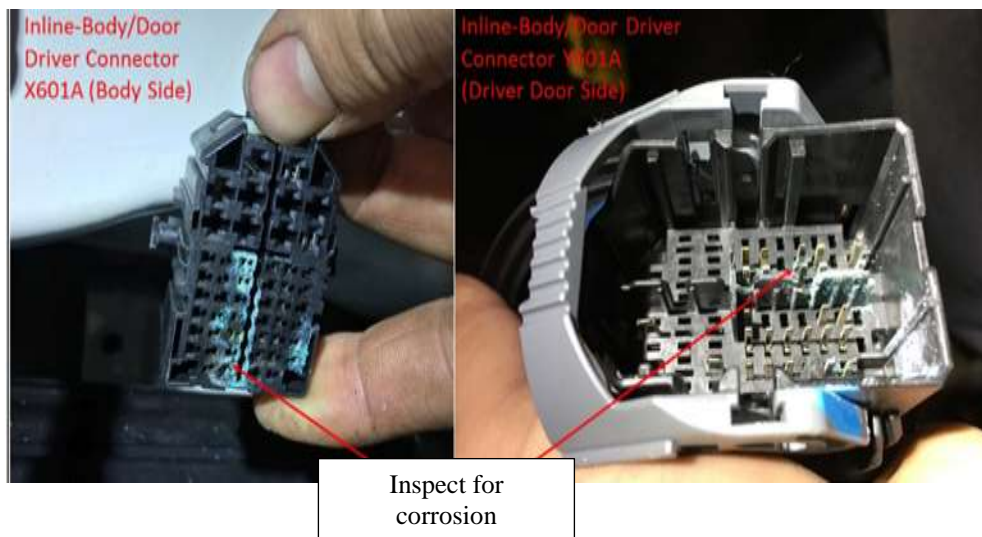
Fig 1

Customer Complaint/Technician Observation: Owner complains power window and or door locks do not operate at times. Technician observed one or more DTC's B18B7-24 (Master Switch-Rear left window switch-signal stuck high), B25C9 (Driver Door Ajar Switch 2 Stuck Closed), B180F-15 (Driver Door Ajar-Circuit Short to Battery or Open), and B18CF-15 (Secondary Driver Door Ajar-Circuit Short to Battery or Open), B22A9-15-ECU Internal Performance-Circuit Short To Battery Or Open.

Repair Procedure: Inspect the driver door/body harness grommets and connector for corrosion. Align grommet for proper sealing, clean and secure connector to complete Fig 1, 2.

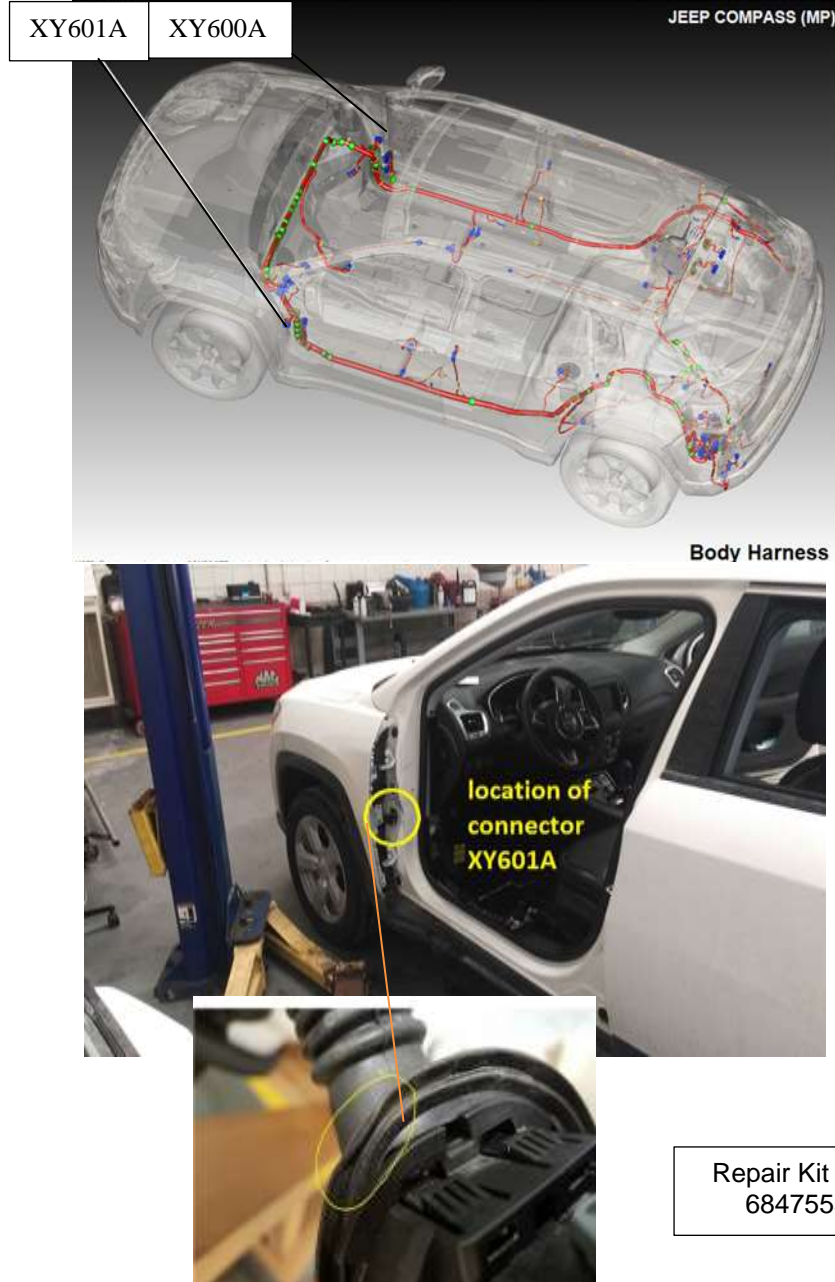
Fig 2, align sealing grommet as needed.
