## STAR ONLINE PUBLICATION

**Case Number:** S2023000017 Rev A

**Symptom/Vehicle Issue:** Whistle Wind Noise From Windshield Area.

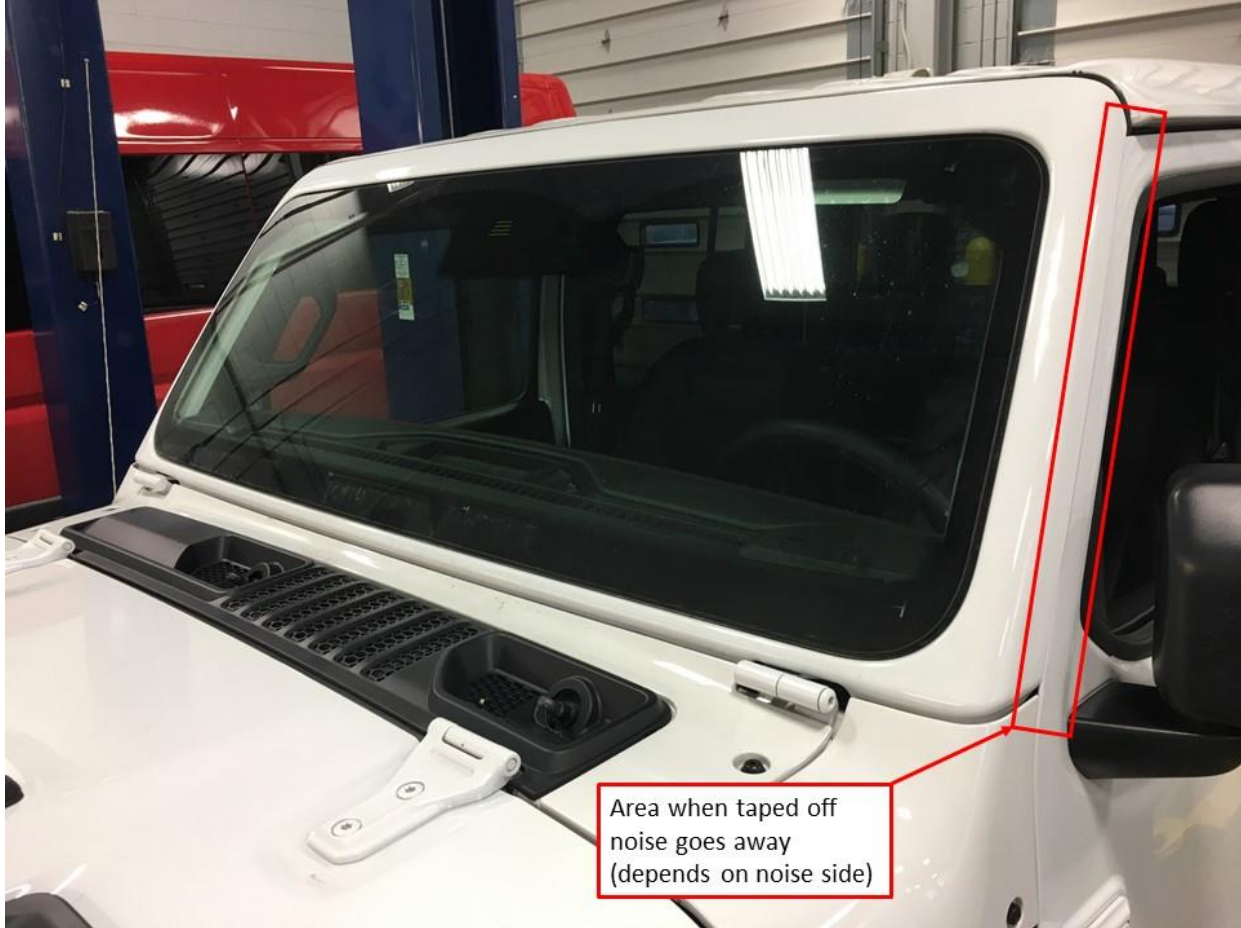
Fig. 1

**Discussion:** The customer may complain of a whistle wind noise from windshield area, this particular vehicle had whistle noise when going above 50 MPH. To isolate a leak area, apply wide masking tape over the windshield frame to the gap between the windshield frame and the door at the A-Pillar. See Fig.1

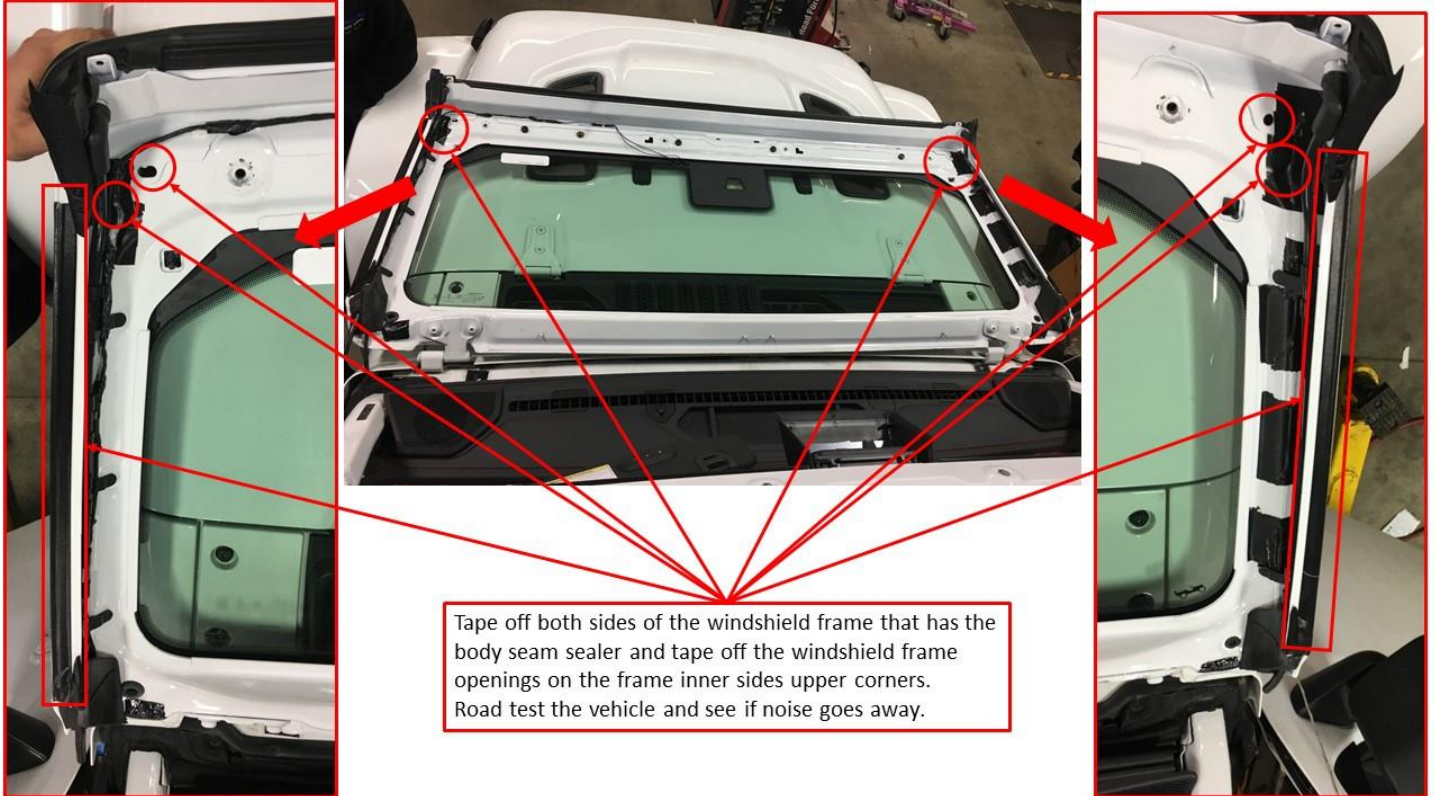
Drive the vehicle to see if the wind noise goes away. If this solves the issue, fold down the windshield frame and apply wide masking tape over the windshield frame outer sides over the body seam sealer, and cover the windshield frame openings at the upper frame corners. See Fig. 2 and Fig. 3
