STAR ONLINE PUBLICATION

Case Number: S2123000052

Symptom/Vehicle Issue: Wind Or Whistle Noise From Exterior Side Mirror At Highway Speeds. Noise can be heard with front windows down between 30 and 60 MPH from both LH and RH exterior rear view mirrors.

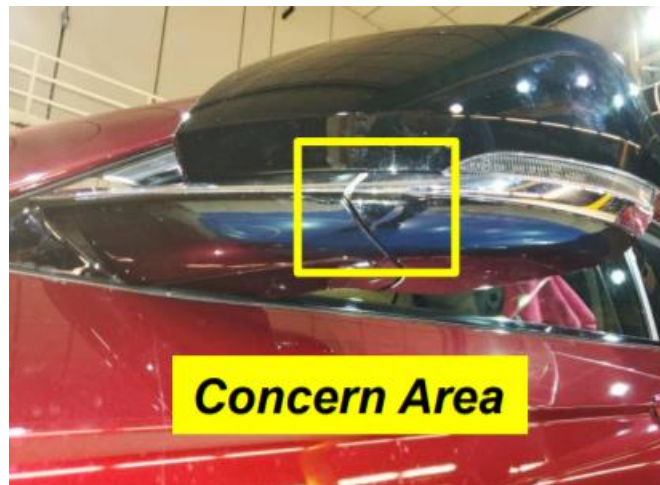
Discussion: Inspect the side mirror on the side that has the noise complaint. Attempt to duplicate the condition with 1 window down at a time driving speeds from 30-60mph. If duplicated, apply a piece of tape over the vertical joint shown in Fig 1 and test drive the vehicle again in the same manner. If the noise is gone with tape applied- perform the repair below.

Fig 1 vertical seam

Remove tape applied to the mirror for testing. Obtain a clear RTV or clear seam sealer such as Kent Products p10200 Hi Tech Clear. Following the products application and curing directions carefully apply the sealer in the vertical gap on the mirror head at the molding. It may help application to cut the tip of the applicator on an angle and so the opening size controls the flow of product into the gap. Apply enough to discretely fill the vertical gap shown in figure 2. Be mindful to keep sealer out of the mirror's moving joints and wipe/remove any excess that could be visible.

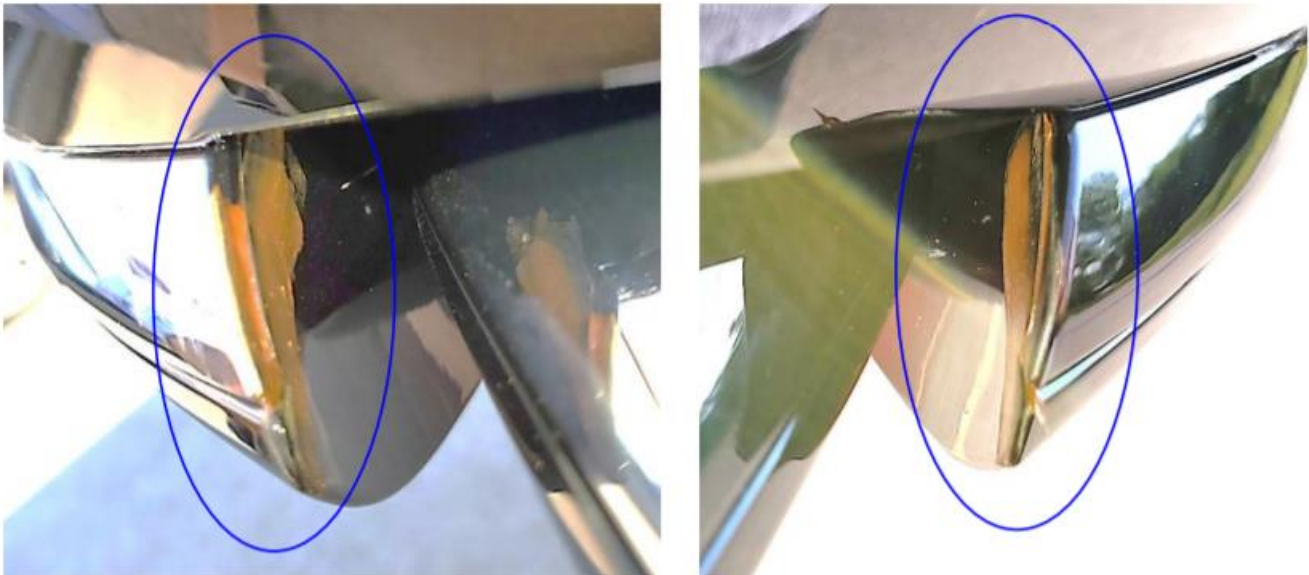
Fig 2 Seam with sealer applied.

Perform a test drive in the same manner used to duplicate the condition. 1 window down at a time driving up to 60 mph to confirm condition is no longer present.
