Case Number: S2123000061

Symptom/Vehicle Issue: Leather Steering Wheel Has Loose Material Poor Appearance

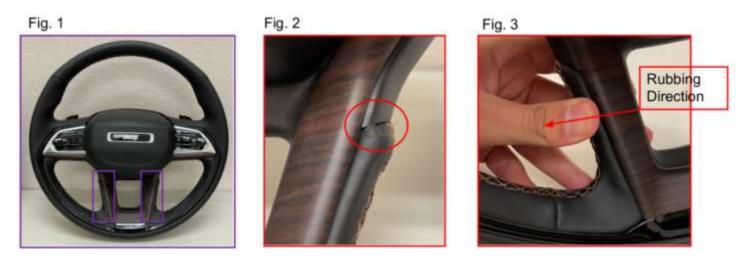
- 1. Look for any evidence of exposed leather edges along the lower spokes as shown in Fig 1-3.
- 2. Run your thumb along the spoke as shown in Fig 3 to see if the leather is loose.
- 3. If either step 1/or 2 indicate the issue noted, order a replacement steering wheel to resolve.
- 4. If no findings in step 1 or 2 as shown, the steering wheel is OK.

Repair Procedure: Inspect the steering wheel areas as shown while using the below guidelines to determine if the steering wheel requires replacement.
