## STAR ONLINE PUBLICATION

**Case Number:** S2108000117

**Symptom/Vehicle Issue:** Right Rear Side Marker Parking Lamp Does Not Illuminate

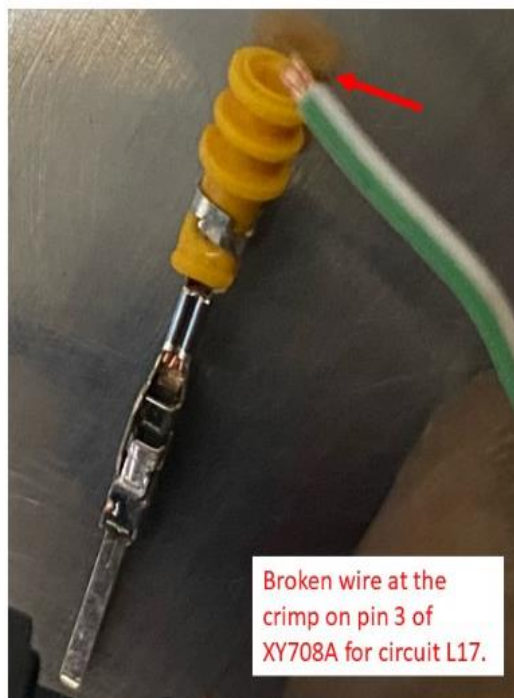
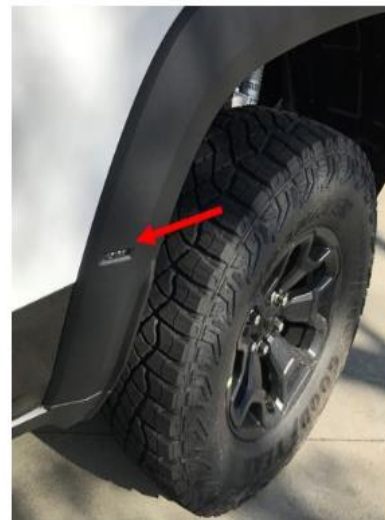
Fig 1

**CONNECTION: XY708A** **RAM 1500 (DT)**

Black 12 way PIN 3  
WH/GN  
Repair kit  
6849388AA

**Chassis Taillamp Right Jumper Harness**

**CONNECTION: XY675A** **RAM 1500 (DT)**

Black 16 way PIN 3  
WH/GN Repair Kit  
6849028AA

**Chassis LT Harness**

**Repair Procedure:** Inspect the side marker park lamp connector for power, lamps on. If no power, inspect the L17 circuit at XY708A inline connector for any damaged and or pushed out terminals. If no concerns, trace the L17 circuit back to XY675A pin 3 as needed, see Fig 1, 2, 3.
