**FT5198 Water Inside Roof Fuse Box (MQR 7621-2374)**

# Service Instruction

## MQR 762-2374 Potential Water Intrusion in 24V Fuse Box on Cradle – FT5198 Rev0

- 1) Potential torque missing on the cable gland dome nuts which could lead to water intrusion.
- 2) Potential sealing issue of the fuse box cover which could lead to water intrusion.

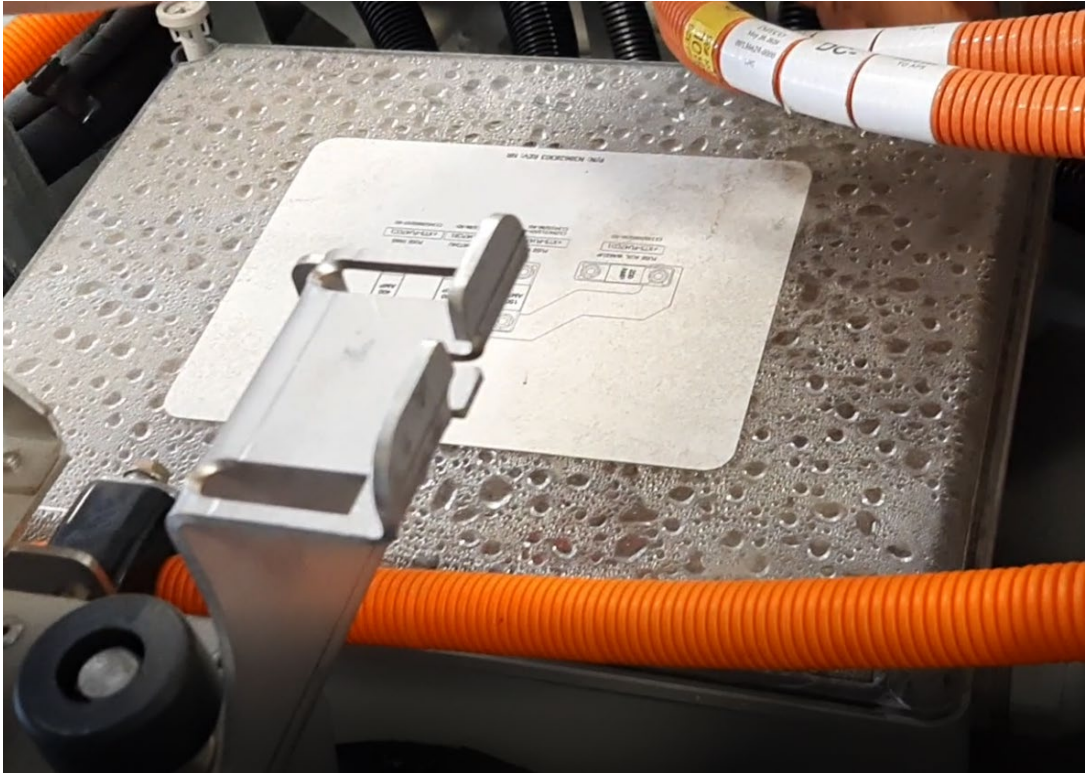
Figure 3: Fuse Box Condensation

7. Remove the cover of the fuse box and inspect for signs of water intrusion. (See figure 3 and 4).
  - a. If no water is found, proceed to step 8.
  - b. If water is present, proceed to step 11 for level 2 procedure.

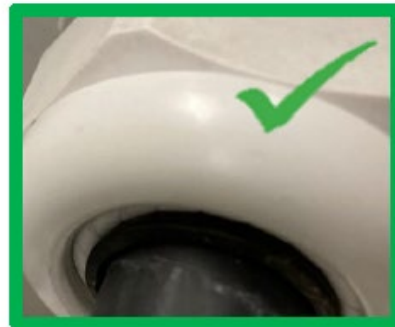
Figure 5: Cable Gland Dome Nuts

Table 1: Cable Gland Dome Nut Torque Value

8. Using a torque wrench and crowfoot attachment, torque the cable gland dome nuts in figure 5 according to table 1. Apply torque seal.

| ITEM | Torque Value (Nm) | Torque Value (lb-in) |
|---|---|---|
| 1 | 6.5 | 58 |
| 2 | 5 | 45 |

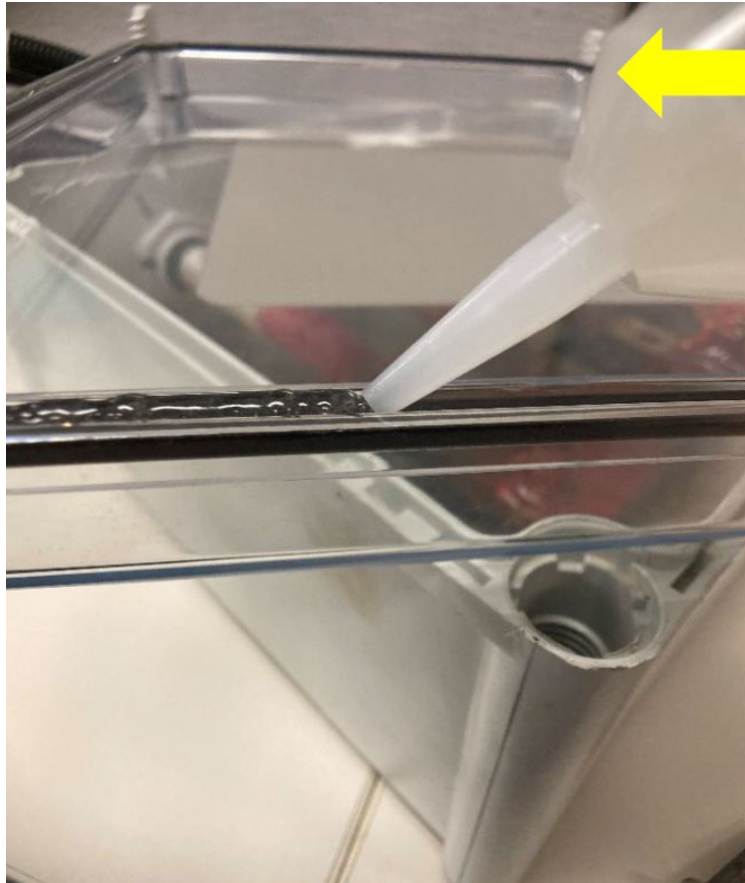
Figure 6: Application of NyoGel on Cover Seal

9. Apply a layer of NyoGel 760G to the face of the seal around the entire perimeter of the fuse box cover. Use a syringe to ensure consistent application. There must be no gaps. (See figure 6).
  - a. The nozzle of the syringe may be trimmed to help the application.
