## MAZDA DEALER EMAIL

**Subject:** Dealer Rework (DRW) 44 – 2022MY CX-9 White Particle Contamination on Vehicle

## DRW44 – CX-9 White Contamination on Body Surface

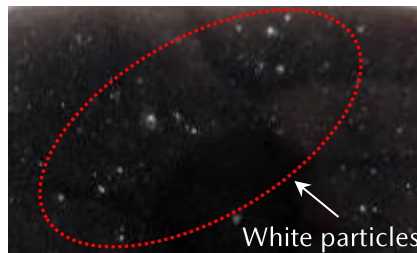
On certain subject 2022MY CX-9 vehicles, there may be atmospheric fallout (white particles/contamination) on the body surface.

**Perform a visual inspection on the entire surface of the vehicle upon arrival at the dealer. If white spots from contamination are found on the body surface, wash the vehicle using specific instructions according to the Repair Procedure documents.**

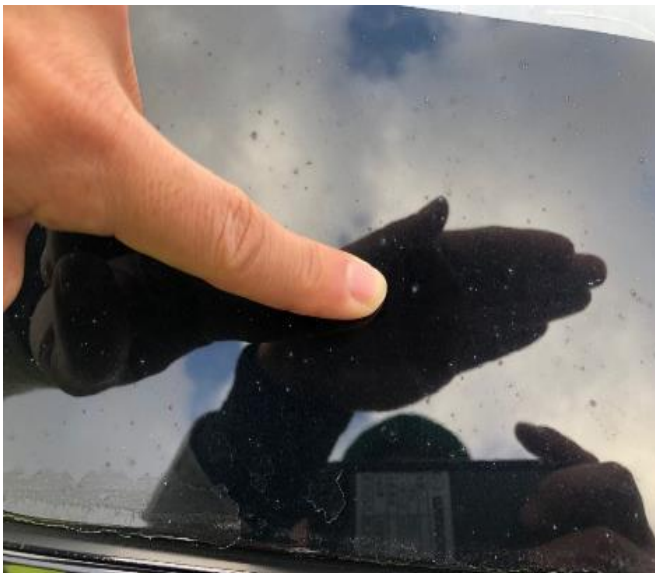
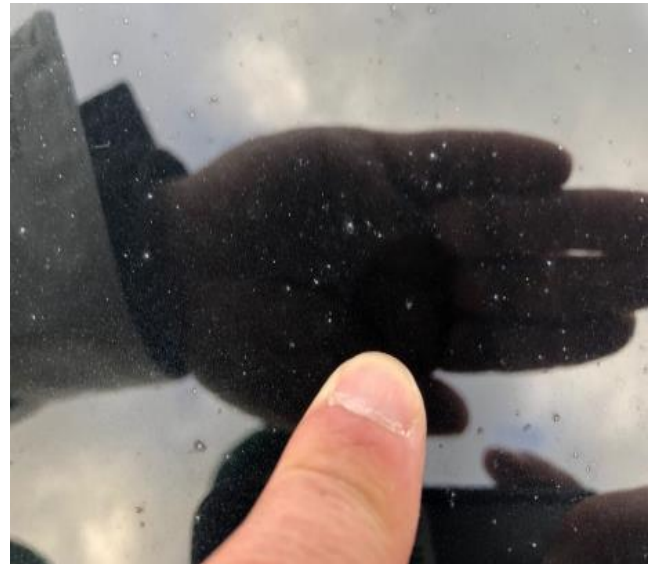
Example of Spots on vehicle

**Condition of Concern:** White contamination from atmospheric fallout may be adhering to the vehicle body. The spots remain after rinsing the vehicle with water. (White residue remains even after the surface contamination can be removed)

- 1) Perform visual inspection for entire surface of the vehicle.
- 2) If white spots from contamination are found on the body surface, remove them as outlined below.
  - a) Wet vehicle with warm water over the affected surfaces.
  - b) Remove the white spots using a soft cloth (such as microfiber) soaked in warm water.
  - c) Wash the affected area of body surface using car shampoo of PH 7 or lower (mild acidity).
  - d) Confirm that no traces of white contamination remain on the body surface.
  - e) Finish by washing the entire vehicle.
  - f) Once dried, final check that no spots remain on the vehicle.

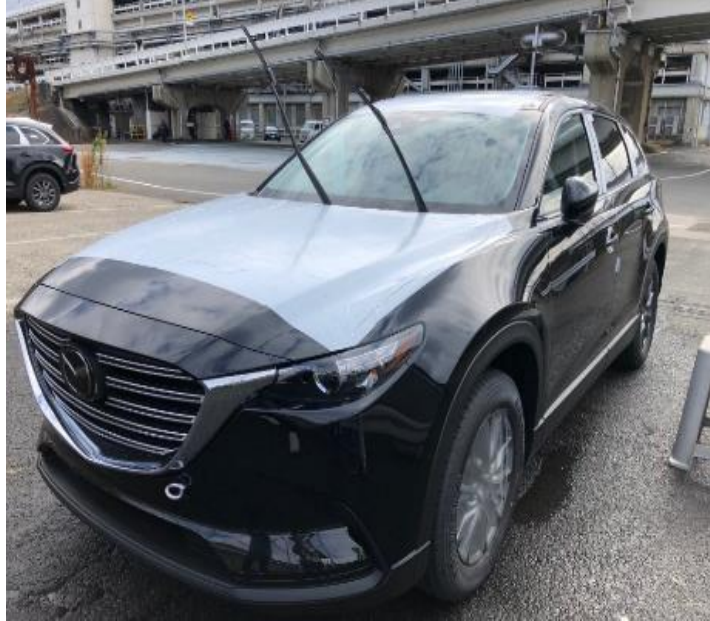
1. Raise the front wipers - Be careful not to scratch the body when you raise the wipers

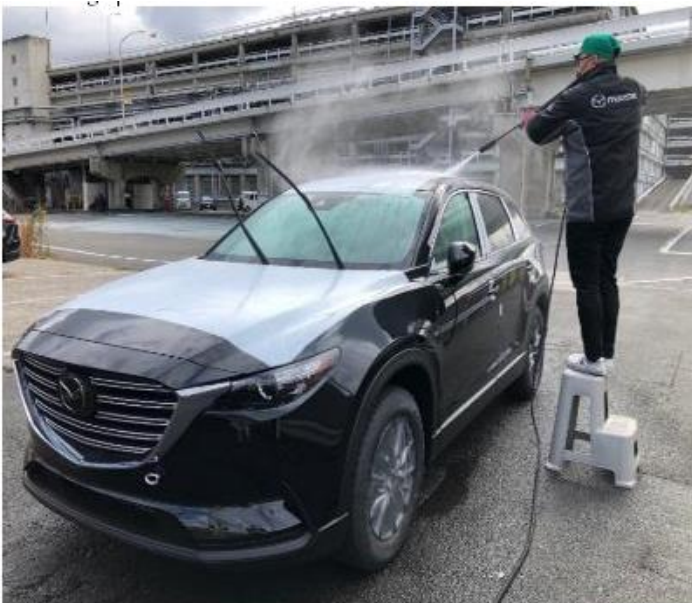
2. Use a high-pressure washer to remove the dust and dirt on the vehicle surface. Soak the vehicle with plenty of water, spraying water on the body thoroughly so that the entire vehicle is wet.

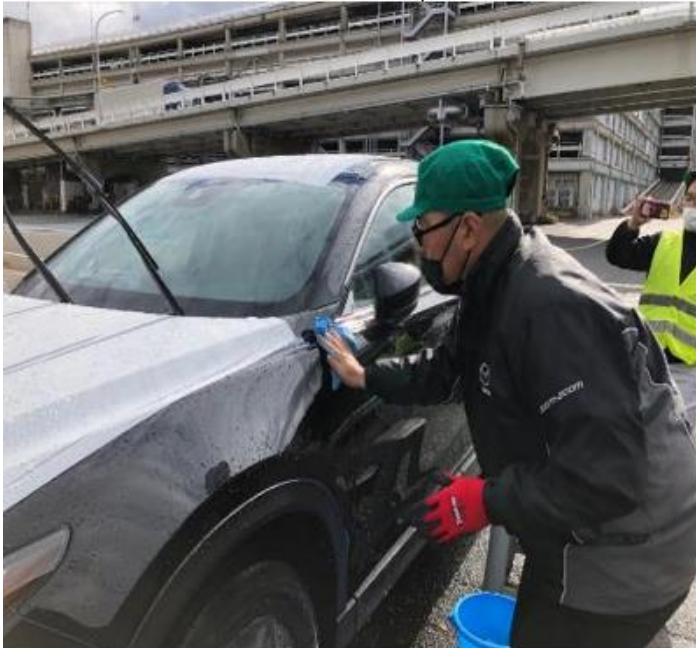
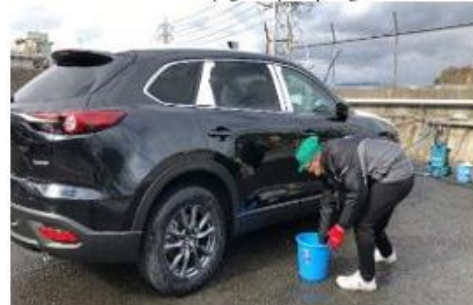
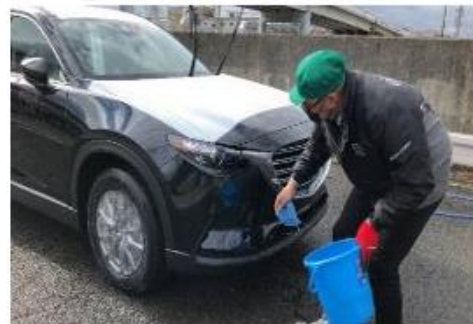
3. Soak the fine-texture car wash sponge with water (DO NOT squeeze out water). Gently wipe the vehicle to remove white contamination.
  - a. Soak the sponge with water frequently
  - b. Do not have to rub very hard
  - c. Do not touch the vehicle unnecessarily

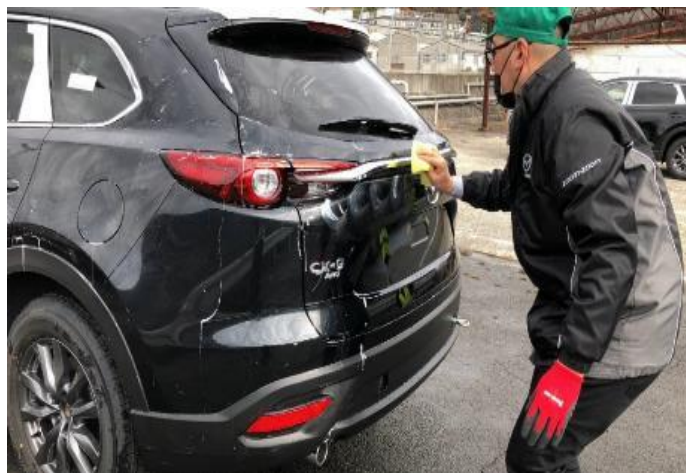
4. Soak the car wash sponge with plenty of water and car wash shampoo. Don't spray shampoo on a body directly.
  - a. Continue washing the spots with shampooed sponge lightly until the white residue is removed
  - b. Don't put too much effort, work in a polishing motion while checking for removal of the residue
  - c. Pay extra attention in cleaning the glass and horizontal surfaces (such as roof & hood) as well as vertical surfaces

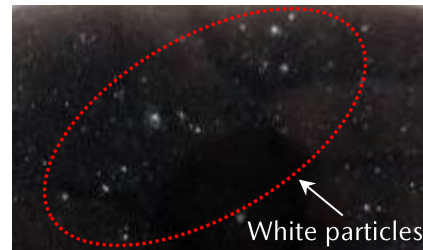
On the subject vehicles, atmospheric fallout (white particles/contamination) may be adhering on the body surface.

- 1) Perform visual inspection for entire surface of the vehicle.
- 2) If white spots from contamination are found on the body surface, remove them as outlined below.
  - a) Wet vehicle with warm water over the affected surfaces.
  - b) Remove the white spots using a soft cloth (such as microfiber) soaked in warm water.
  - c) Wash the affected area of body surface using car shampoo (mild acidity).
  - d) Confirm that no traces of white contamination remain on the body surface.
  - e) Finish by washing the entire vehicle.
  - f) Once dried, final check that no spots remain on the vehicle.
