TECHNICAL SERVICE BULLETIN

Crew Cab - Folding Rear Seat Backrest Assembly Excessive Latching Effort When Returning To The Upright Position

22-2026

Ford 2019-2022 Ranger	Crew cab
---------------------------------	----------

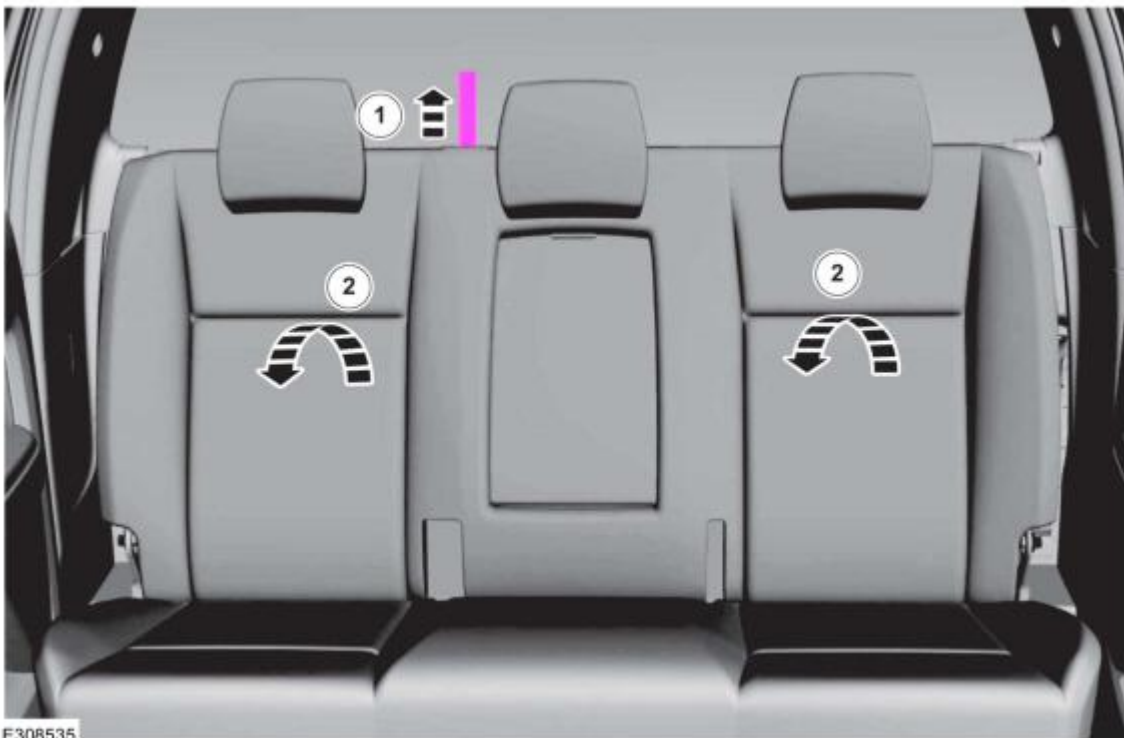
Figure 1

2. Release the rear seat backrest latch (Figure 1 Callout 1) and lower to the fold flat position. (Figure 1 Callout 2)

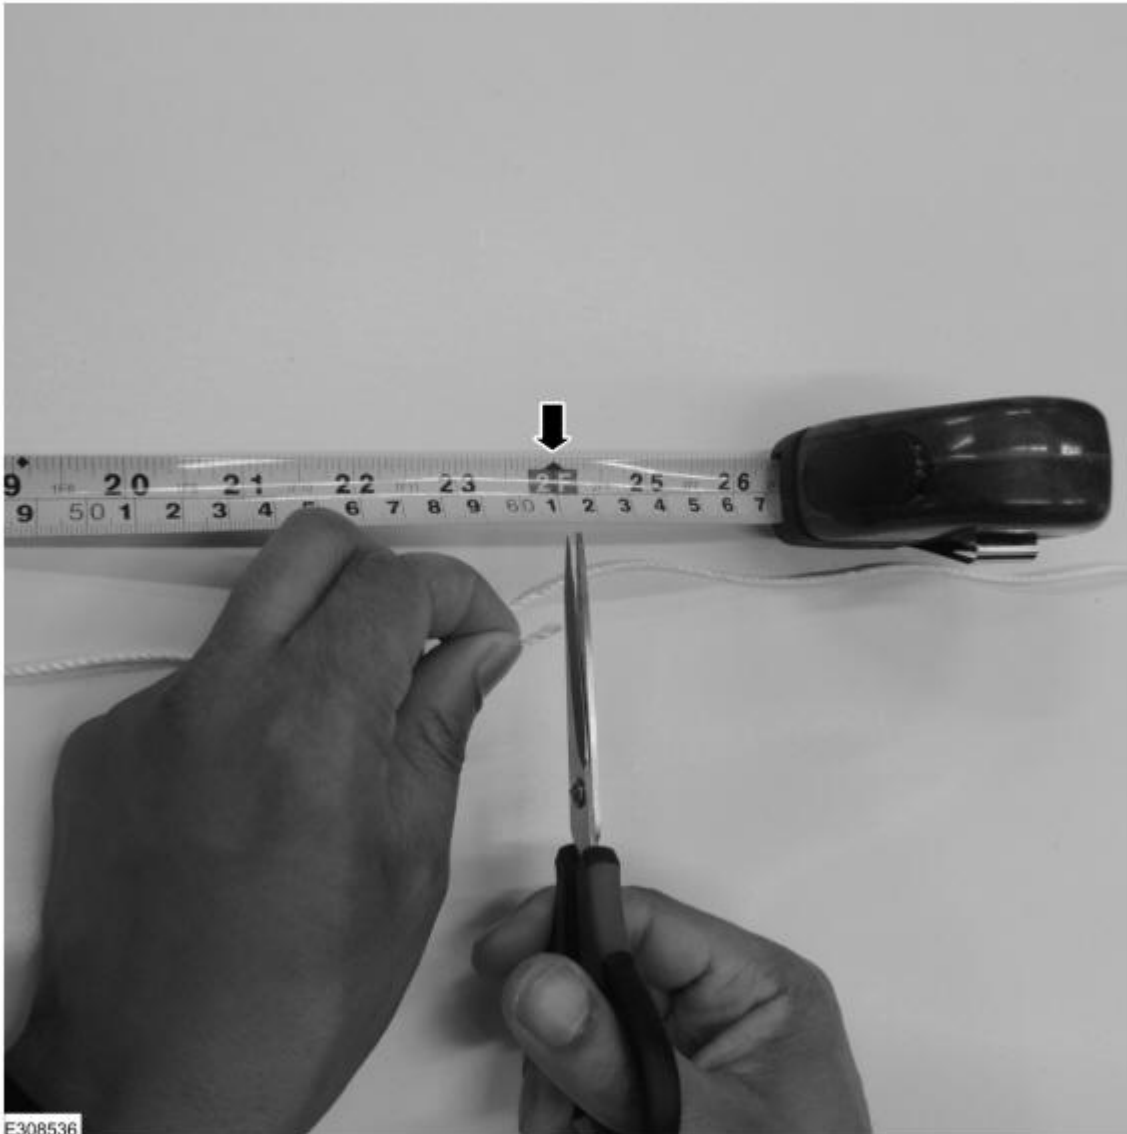
Figure 2

3. Measure and cut a 60 cm (2-foot) piece of string. (Figure 2)

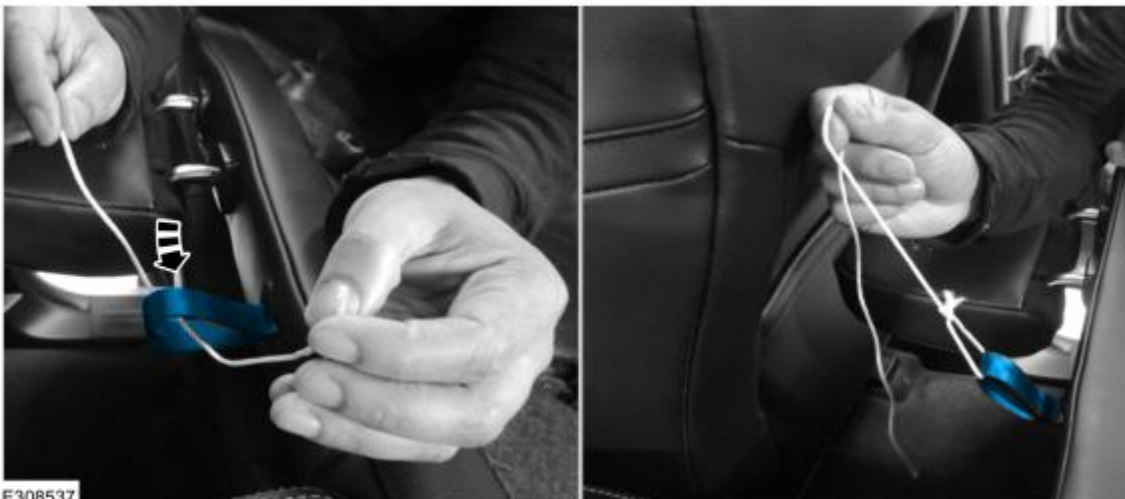
Figure 3

4. Guide the string through the rear seat backrest release strap and double knot a loose loop. (Figure 3)

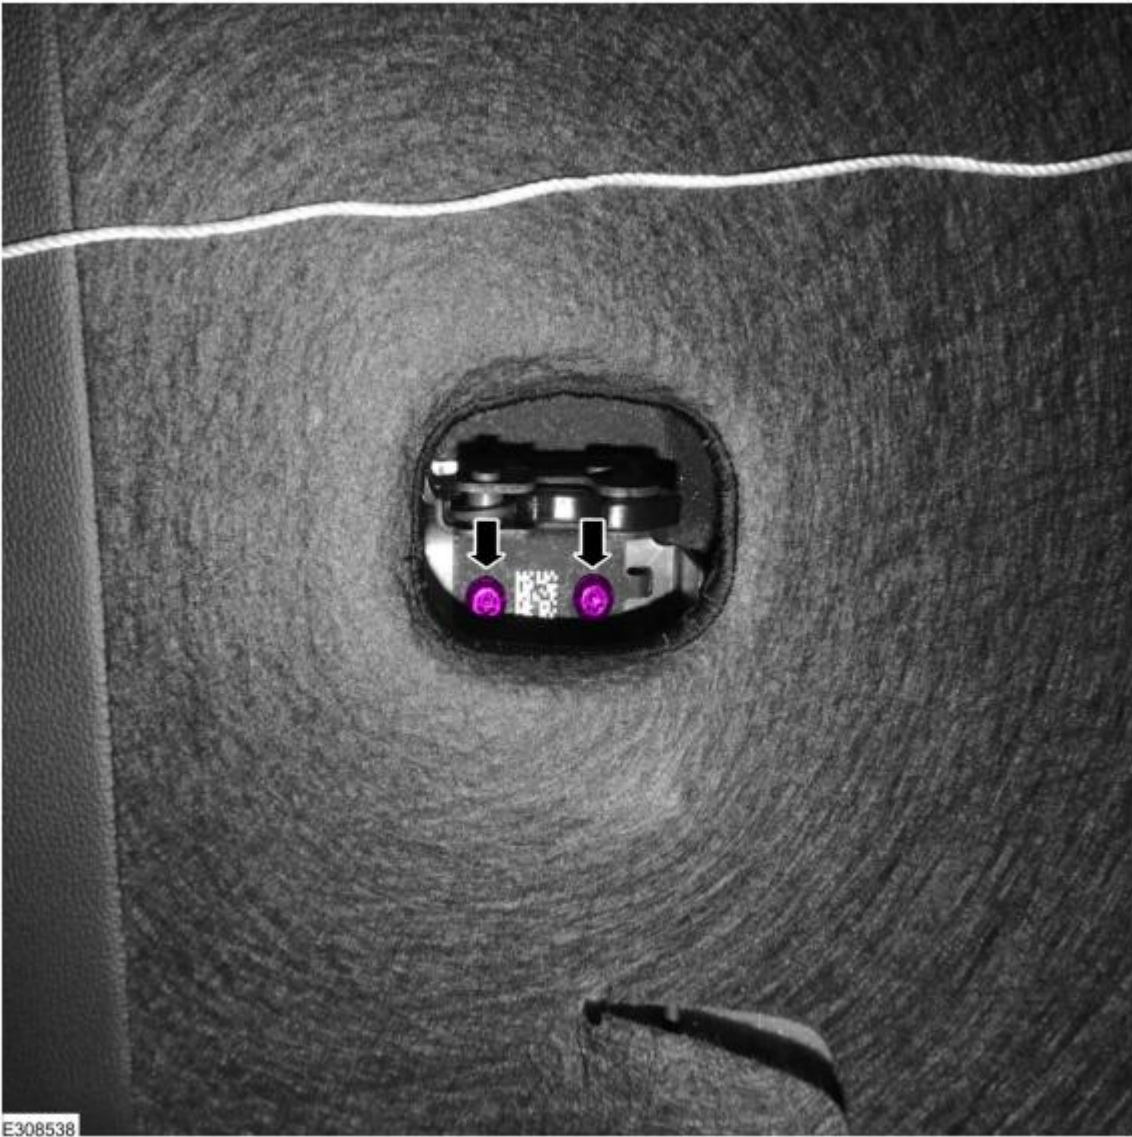
Figure 4

5. Remove the rear seat backrest latch retainers. (Figure 4)

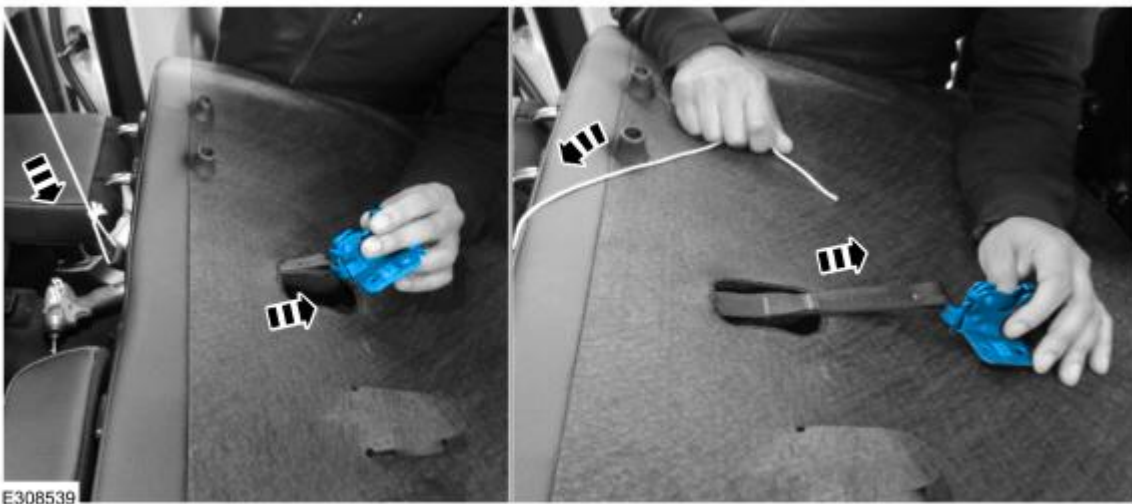
Figure 5

6. Holding the string, guide the rear seat backrest latch up and out of the rear seat backrest assembly just enough to access and remove the rear seat backrest latch release strap. (Figure 5)

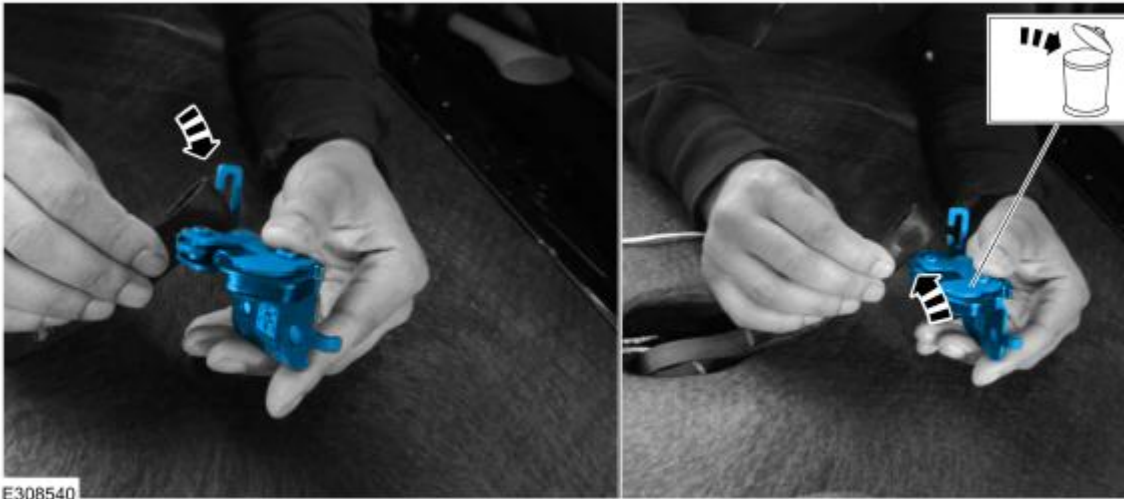
Figure 6

7. Remove and discard the rear seat backrest latch from the rear seat backrest release strap. (Figure 6)

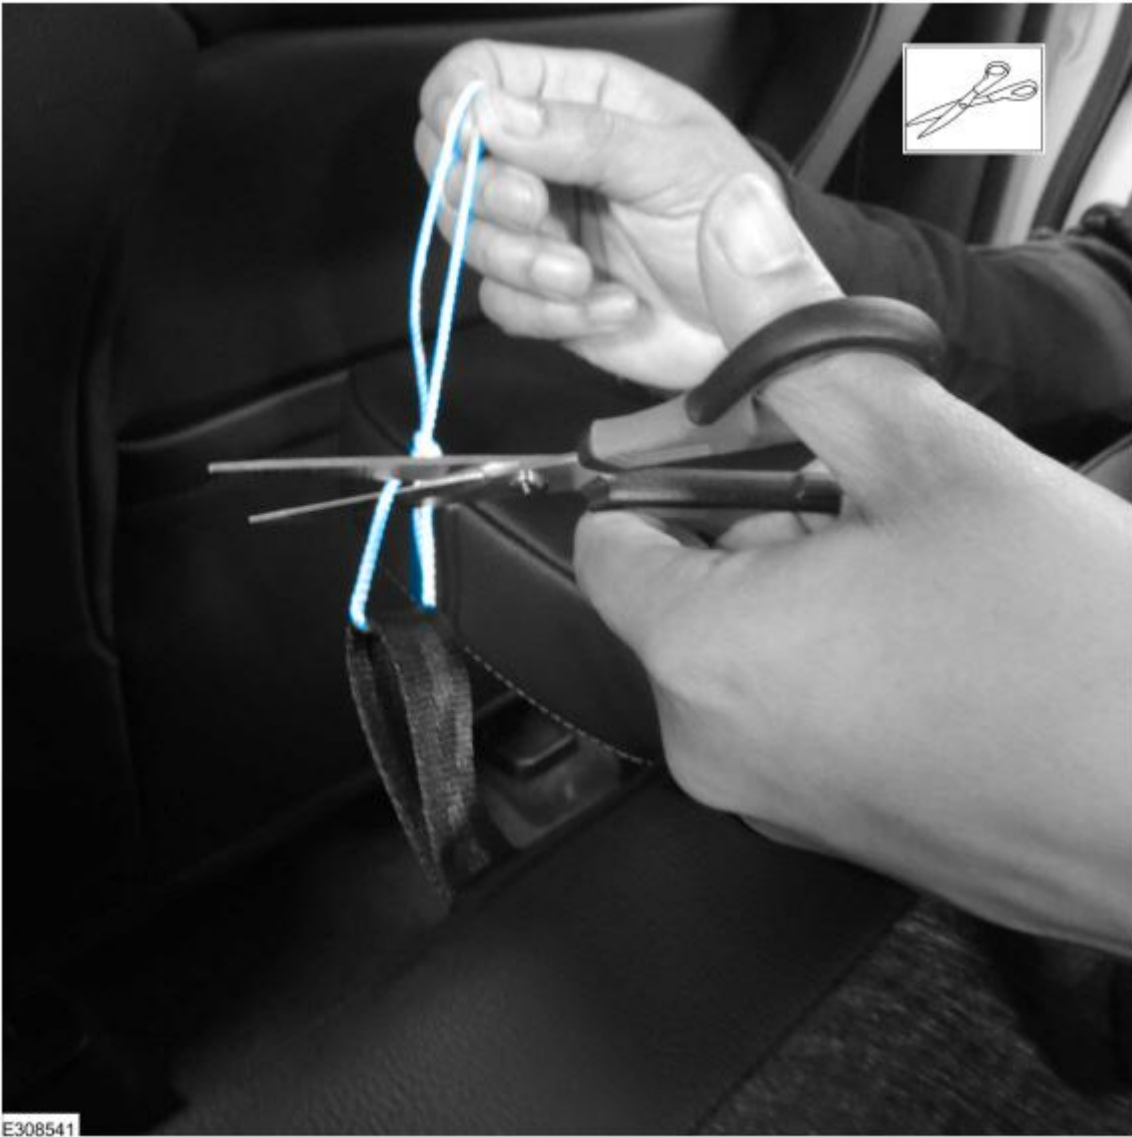
Figure 7

8. Install the rear seat backrest release strap onto the new rear seat backrest latch.
9. Install the new rear seat backrest latch by pulling the string attached to the rear seat backrest release strap back through the seat backrest cover and guiding the rear seat backrest latch back into the rear seat backrest assembly. (Figure 5)
10. Install the rear seat backrest latch retainers. (Figure 4)
 - (1). Tighten both retainers to 1.2 Nm (10.6 in-lb).
11. Remove the string attached to the rear seat backrest release strap. (Figure 7) Make sure to cut the string as far away from the rear seat backrest release strap as possible or damage to the release strap may occur.

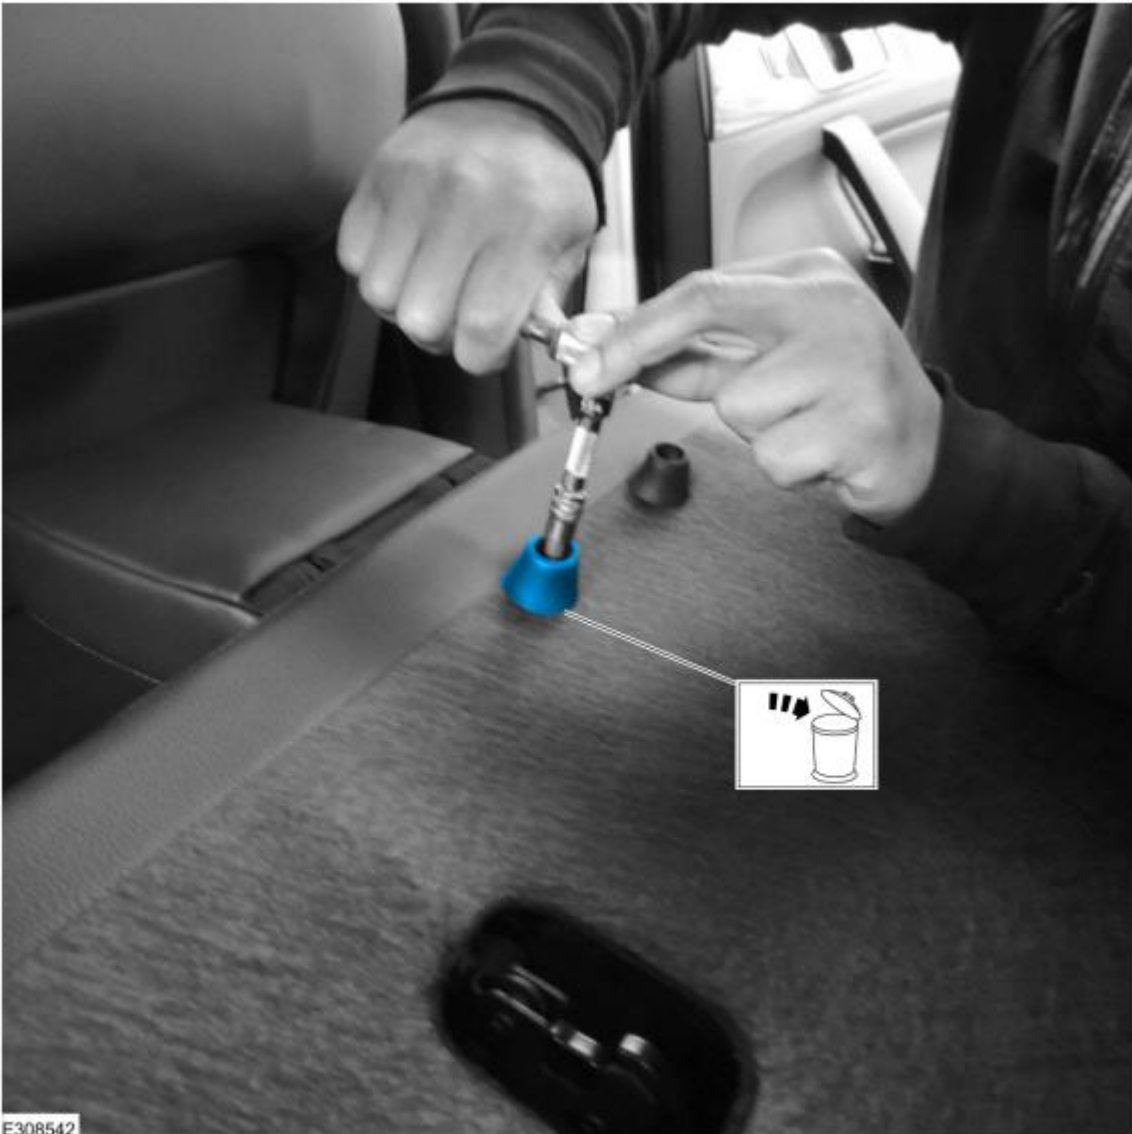
Figure 8

12. Remove and discard the passenger side inboard rear seat backrest bumper on the backside of the rear seat backrest assembly. (Figure 8)

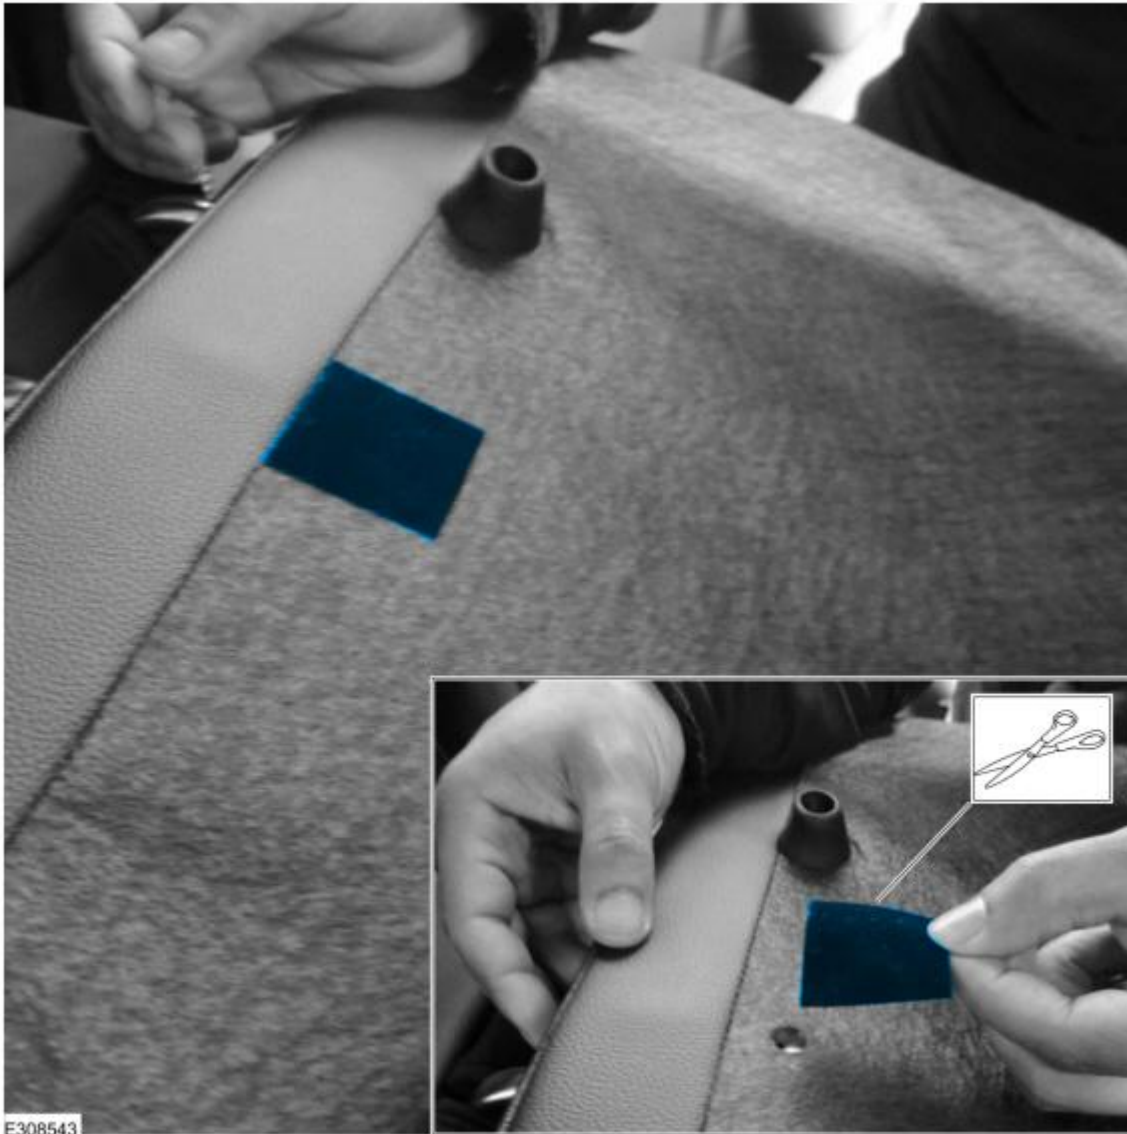
Figure 9

13. Cut a 40 mm by 40 mm (1.5 inch by 1.5 inch) piece of flock tape and install it over the rear seat backrest bumper retainer hole. (Figure 9)

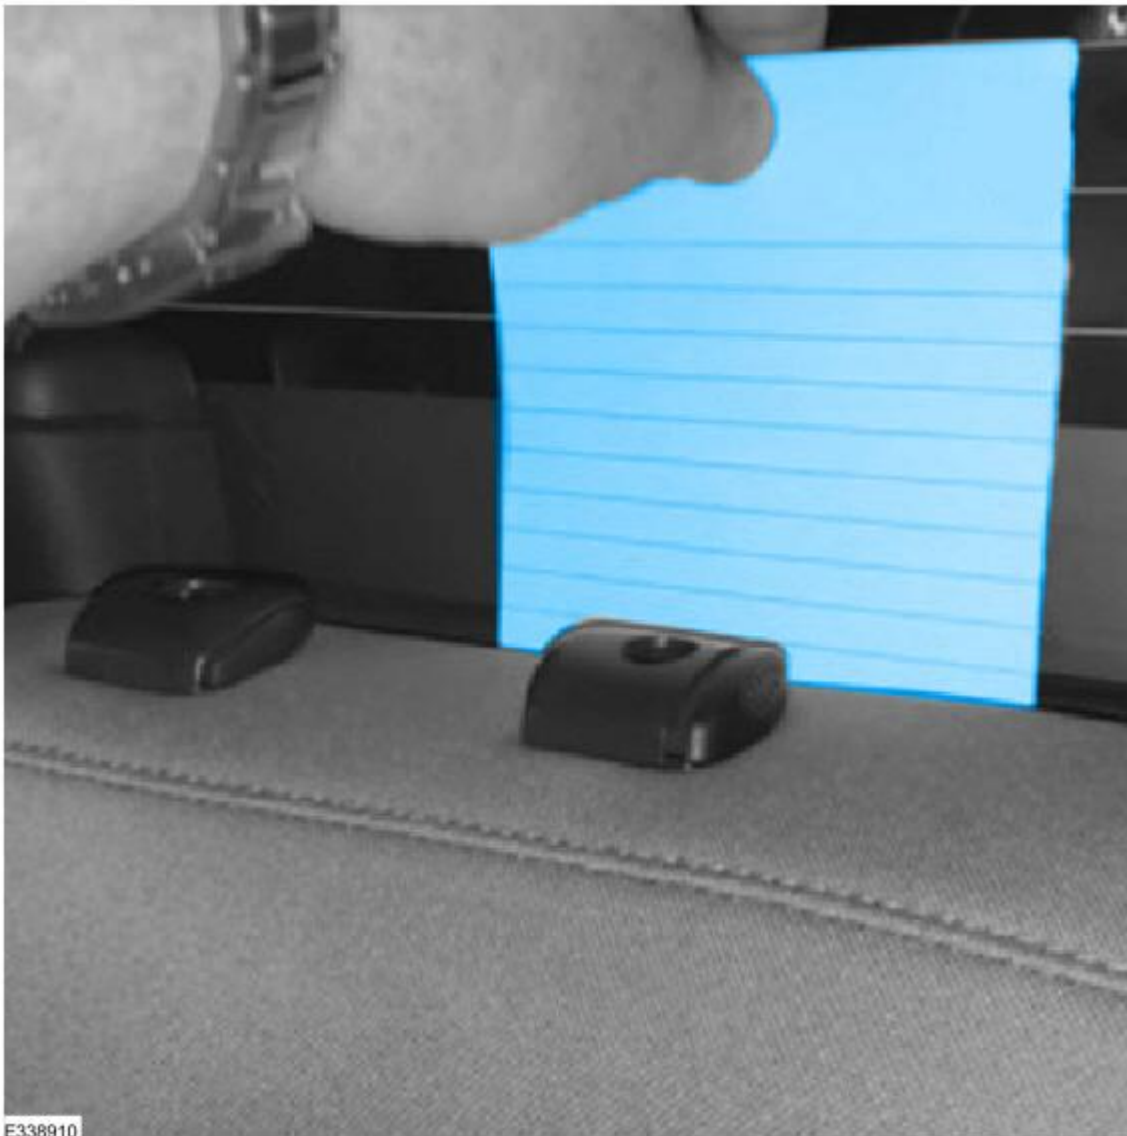
Figure 10

- (1). While covering one rear seat backrest bumper with a sheet of paper, raise the rear seat backrest so it is in the upright position, but not latched, and lightly tug on the paper to determine if that bumper is contacting the rear of the cab. Repeat this test on all 3 bumpers.

- (2). The rear seat backrest bumper that holds the paper will be considered rear seat backrest bumper 'X'. Remember the location of rear seat backrest bumper 'X', as it will be used later in the procedure. (Figure 10)

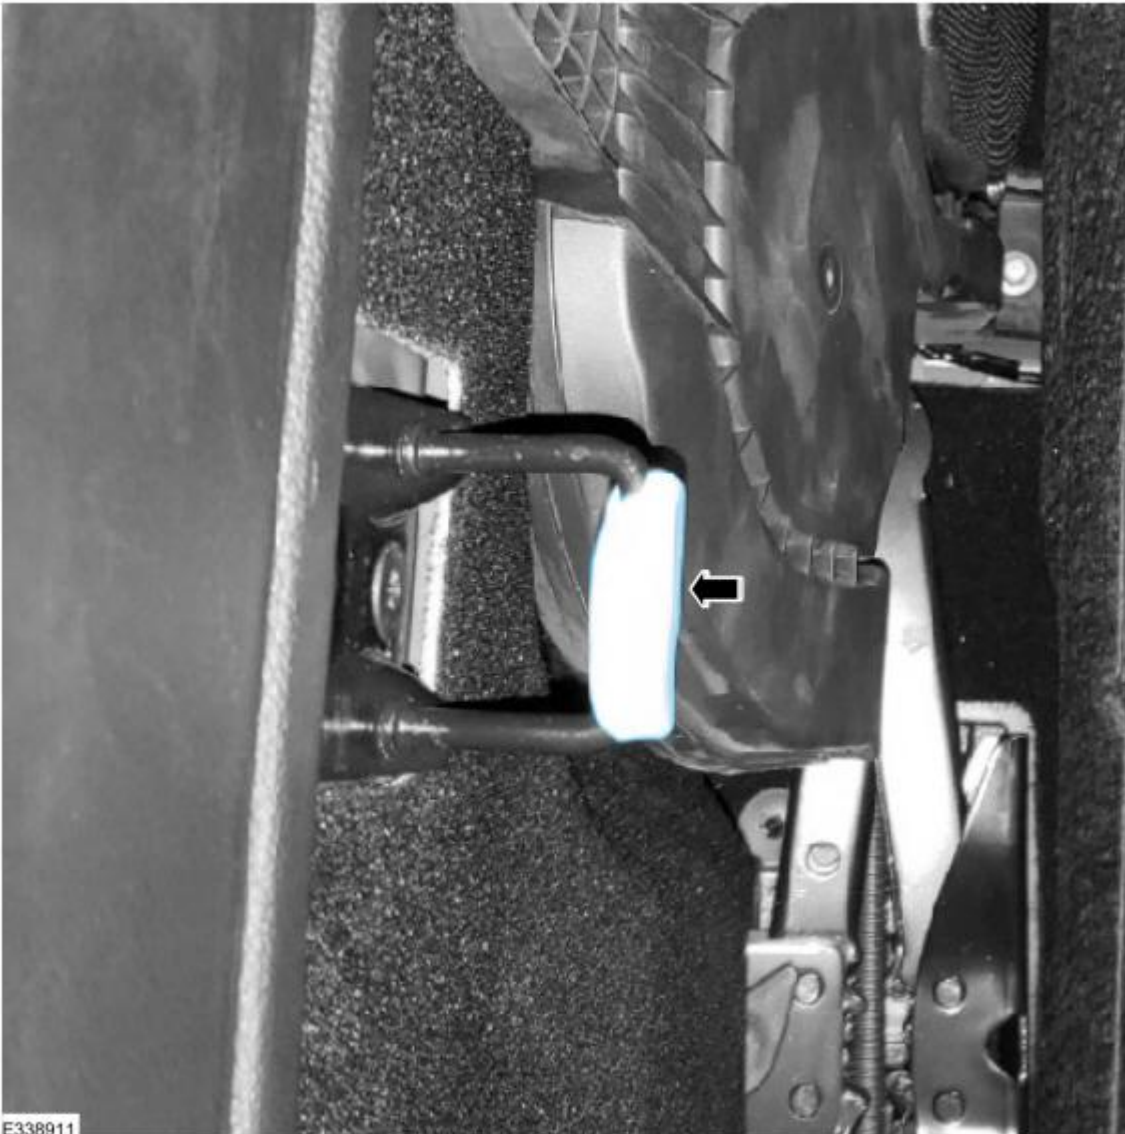
Figure 11

- (1). With the rear seat backrest assembly folded to the flat position, apply modeling clay to the width of the striker. The modeling clay should be no more than 5mm thick on the forward side of the striker. (Figure 11)
- (2). While holding a sheet of paper over rear seat backrest bumper 'X', raise the rear seat backrest assembly until vertical.
- (3). Allow gravity to pull the rear seat backrest assembly the rest of the way against the modeling clay while lightly tugging on the paper to confirm when the rear seat backrest bumper 'X' is against the cab. If the paper is not being held, apply very light pressure near rear seat backrest bumper 'X' until resistance can be felt when tugging on the paper.

NOTE: Applying too much pressure against the rear seat backrest may compress the rear seat backrest bumpers and give a false impression in the modeling clay.

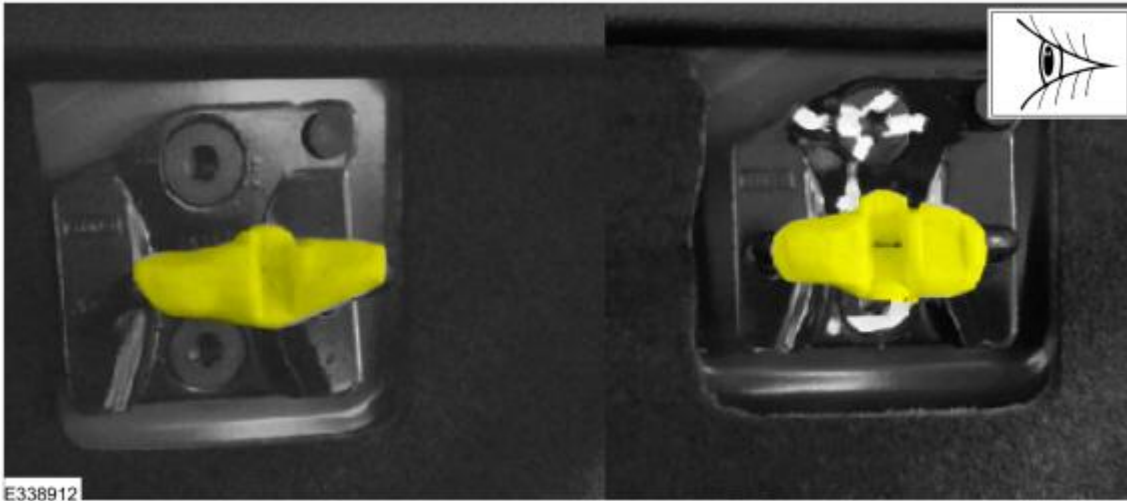
Figure 12

18. Lower the rear seat backrest assembly to the fold flat position and inspect the impression in the modeling clay left by the rear seat backrest latch. Is the striker visible through the modeling clay? (Figure 12)

(1). Yes - no adjustments to the rear seat backrest bumpers are necessary, however, material may be removed from the rubber bumpers to reduce seat latching efforts for customer preference, but removing too much material may result in rear seat backrest noise, vibration, and harshness (NVH) concerns.

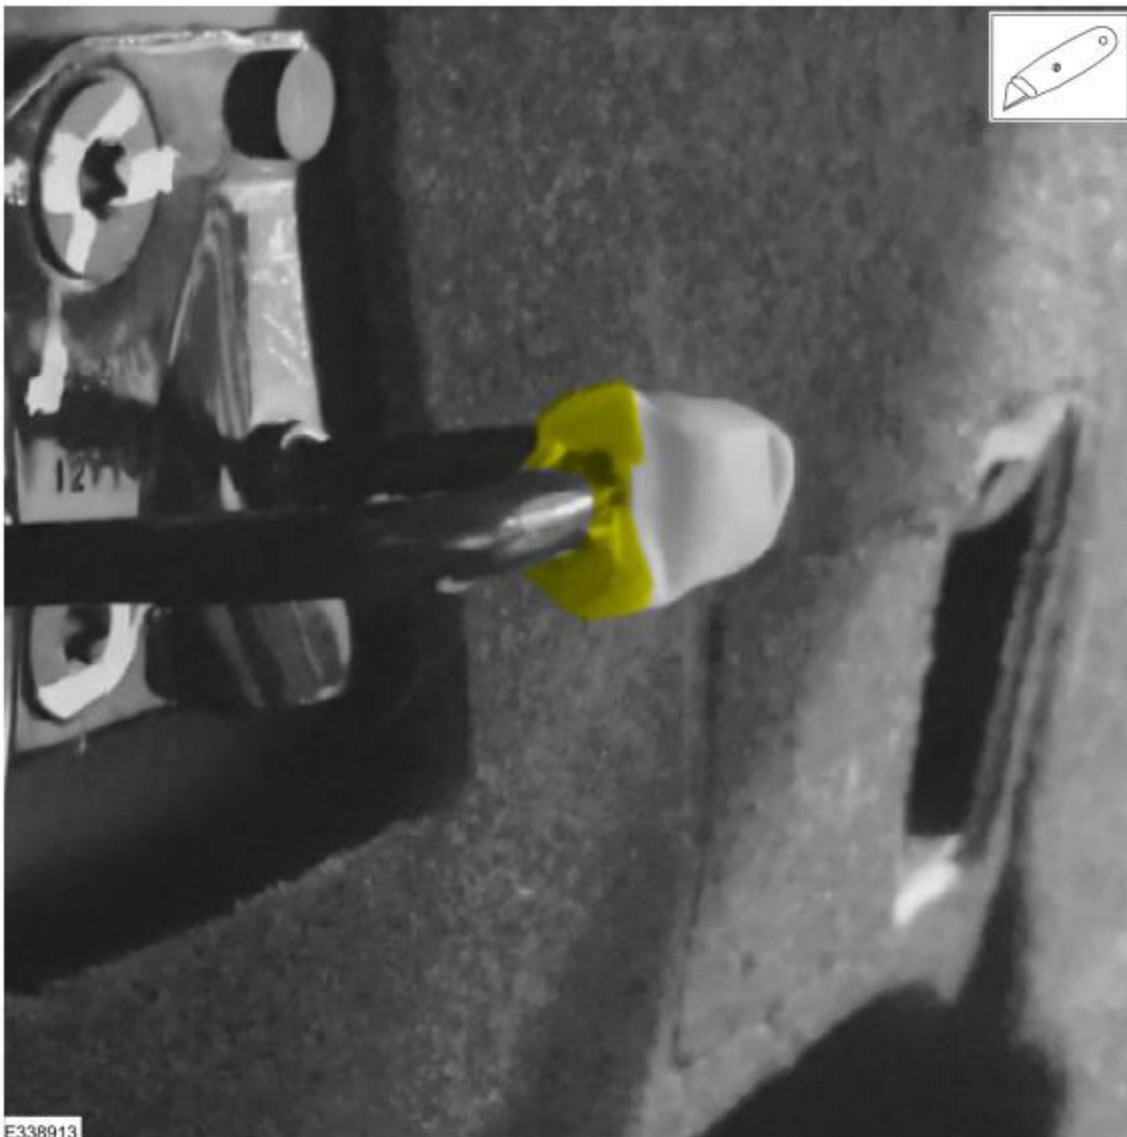
Figure 13

19. Using a knife or blade, cut away half of the modeling clay through the center of the impression to show a cross section of the impression left by the rear seat backrest latch. (Figure 13)

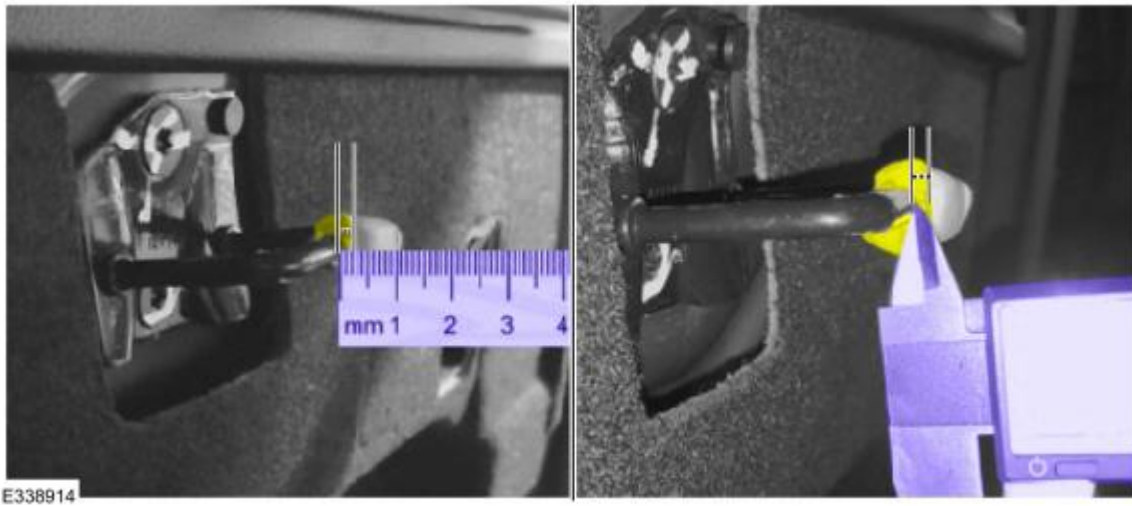
Figure 14

20. Using a ruler or dial caliper, measure the distance between the striker and the deepest part of the impression left in the modeling clay by the rear seat backrest latch. This measurement will be how much material is to be removed from each rear seat backrest bumper. (Figure 14)

21. Per the modeling clay measurement, mark the top of each rear seat backrest bumper in 4 places, 90° apart, to indicate the amount of material to be removed.
22. Using sand paper or sanding block (80 grit is preferred), remove the measured amount of material from each rear seat backrest bumper. Make sure that any shavings are cleaned prior to returning the vehicle to the customer.
