Bulletin No.: PIT5855B

PIT5855B Heated and Ventilated Seats Inoperative

Brand:	Model:	Model Years:	VIN:		Engine:	Transmissions:
			from	to		
Cadillac	XT5	2021	All	All	All	All
Cadillac	XT6	2021	All	All	All	All

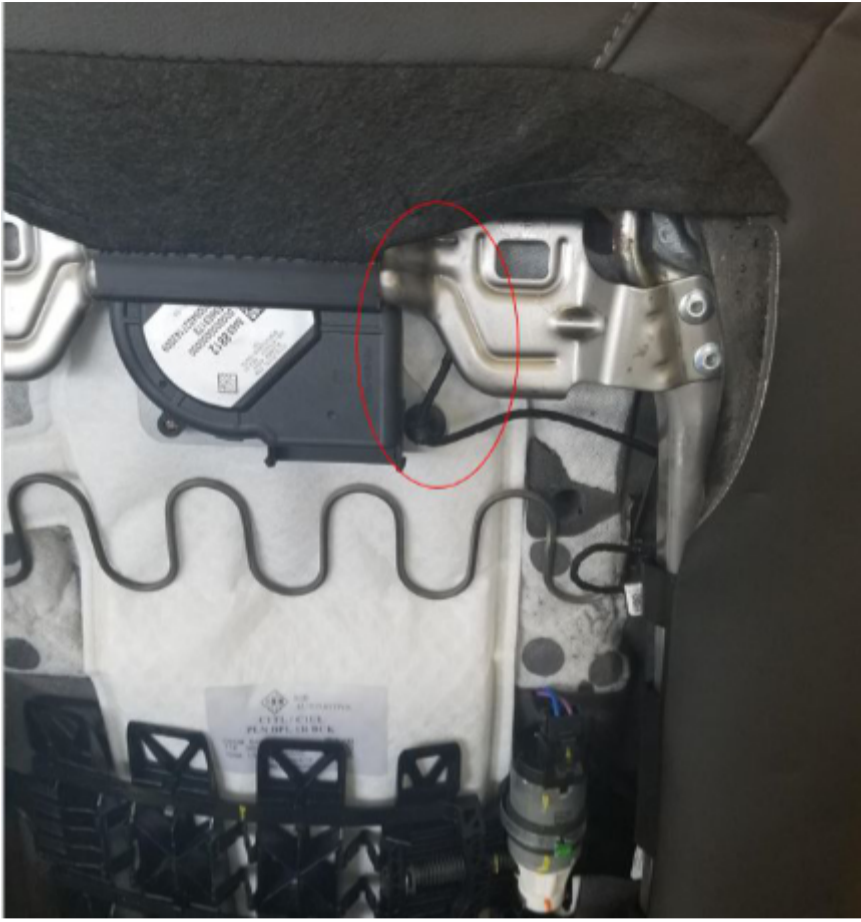
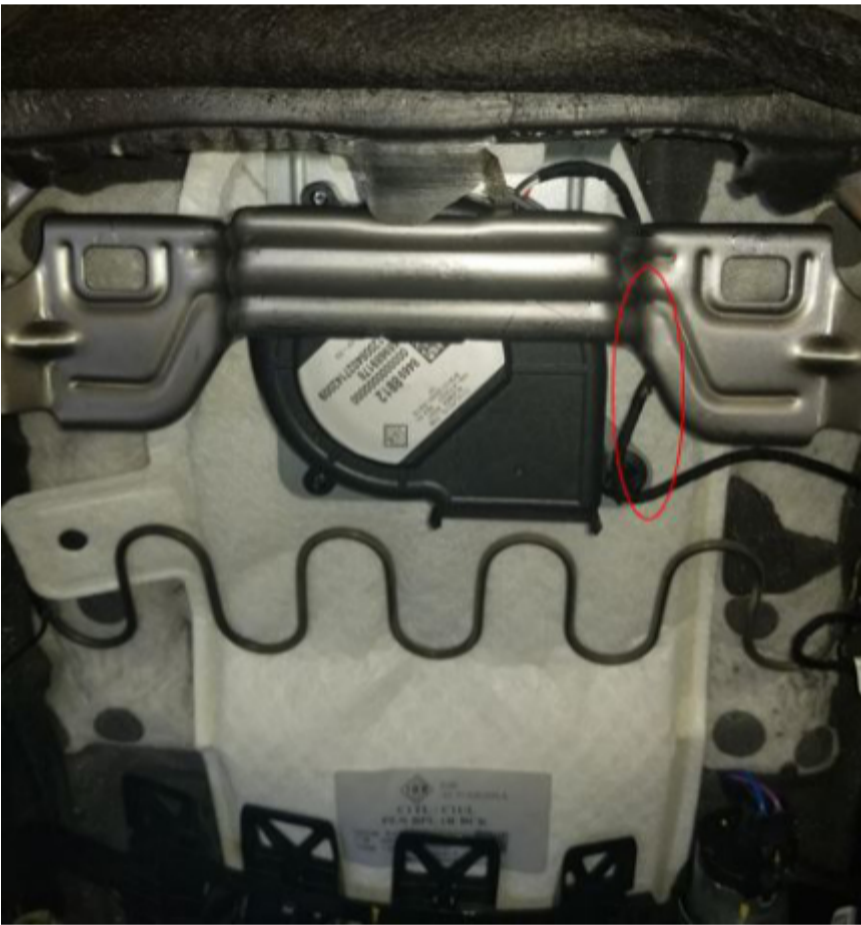
Inspect the harness that goes to the seat back blower for chaffing on the seat back frame in the areas shown below.

If no damage is found to the circuits in the passenger seat back, inspect the driver's seat

back in the same areas.

Repair the damaged circuits following the correct procedure in SI for wire and connector repair.

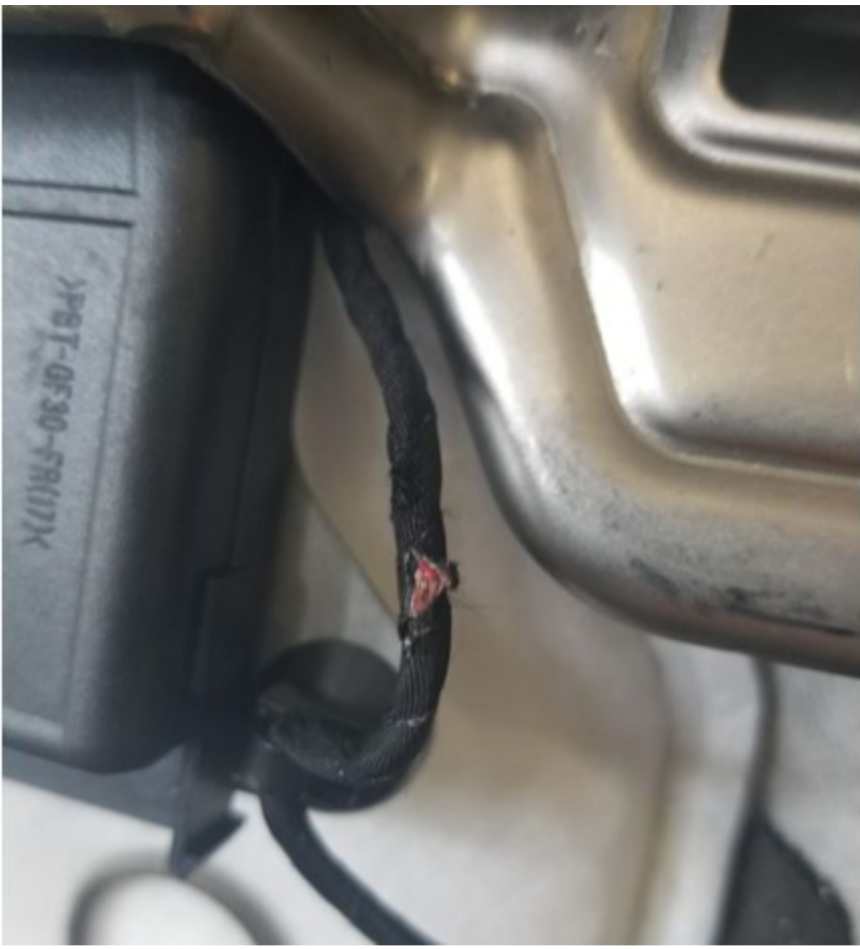
The harness may need to be moved to see the area that is damaged.

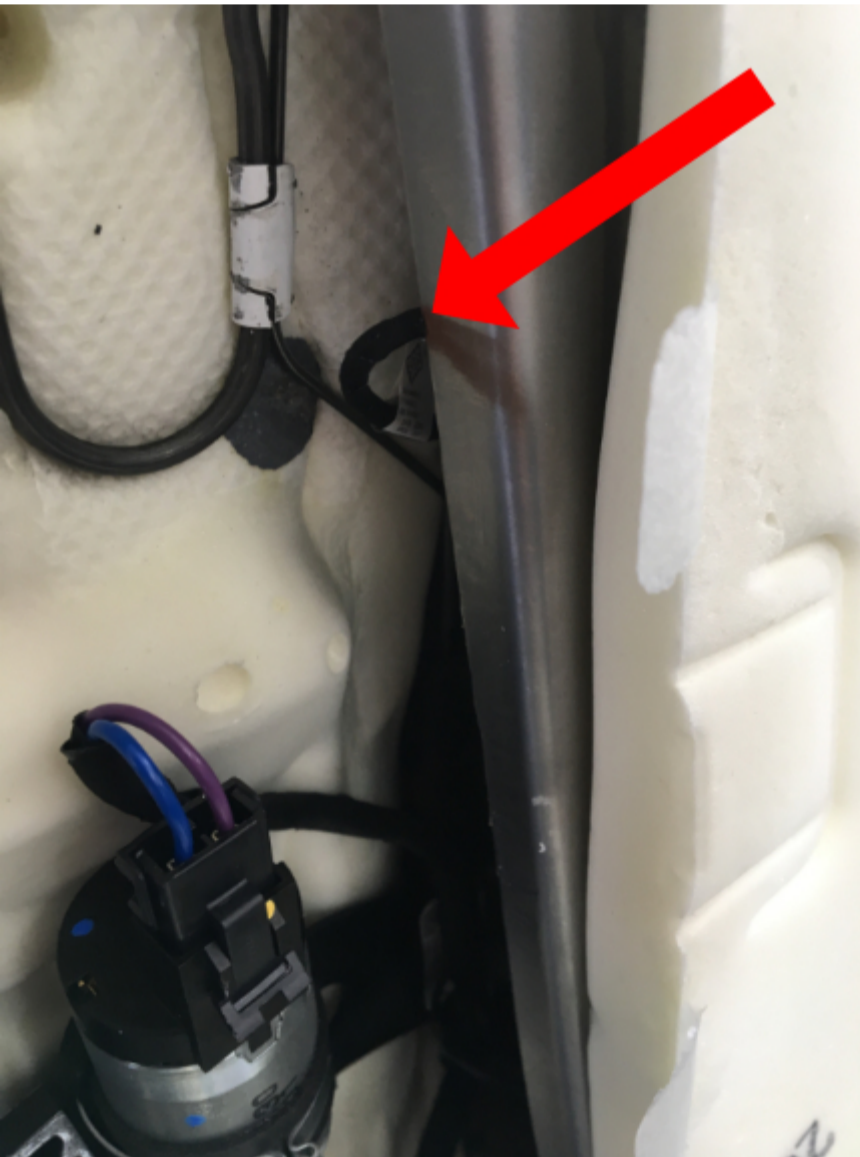
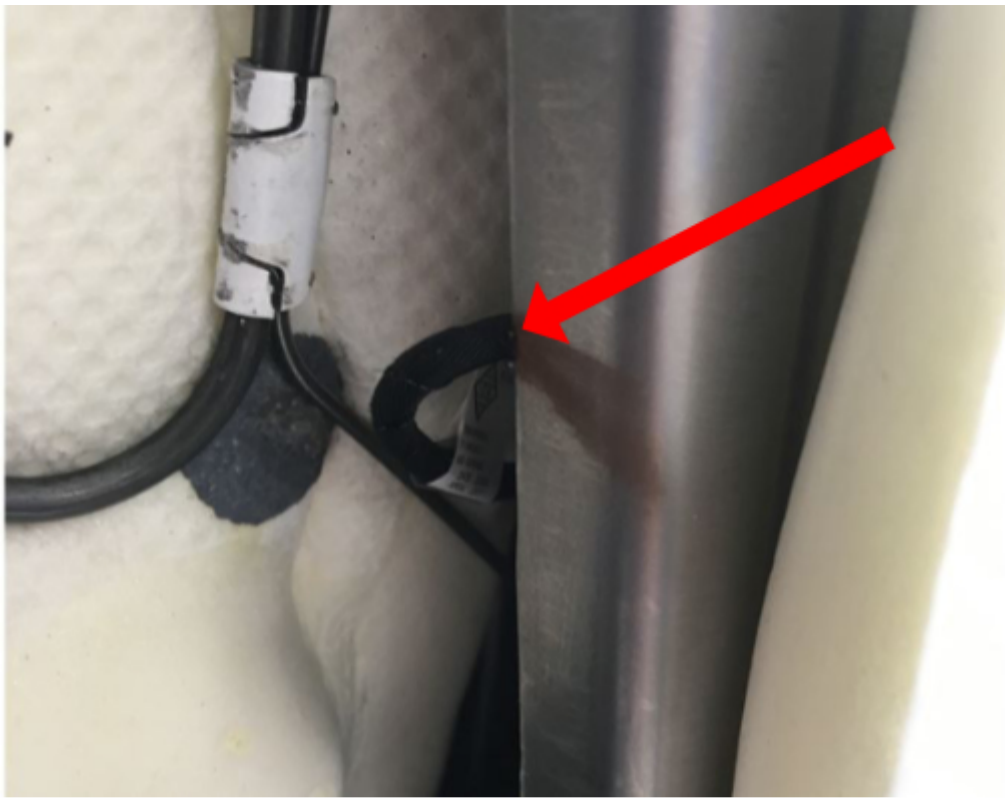
If no damage is found in this area, also inspect the harness along the side of the seat frame as shown in the two photos below.
