Preliminary Information

PIT5600D Dent/Ripple Appearance Around Wheel Well Opening

Brand:	Model:	Model Years:	VIN:		Engine	Transmissions:
	Model.		from	to	Engine:	Transmissions.
Chevrolet	Colorado	2015 - 2022	All	All	All	All
GMC	Canyon	2015 - 2022	All	All	All	All
Involved Region or Country: Nor		North America				
Condition:		Raised dents or ripple appearance in the side outer panel of the cargo box around the perimeter of the wheel house opening.				
Cause: Lo		Lodging of stone/aggregate/debris between the wheelhouse, and the side outer panel.

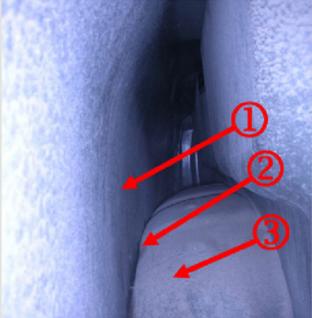
1. Remove the tail lamp to access the inner area of the side outer panel above the wheelhouse, see picture below.

2. Inspect for any stone/aggregate/debris. Remove as needed using a power washer and/or shop air blow gun.

3. The use of a body hammer (Snap on, cross peen, short curve, #BF608B, or comparable tool) to lightly tap the side outer panel may help to dislodge any stuck stone/aggregate/debris.

4. Access the rear of the inner wheelhouse area through the tail lamp cavity; and the front of the wheelhouse from under the vehicle, and coat the inner hem of the wheel house to side outer panel, with 3M Rust Fighter I, or equivalent, see latest version of 01-08-51-003.

8. Reinstall tail lamp.
