# Technical Service Bulletin

## 17 UV leak additive for finding oil leaks

17 22 17 2060750/3 March 3, 2022. Supersedes Technical Service Bulletin Group 17 number 21-12 dated February 2, 2021 for reasons listed below.

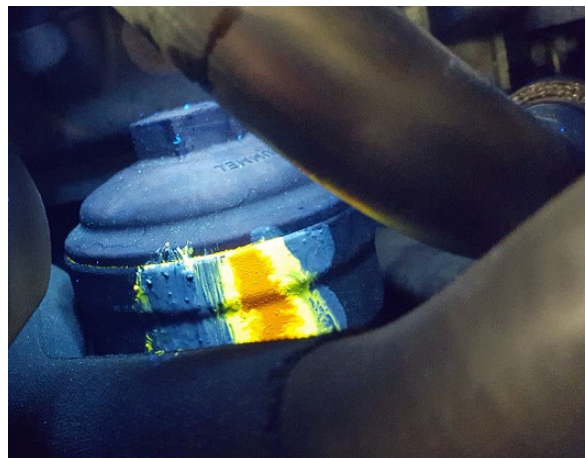
**Figure 1.** Example of finding a leak using the additive and UV lamp.

1. Add one bottle of search additive G 052 940 A1 to the engine via the oil filler neck. One bottle is sufficient for up to 5 quarts of engine oil. For larger oil quantities, use double the amount. There is no danger of damaging the engine if extra additive is put in.
2. Run the engine and locate the leak using UV lamp VAS 231005 or equivalent (Figure 1).
