Service Bulletin

Bulletin No.: 22-NA-047

Subject: Information on Coolant Loss and/or Coolant Odor

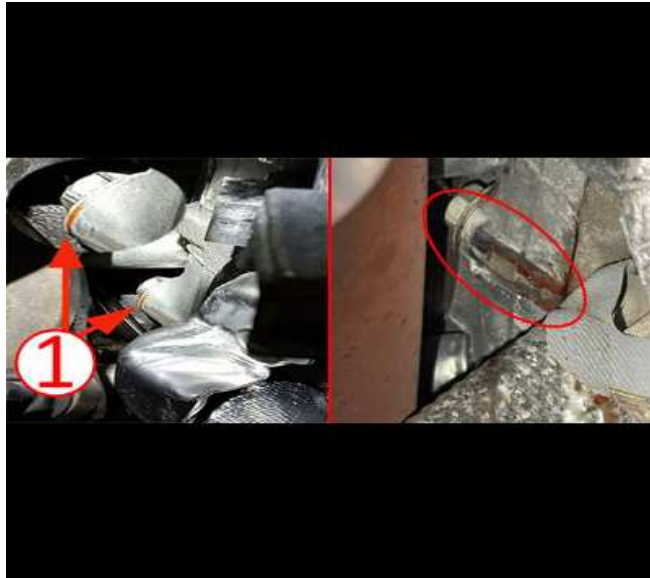
5994860

This condition may be caused by a coolant leak at the outer head bolt boss (1) on the cylinder head:

⇒ To verify this condition, pressure test the cooling system and inspect for a leak in this area. Streaks may also be noticed running down the side of the boss/head as well. Examples of leak are shown above.

If a leak is found in this area it may be caused by porosity within the right or left cylinder head and may require replacement.
