GROUP	MODEL
Emissions Service Campaign	2022MY Seltos (SP2), Soul (SK3)
NUMBER	DATE
SC224	March 2022

VOLUNTARY EMISSIONS SERVICE CAMPAIGN

SUBJECT: **ENGINE OIL FILLER CAP REPLACEMENT (SC224)**

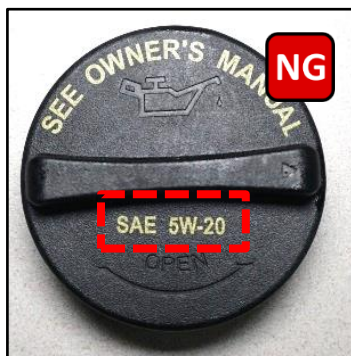
Incorrect Oil Filler Cap
(SAE 5W-20)

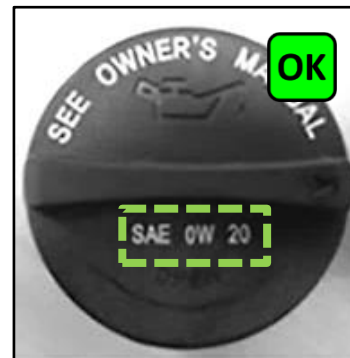
Correct Oil Filler Cap
(SAE OW 20)

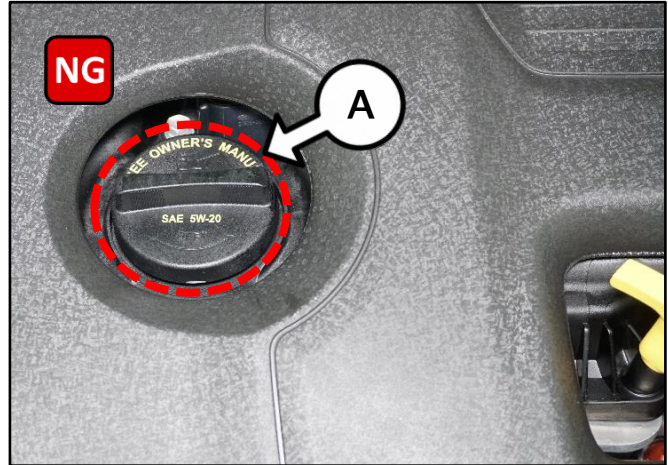
1. Open the hood and remove the existing oil filler cap (A).

Note: The incorrect viscosity is printed on the cap (SAE 5W-20).

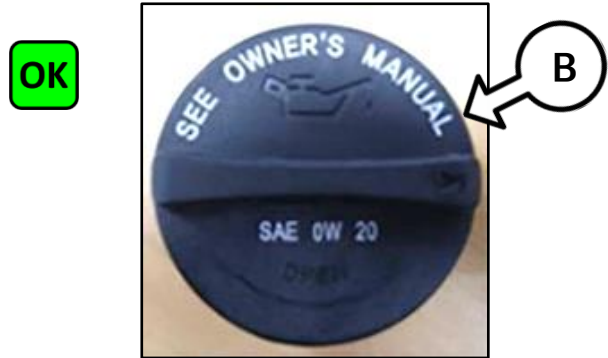
2. Replace with the new oil filler cap (B) with the correct viscosity printed (SAE 0W 20).

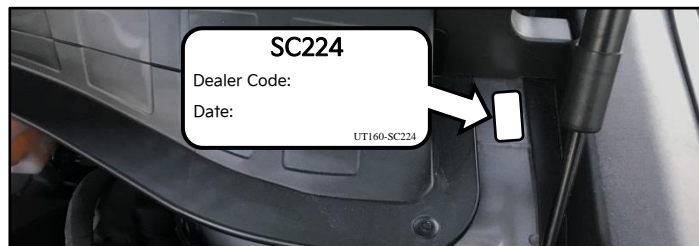
CA and S.177 States Only: Apply SC224 Campaign Completion Label onto the body in the area next to the shock tower, as shown. **NOTE: Be sure to clean the mounting surface to ensure proper label adhesion.**

The dealer must fill in the Dealer Code and Date information fields on the Campaign Completion Label. Once complete, affix the campaign completion label under the hood of the vehicle, as shown below.
