**1801.4** 4636

### **Brake Squeal**

Binder - Advanced Technical Information This bulletin replaces bulletin Group 4, #1801.3, dated 12/08/2020.

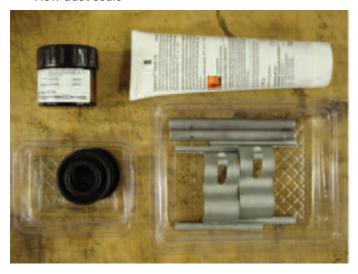
- Remove brake caliper
- Remove pads and hardware
- Have the following parts on hand:
  - Caliper paste 000.043.117.00
  - Optimoly paste 000.043.020.00 (the 100g tube should last through several repairs)
  - New hardware kit
  - New dust seals

• Clean brake caliper so that there are no contaminants present when the dust seals are removed

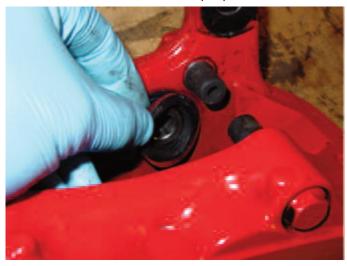
• Remove dust seals from the caliper pistons

- Extend the pistons against a block of wood to keep them from coming out of the caliper. (It may be necessary to retract and extend the pistons several times to free up the movement)
- Apply brake caliper paste to the piston and install new dust seals on the pistons
- Retract the pistons and seat the dust seals
- Install pads and new hardware
- Install caliper on vehicle
- Flush brake fluid
- Test-drive the vehicle
