Service Bulletin

PRELIMINARY INFORMATION

Subject: Underbody Component Corrosion

Models: 2022 and Prior GM Passenger Cars and Trucks (Excluding Medium Duty Low Cab Forward)

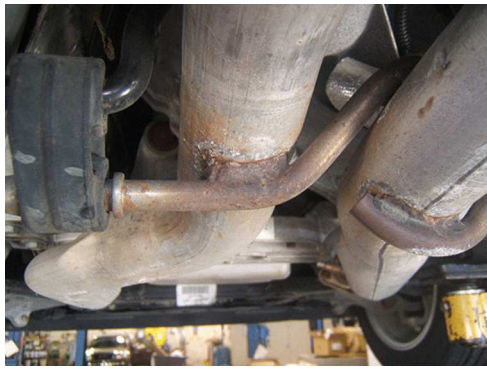
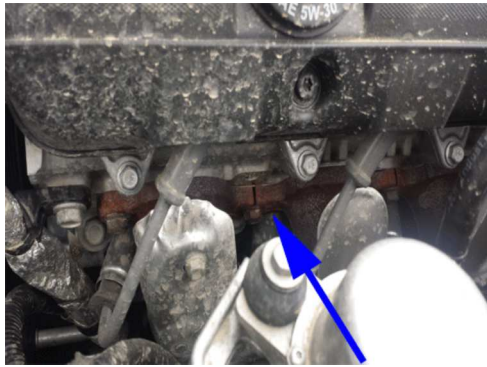
Exhaust system components

Note: During transit between the plant and the dealer, some of the exhaust system components may corrode as a result of salt exposure. These exhaust parts are made of a bare mild-grade stainless steel that will oxidize, or appear rusty. Over time, these components will have a uniform rust-like discoloration, which should be considered a normal condition.

No repair or consideration should be given for this condition. Surface corrosion on unprotected components will vary with age and exposure. Corrosion on these components has no detrimental impacts, either in short or long term durability.
