Service Bulletin

Bulletin No.: 16-NA-172

Subject: Information on Removal of Wheel Washers Prior to Installation of Outer Dual Rear Wheel

Brand:	Model:	Model Year:		VIN:		Engine:	Transmission:
		from	to	from	to		
Chevrolet	Express	2016	2022			All	All
GMC	Savana	2016	2022			All	All

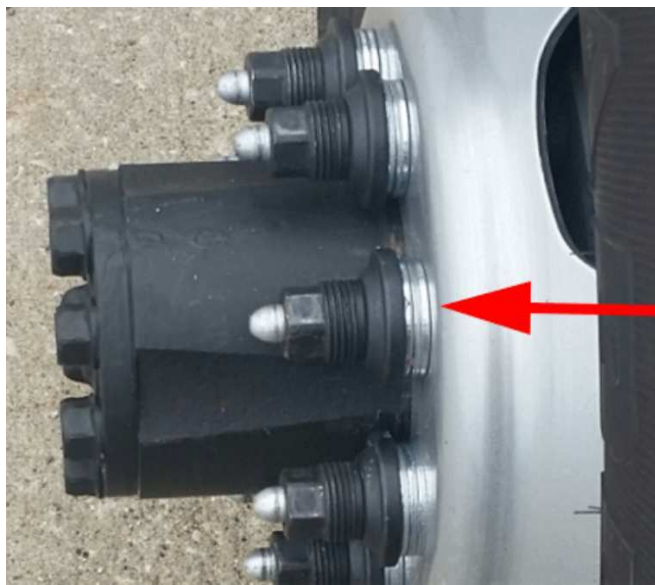
4520743

During transportation preparation, the outer dual rear wheels are removed and 3 washers are installed on each wheel stud for proper lug nut torque. This ensures the nut threads are not damaged by bottoming out on the wheel bolt.

Prior to reinstallation of the outer dual rear wheels, ensure that the washers are removed and inspect wheel bolts and lug nut threads for damage.
