| Subject: ACCESSORY ILLUMINATED DOOR SILL PLATE INSTALLATION INSTRUCTIONS CORRECTION | Service Alert No.: SA-027/22 |

2023 CX-50

DESCRIPTION

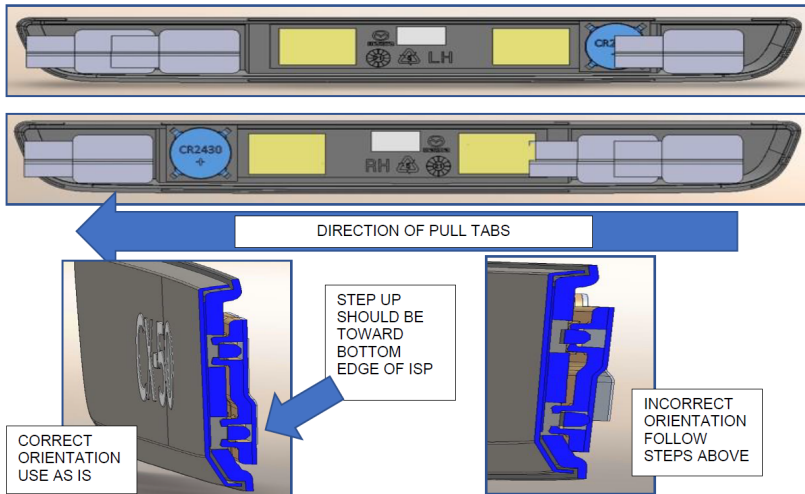
CLIP ORIENTATION

1. Remove both left and right front scuff plates from the foam sleeve.
2. Turn over and observe the orientation of the attachment clips located on the backside of the parts.
3. Clips should be oriented as shown below.

4. If clips are in the wrong orientation, remove them from the scuff plate and reinstall them in the correct orientation.
