TECHNICAL TOPICS

3rd Row Seat Folding Actuator Lower Level Assembly

17MY-Onwards Discovery

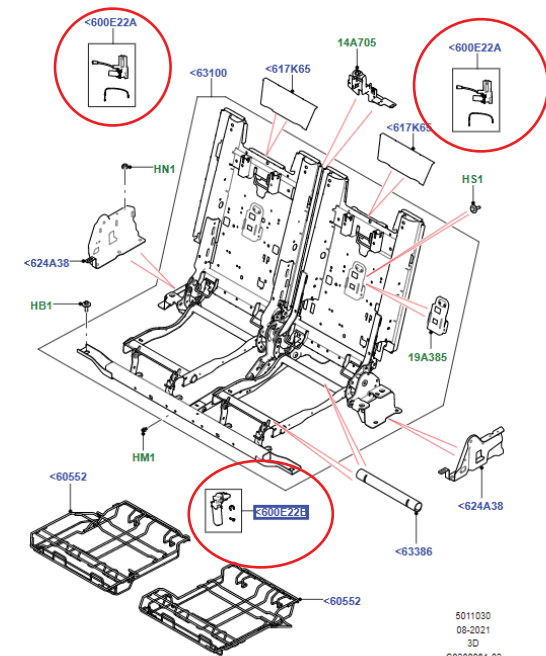
- A customer may report that the 3rd row seat backrest is stuck in the upright position.

- This may be caused by a 3rd row seat fold motor malfunction.

- The 3rd row seat backrest and base motors have now been released as a lower level service part, preventing the need to replace the seat frame assemblies to service the motors.
- Please refer to the lower level assembly service parts to conduct repairs wherever possible upon diagnosis of a seat fold motor failure.
- The service procedure has been added to the Workshop Manual, section 501-10: Seating > Removal and Installation > Third Row Seat Recline Motor or Third Row Seat Folding Actuator Motor.
