STAR ONLINE PUBLICATION

Case Number: S2121000014 REV. C

Symptom/Vehicle Issue: Service 4WD Message Illuminated. Diagnostic Trouble Code (DTC) C1472-92 – Transfer Case Clutch Control – Performance or Incorrect Operation.

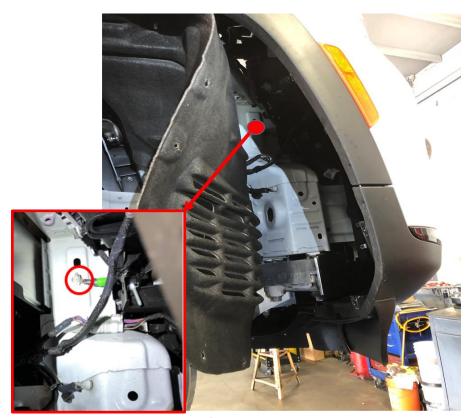
Figure 1.

- f. Shift the vehicle back into park and repeat steps a-d.
- g. Clear all DTCs and take the vehicle for a test drive to ensure the C1472 does not return.
- 4. Did C1472-92 reset?
 - a. Yes>>> Closely inspect ground G910A for being loose, and repair as necessary. Please see (Figure 1.) for location. If no issues are found with G910A, please contact Star for further diagnostics.
 - b. No>>> No further action is required. Release the vehicle to the customer.
