SIB 51 02 22

SERVICE ACTION: OPTIONAL ACCESSORY MIRRORS

2022-02-04

| Model | Model Description |
|---|---|
| K63 | S 1000 R |

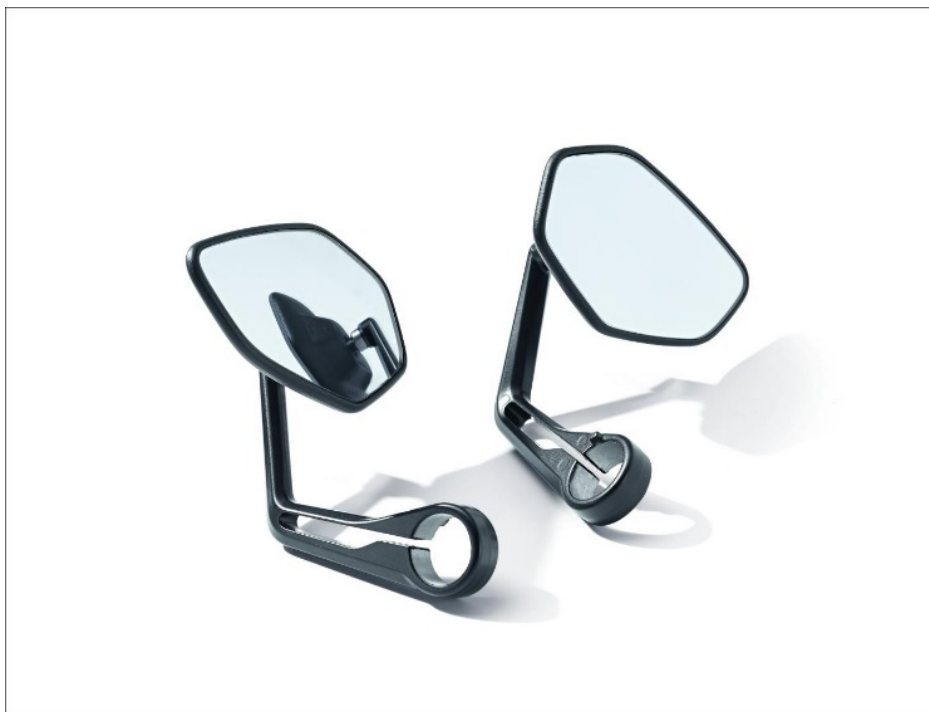
Bonding on the K63 handlebar accessory mirrors may fail, resulting in the loosening of the mirror-glass at the mirror assembly.

The following part numbers are affected:

- 51 16 1 542 963 – Handlebar end mirror, left

- 51 16 1 542 964 – Handlebar end mirror, right

If the handlebar-end optional accessory mirrors are found on K63 motorcycles, and they are not engraved with AI 04 or AI 06, please replace them with new parts, numbers listed below, using installation instructions “77 22 028 – install mirror, right and left”.

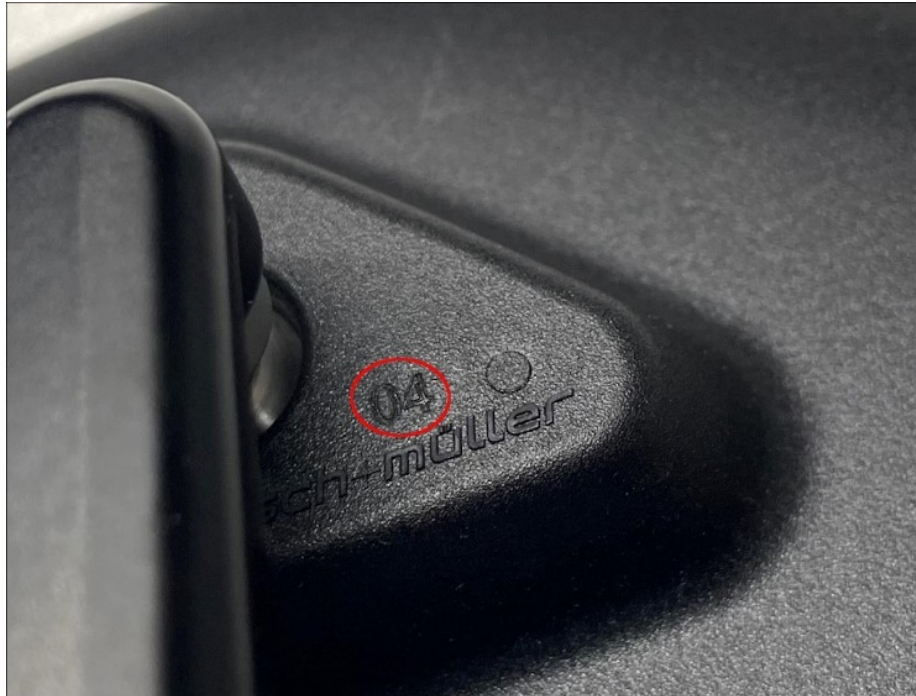
New revised accessory handlebar-end mirrors with markings AI 04 and AI 06 have improved bonding material and are offered as the replacement for the previous versions.

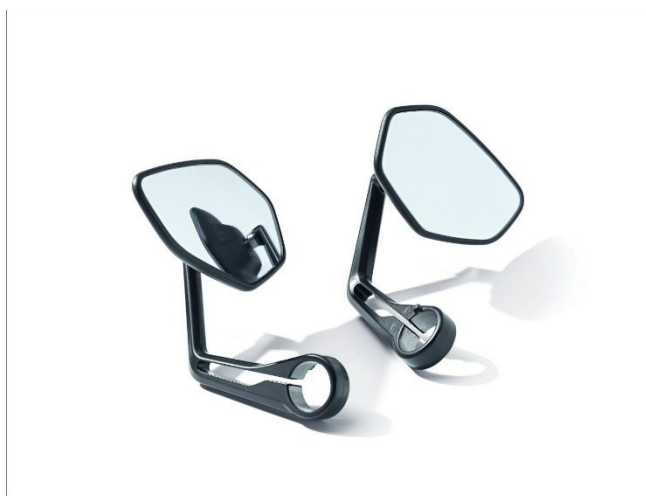
Bonding on the K63 handlebar accessory mirrors may fail, resulting in the loosening of the mirror-glass at the mirror assembly.

The following part numbers are affected:

- 51 16 1 542 963 – Handlebar end mirror, left
- 51 16 1 542 964 – Handlebar end mirror, right

If the handlebar-end optional accessory mirrors are found on K63 motorcycles, and they are not engraved with AI 04 or AI 06, please replace them with new parts, numbers listed below, using installation instructions “77 22 028 – install mirror, right and left”.

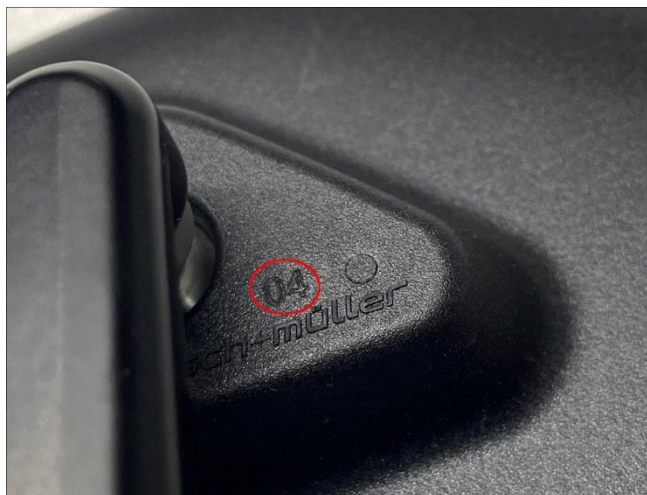
New revised accessory handlebar-end mirrors with markings AI 04 and AI 06 have improved bonding material and are offered as the replacement for the previous versions.
