Service Bulletin

Bulletin No.: 19-NA-233

Subject: Diagnostic Tip for Misfire, Malfunction Indicator Lamp (MIL) Illuminated - DTCs P0300, P0301. P0302. P0303 and/or P0304

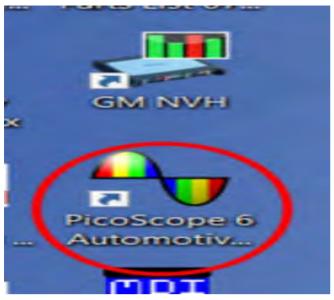
5419685

- Remove the Fuel Pump Relay from the Underhood Fuse Block.
- Connect the PicoScope to the computer using the included USB cable as you would do using GM NVH.
- 3. Connect test leads to the battery (hook the colored lead to Battery (+) and the black lead to Battery (-)) and to channel A of the PicoScope.

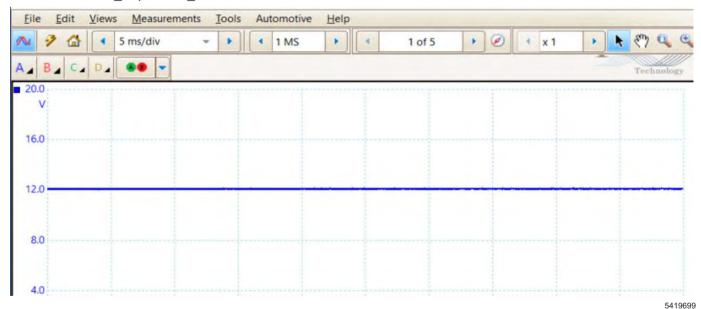
5. With the PioScope hooked up and the software running, a steady line at battery voltage on the graph should be displayed.

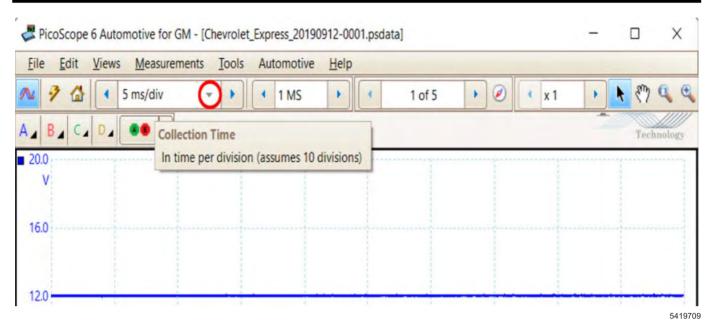
6. Select the Collection Time drop down.

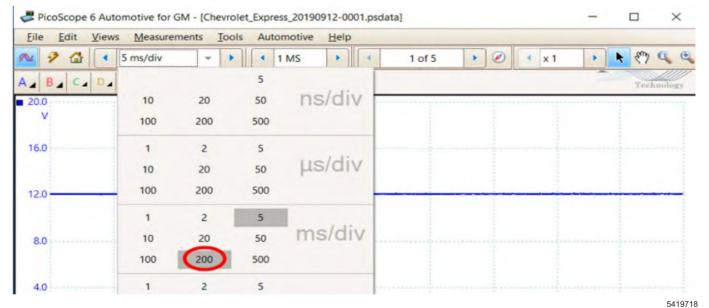
Change the collection time from 5ms/div to 200 ms/div.

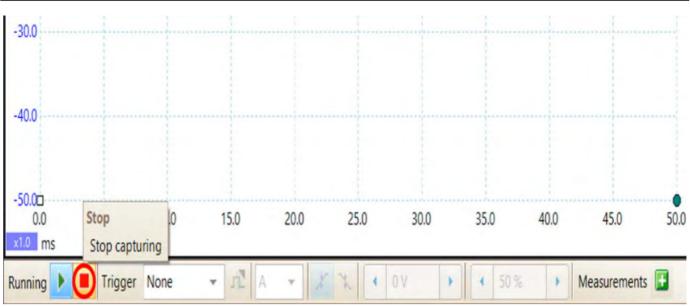
- 8. Crank the engine for two to three seconds.
- 9. Immediately after cranking the engine, select the Stop capturing button at the bottom of the screen.

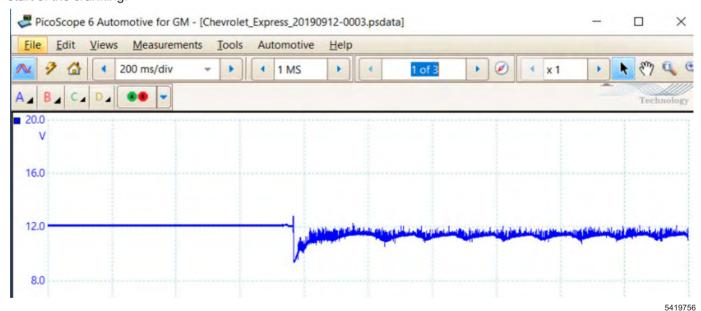
To view the Wave Form, zoom in to the right side of the graph.

The graphic above depicts a viewable Wave Form Pattern.

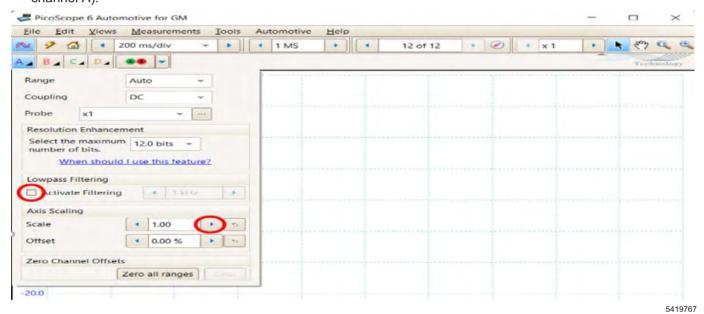
The channel options screen should be displayed.

- Select the Lowpass Filtering Active Filtering check box (1kHz to start).
- ⇒ Change the Axis Scaling Scale value to 26.00.

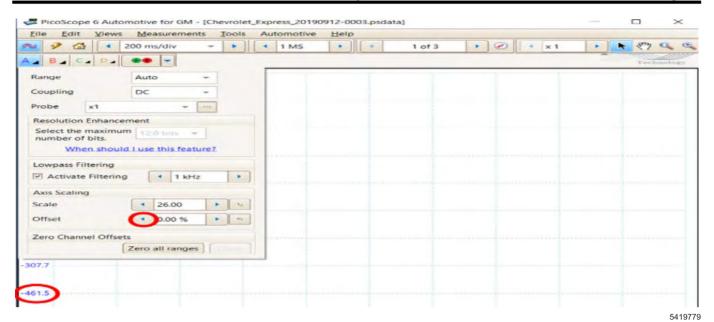
Take note, the voltage graph appears to have disappeared, but if you look at the scaling on the left, you will see that the value is a very high negative number.

⇒ Use the axis scaling offset to bring the graph back into view.

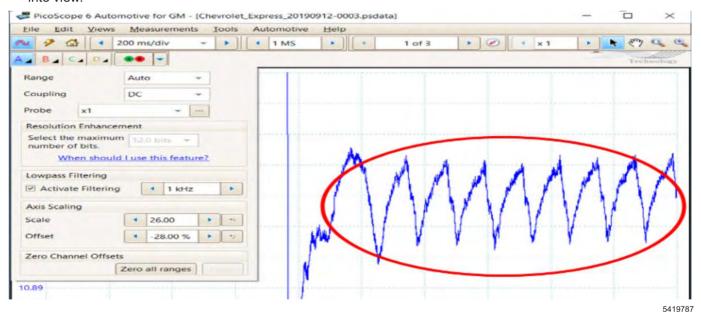
The graphic above depicts a viewable Voltage Graph Pattern.

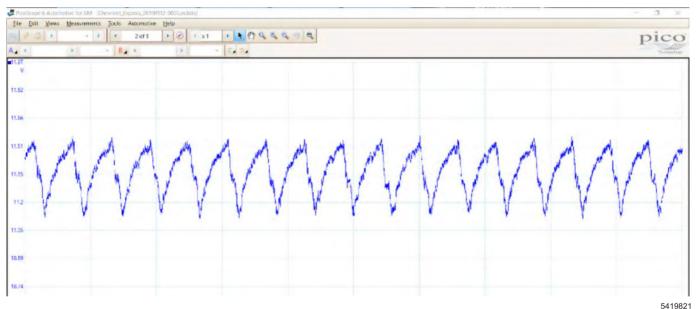
The graph above illustrates an engine that will pass a compression test and there is no reason to think that there is anything mechanically wrong with the engine.

⇒ If the graph does not look like the graph above, Refer to Analyzing Relative Compression Graphs section below.

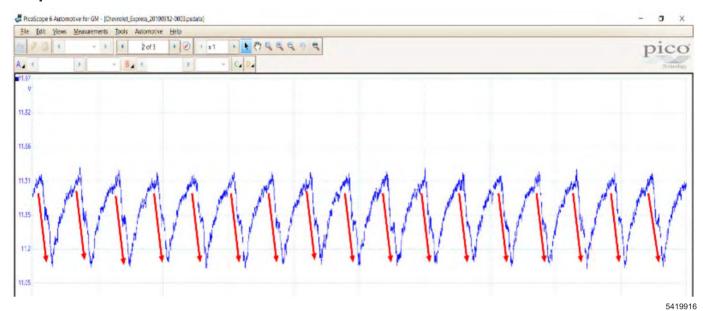
When examining these graphs, view the downward portion of the waveform.

This area of the graph is the engine starter pulling more electricity from the battery during a compression stroke.

By graphing the battery voltage while cranking an engine we can get a good picture of how the compression in each cylinder compares to the compression in each other cylinders in the engine. When you think about an engine being cranked over by the starter, each time a piston compresses the charge in the cylinder, the drag on the starter increases which in turn increases the starter draw and decreases the battery voltage until the air in the cylinder is compressed.

After this compression stroke and before the next cylinder in the firing order begins its compression stroke, there is a short period of cranking where the voltage increases. This is what gives the us the pattern to examine on a scope as well as the distinctive sound of an engine being cranked.

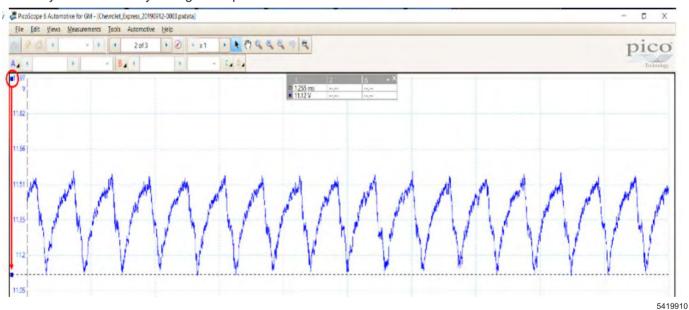
Utilizing a horizontal ruler, line up the bottom of the waveform.

⇒ Select the blue box and drag it to the location that's viewable.

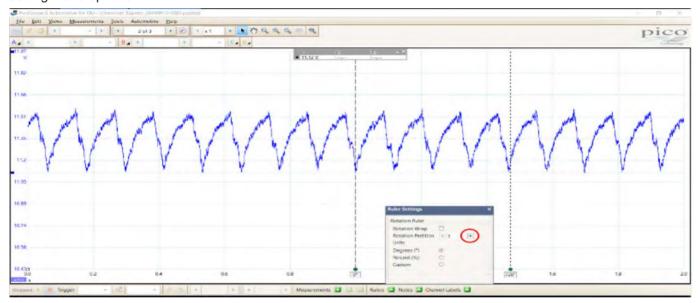
Change the rotation partition to 4, to represent the number of cylinders in the engine.

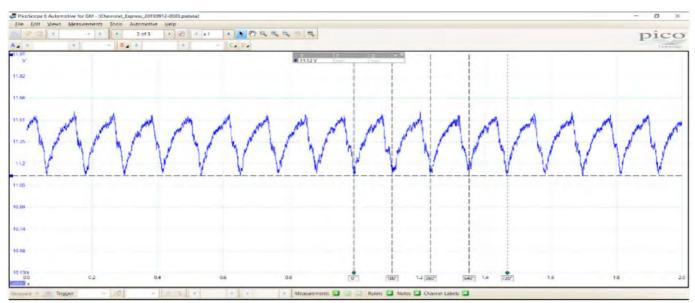
This should help to identify the top of each compression stroke in two rotations of the engine.

It is not an issue if you see a few of these "tips" that do not touch the line. What we are looking for is consistently one of every four points not hitting the line for a four cylinder engine.

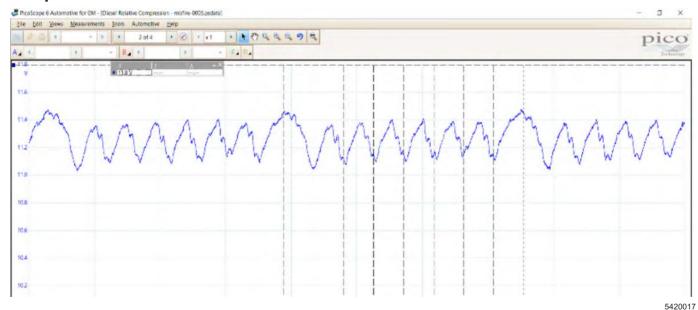
The graphic above depicts an example of an eight-cylinder engine with a cylinder that has no compression in one cylinder.

Note that one of the dips is missing and it repeats every eight dips.

This is a clear indication that there is an issue with this engine.

If each cylinder in the engine are of very close compression, the resulting pattern on the scope will be equal all the way across the screen. If one of the cylinders in a four-cylinder engine has low compression compared to the other three, then every four "waves" will look different than the other three. The same can be said of an eight-cylinder engine that has a weak cylinder, the wave pattern will look different on every eighth wave.

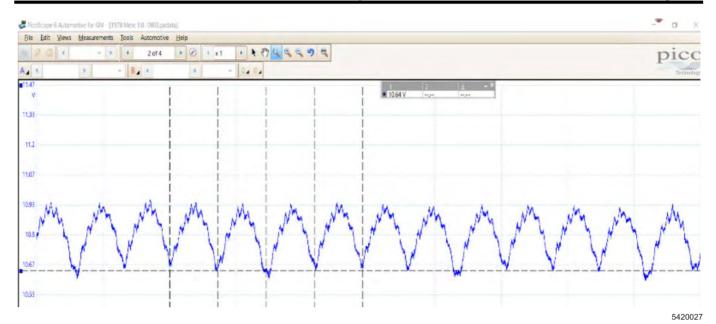
The graphic above depicts an example of a four-cylinder engine with a bad exhaust cam lobe. Note that consistently there is one cylinder with an extra-long compression stroke.

Examination of this engine showed that cylinder number four had a worn down cam lobe.

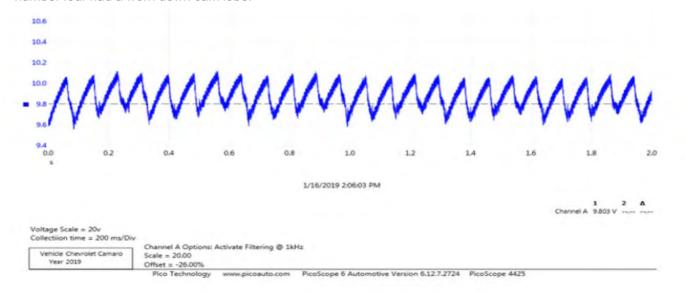
This is a four-cylinder engine with a 20 PSI loss in one cylinder

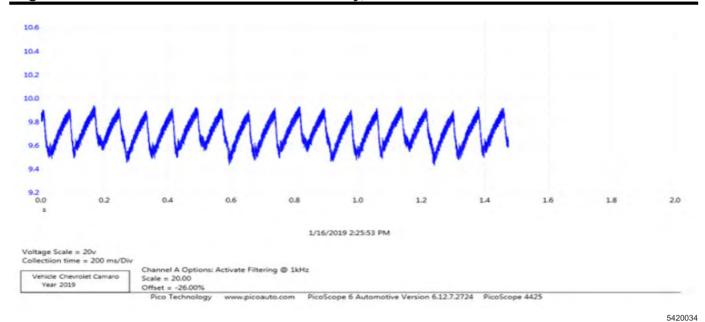
This is a four-cylinder engine with a 40 PSI loss in one cylinder.

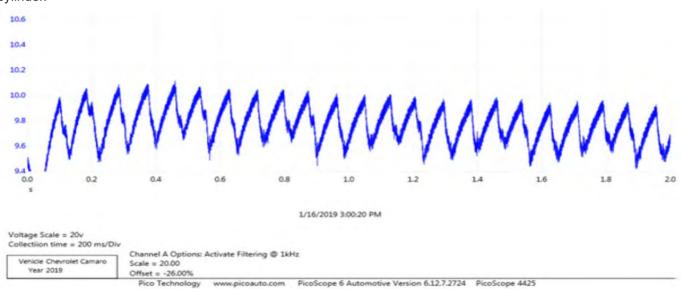
This is a four-cylinder engine with a 60 PSI loss in one cylinder.

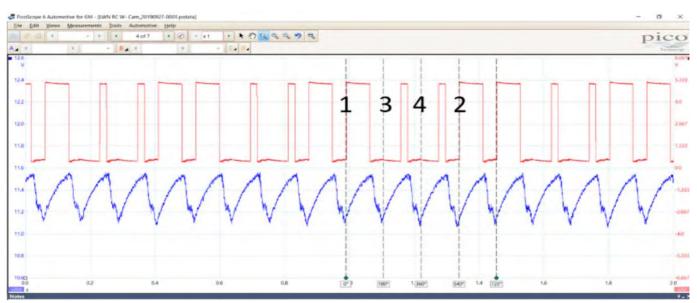
If an engine has low or high compression on one cylinder, it may be useful to add an injector pulse or a Camshaft Position Sensor to help determine which cylinder has an issue.

The graphic above shows the signal from the Cam Position Sensor for reference.
