MAS002970 (MSC 22-02)

Service Campaign 468

MC20 - DCTM Adaptive Parameter Writing

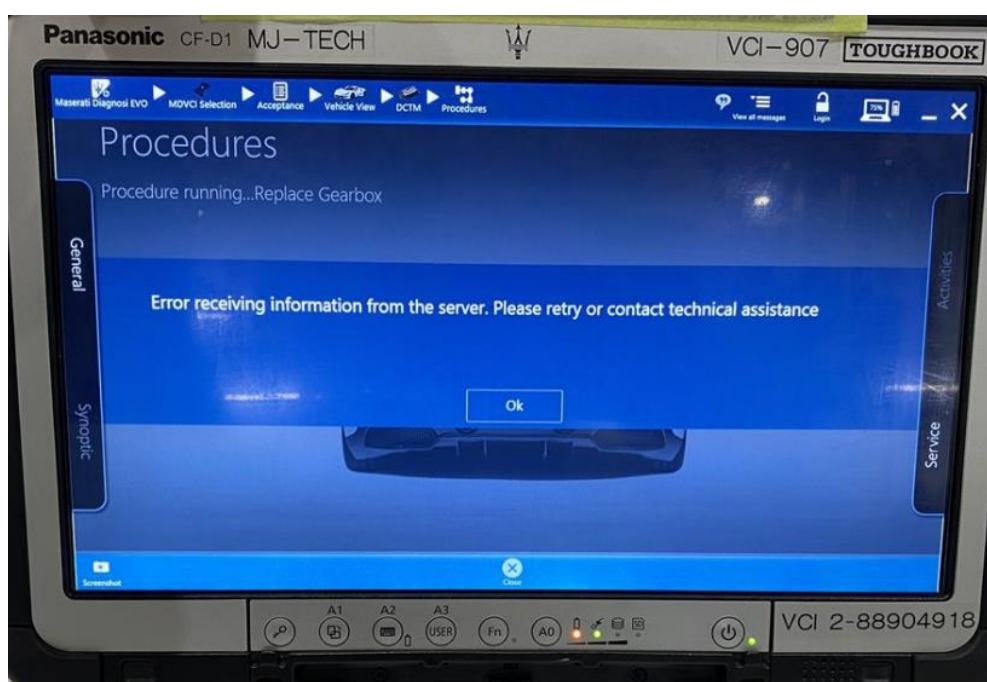
4. During the procedure, the MD EVO will display the following prompt:

"Frame the Data Matrix code of the gearbox, using the MD EVO camera or press Manual Input to enter the gearbox serial number manually. The gearbox serial number is a 30-digit value to be entered without spaces or dashes" => Select Manual Input

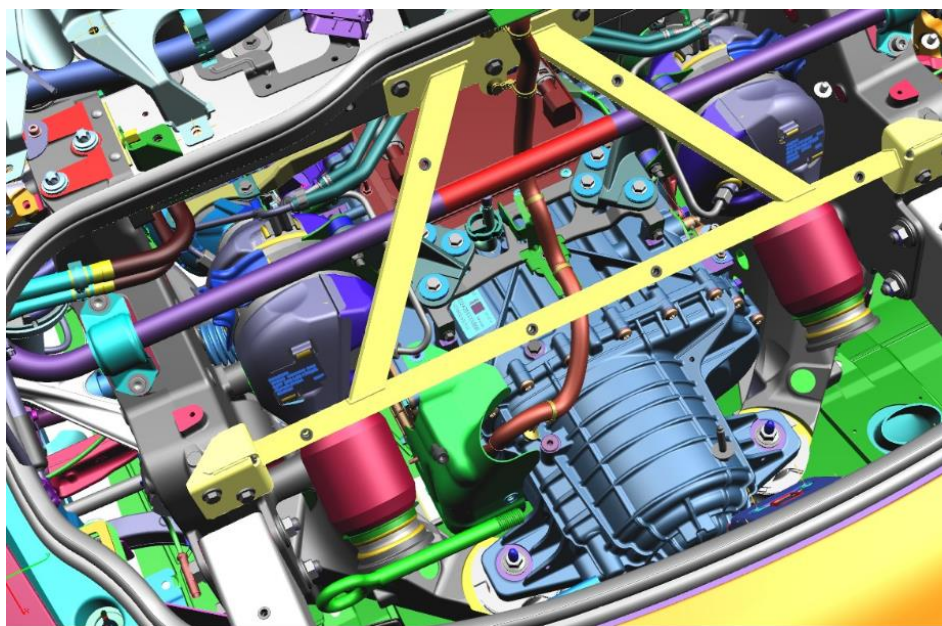
2. The gearbox plate is positioned as shown in the following image

3. Remove the heat guard following the procedure: **9.63.106.0 COLD END HEAT COVER**
4. Take note of the serial number on the plate. Follow the procedures from steps 1-8 for entry with MD EVO

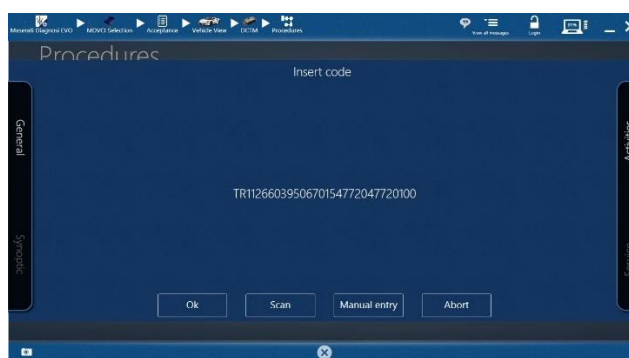
NOTE: The serial number can also be read by activating the MD EVO internal camera, framing the QR code and selecting the "SCAN" function.
