## SERVICE ACTION

Service Action  
Number: N605v2

<b>Incorrect Emission Label Installed</b>	Subject:	Publication No.: N605v2
		Model: Defender (LE)
		Model Year: 2021
		Date of Issue: 03 May 2022

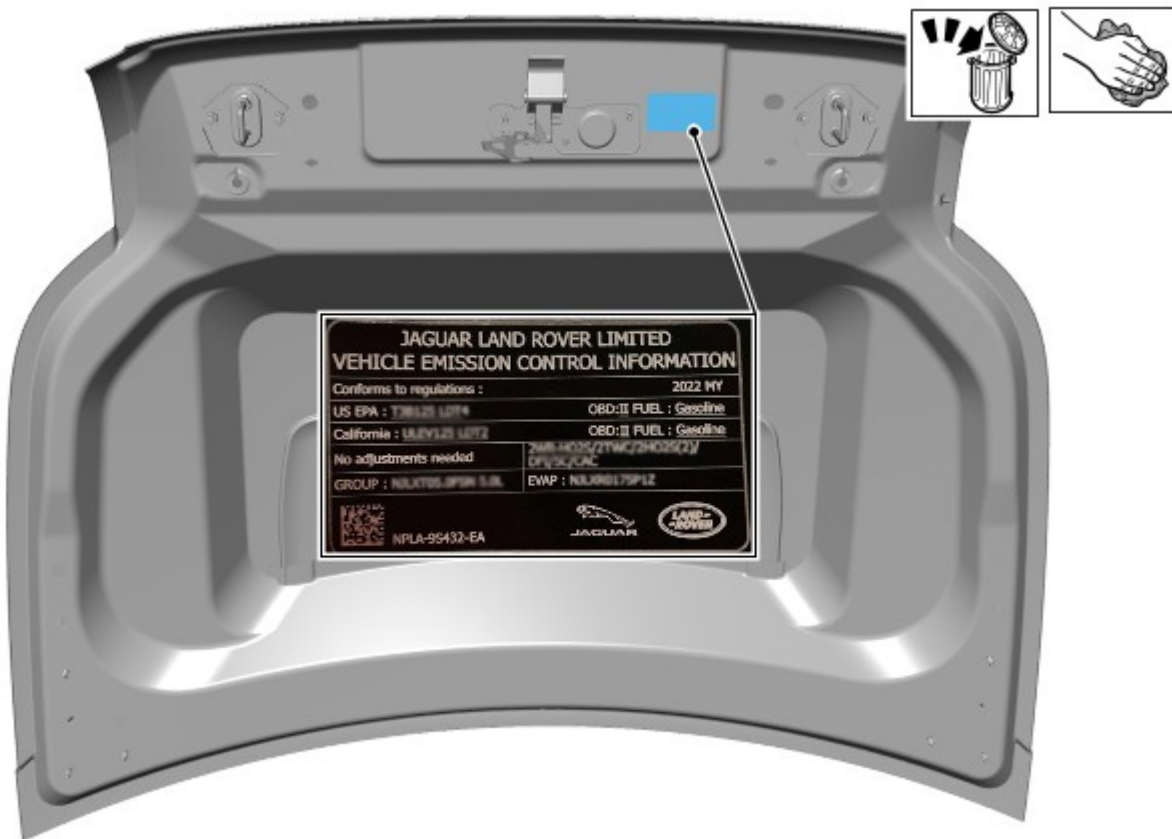
E288167

The new emissions label must be installed in the same position as the previous emissions label.

Apply a small amount of heat to the emissions label to aid the removal of the label.

Remove and discard the emissions label.

- Clean the surrounding area.
- Remove the adhesive backing from the new emissions label.
- Install the new emissions label.
