Technical Service Bulletin

Subject: STRUT / SHOCK ABSORBER REPLACEMENT GUIDELINES	Bulletin No.: 02-004/22
	Last Issued : 05/24/2022

DESCRIPTION

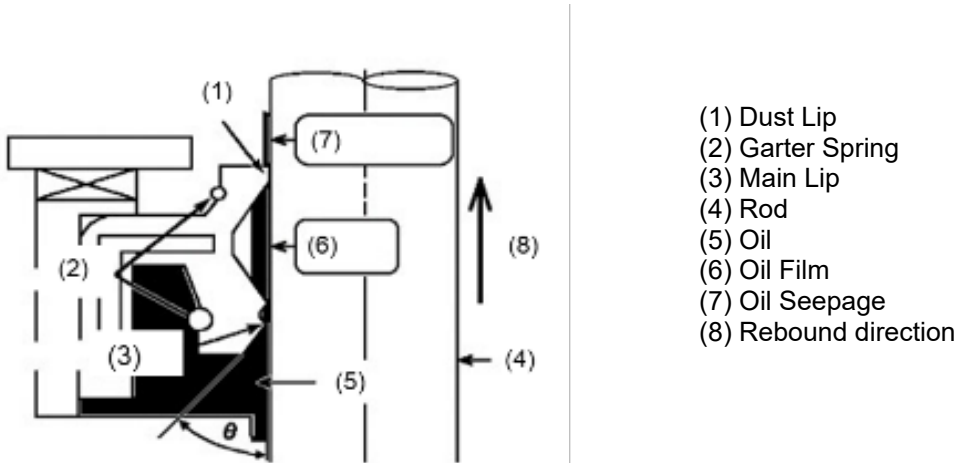
When a shock absorber gets compressed and then rebounds, most of the oil on the rod (4) is wiped off by the main lip (3) and some oil (6) remains inside the space between the main lip and the dust lip (1). When a shock absorber rebounds (8), most of the remaining oil on the rod is wiped off by the dust lip and a very small amount of oil goes outside as seepage (7). This thin oil layer can be wrongly taken as oil leakage, however, seepage of up to 1/3 of the extent of the oil seal zone (as shown in the table below) doesn't affect the normal functioning of the mechanism.
