August 2021
D21M6 **REV3**

Subject: Gen 5 Customer Demo Unit (CDU) and Pre-Series Unit Retrofits

Models Affected: Specific 2021 Freightliner New Cascadia model vehicles, powered with DETROIT™ Gen 5 DD15 Engines manufactured February 3, 2020, through December 14, 2020

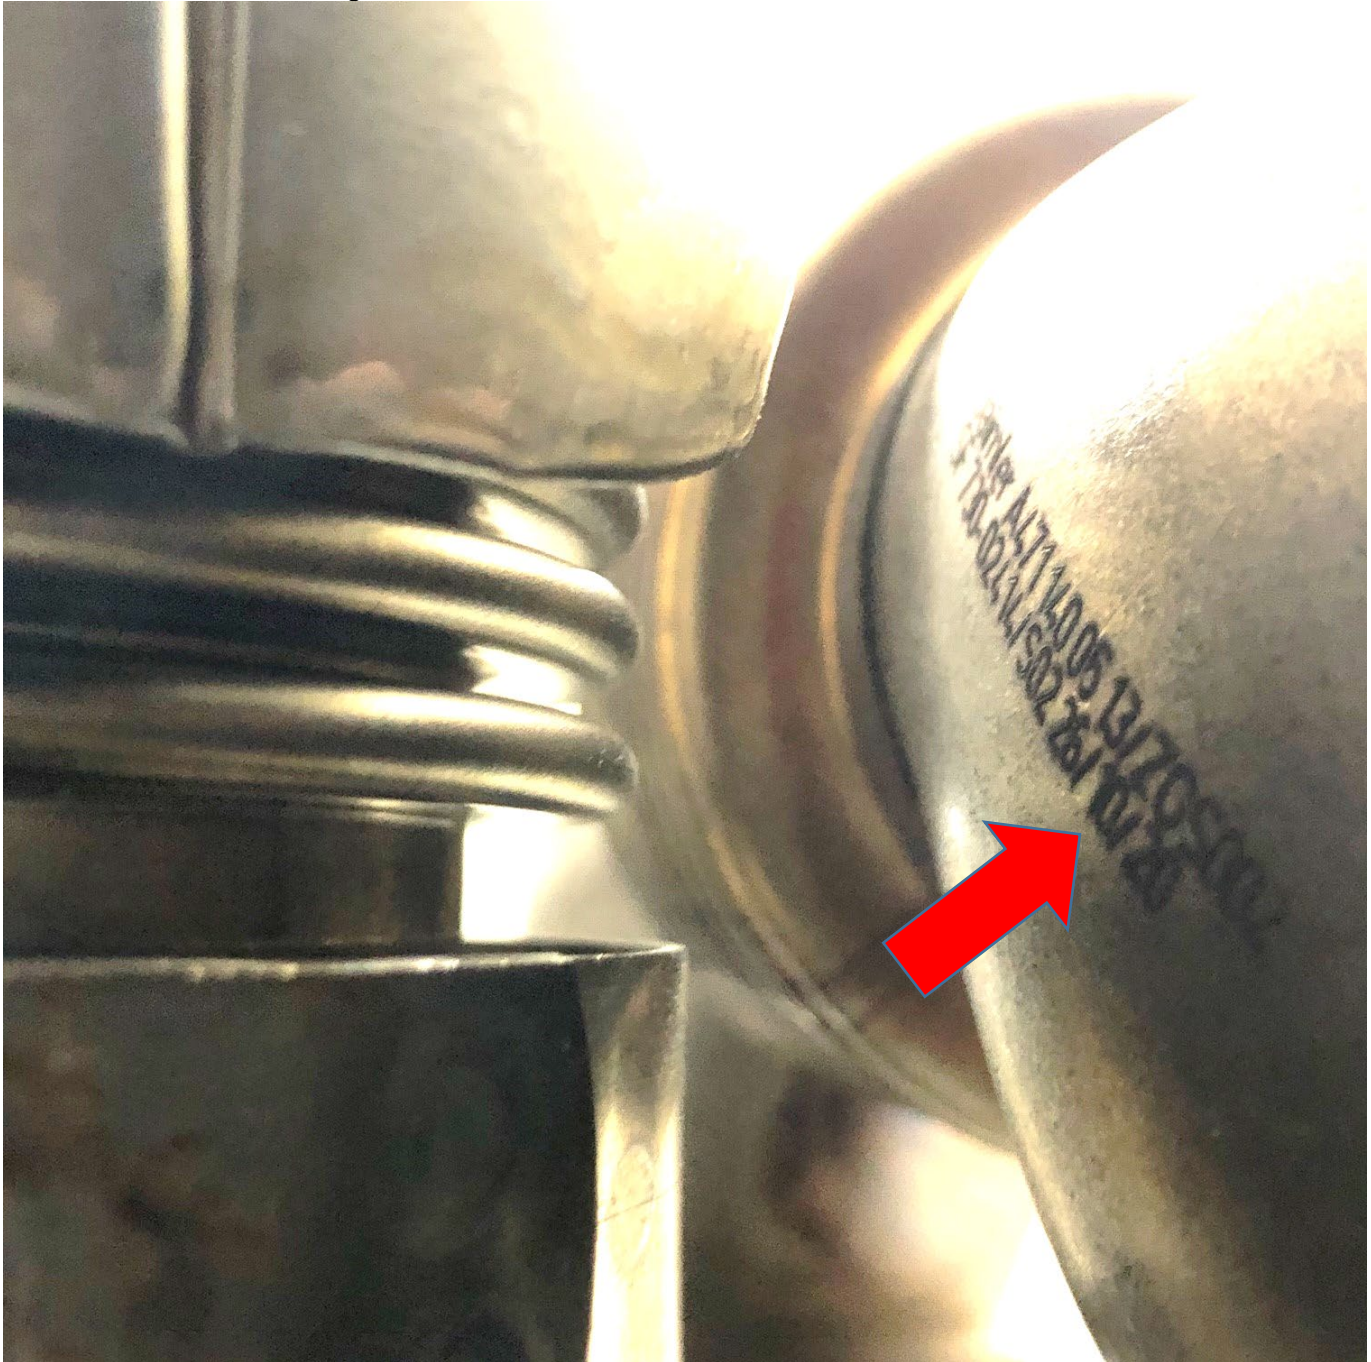
1. Please refer to the image below.

2. The red arrow is pointing to the date found on the EGR hot pipe. The date format is DD/MM/YY.
3. If the date is 31/07/20 or earlier, the EGR hot pipe needs to be replaced. Otherwise, it can be reused.
