# Volvo I-Shift AMT Will Not Calibrate After Incorrect Flywheel Housing Is Installed

## TPI 262-018, Coolant Line Bracket

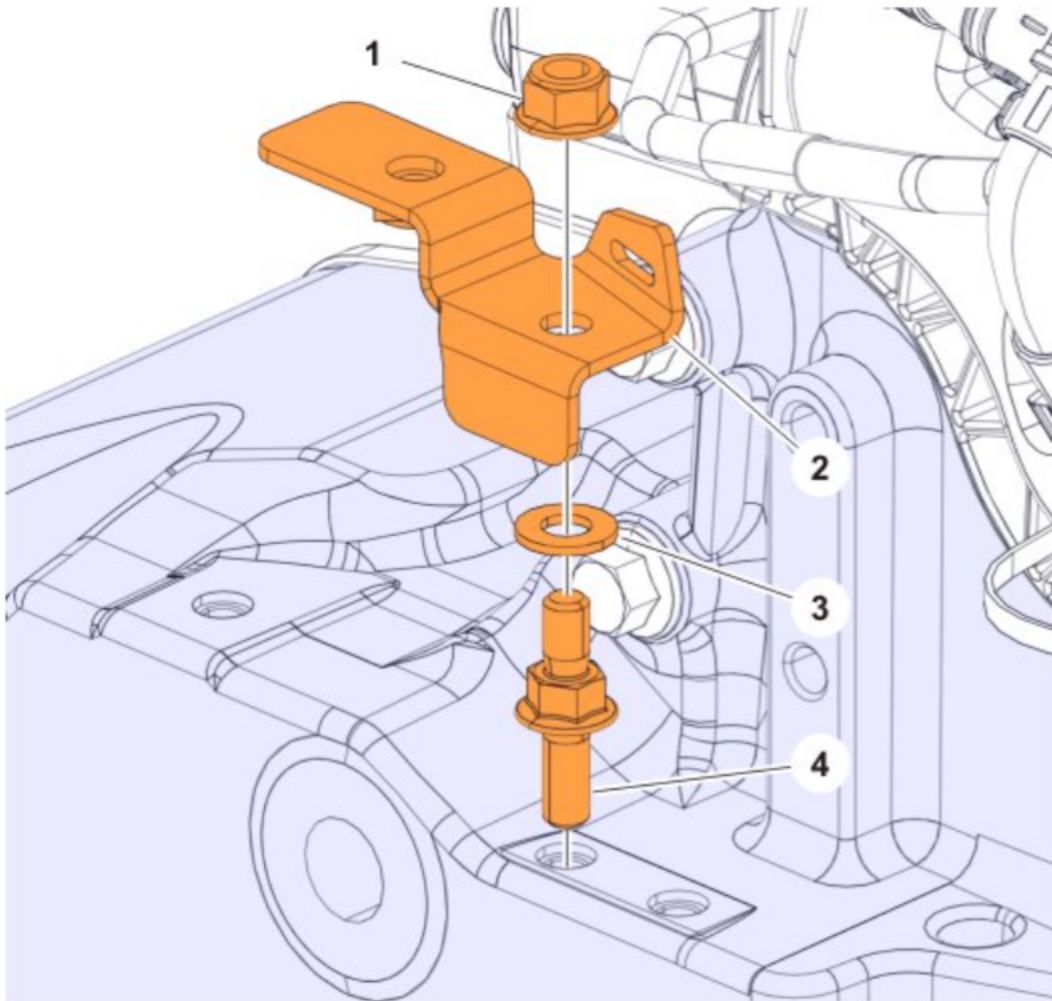
When transferring transmission coolant line bracket (part number 20567404) during flywheel housing replacement, use studded flange screw (part number 20714050), flat washer (part number 3083887) and flange locknut (part number 990950) to mount the bracket to the flywheel housing in the correct angle and clearance.

1. Lock nut
2. Bracket
3. Washer
4. Flange screw

- Install the flange screw in the flywheel housing and tighten to  $24 \pm 4$  Nm ( $18 \pm 3$  ft-lb). Place the flat washer on the flange screw.
- Place the bracket over the flange screw, secure with flange locknut and tighten to  $24 \pm 4$  Nm ( $18 \pm 3$  ft-lb).
