GROUP	NUMBER
ENGINE	22-EM-008H
DATE	MODEL
MAY 2022	ELANTRA (AD) KONA (OS) VELOSTER (JS)

SUBJECT:	DTC P1327 ENGINE REPLACEMENT
-----------------	------------------------------

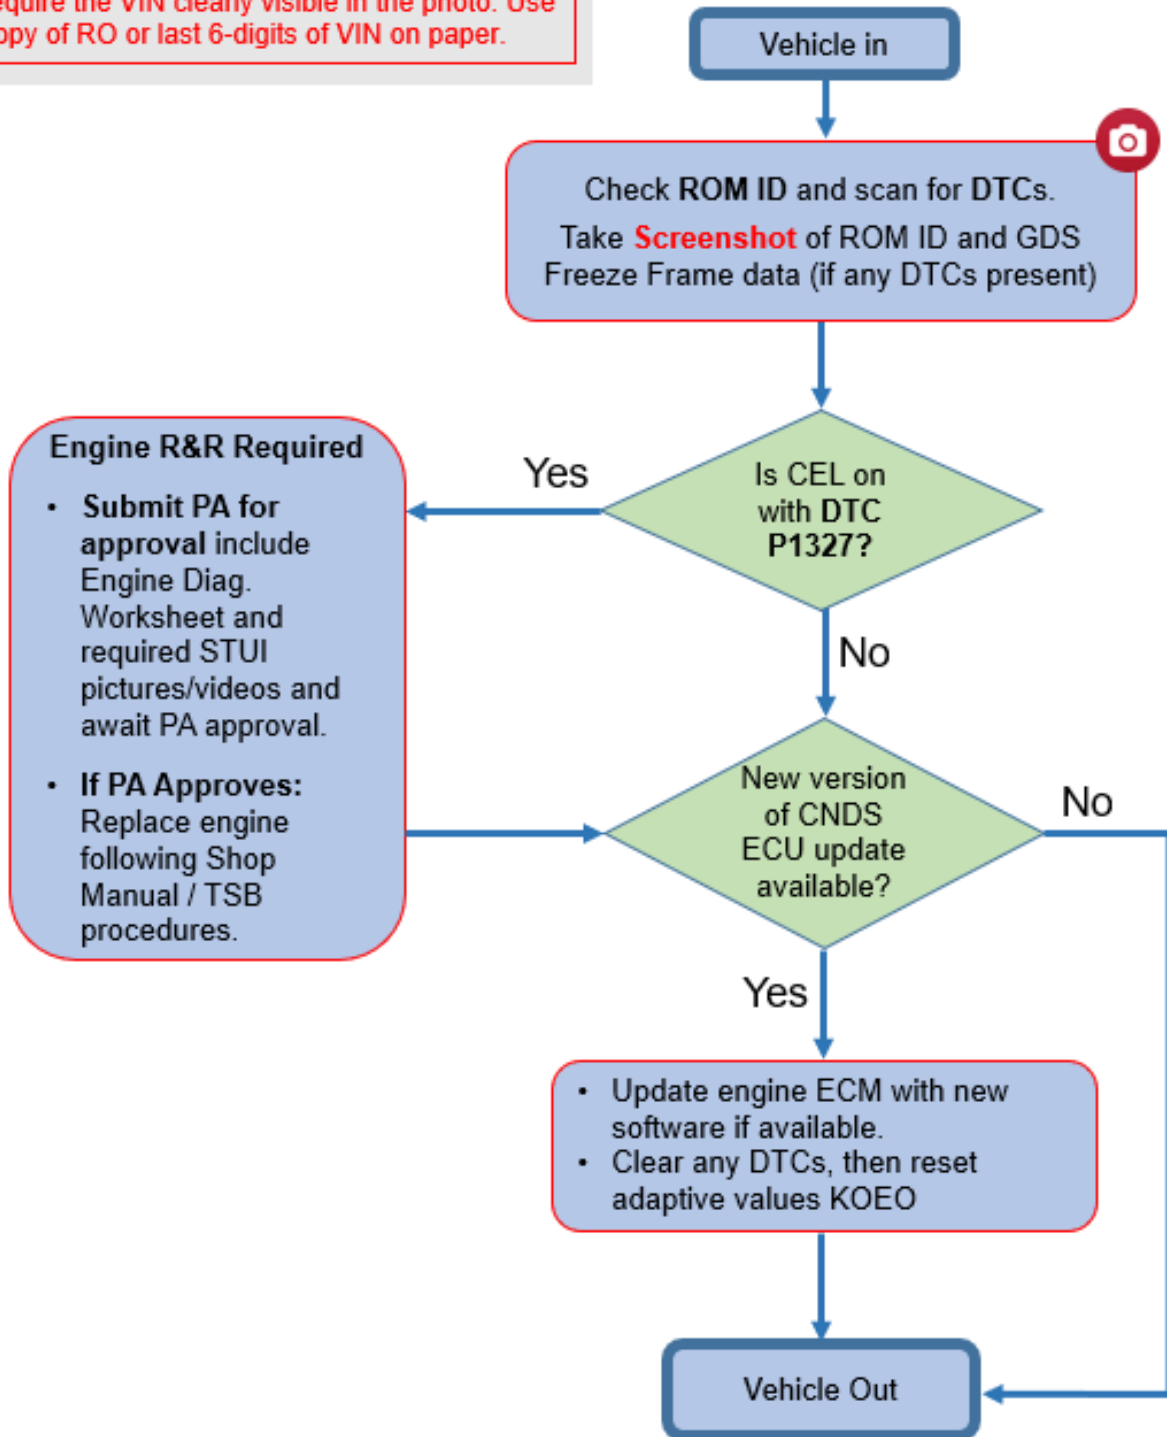
Service Process: DTC P1327

Service Procedure Flowchart:

NOTE: Icon indicates photos/videos required for PA review. Any STUI pictures require the VIN clearly visible in the photo. Use copy of RO or last 6-digits of VIN on paper.

NOTE: Refer to the Service Process Flowchart on Page 2 for the overview of the process.

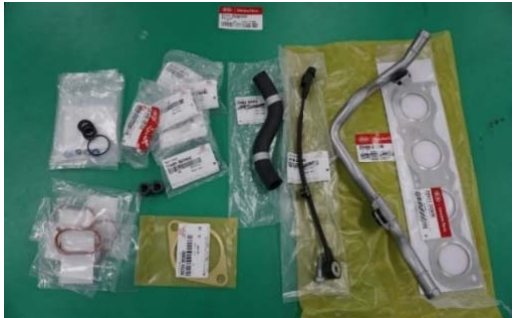
PART NAME	FIGURE / PART NUMBER	NOTE
Engine Service Kit

<p style="text-align: center;">21102-N20AKQQH</p>	(For use with above engine long blocks)
*** Includes Contents Below ***		
PULLEY-DAMPER	23124-2E003 (ALT 23124-2E052)	1EA
BOLT-CRANKSHAFT PULLEY	23127-2E000	1EA
ROD ASSY-OIL LEVEL	26611-2E022	1EA
GASKET-EXMANI	28521-2E000	1EA
GASKET-INMANI	28313-2EAA0	1EA
KNOCK SENSOR	39250-2E000	1EA
BOLT-FLANGE	11403-08306K	1EA
HOSE ASSY-HEATER	25480-2E000	1EA
GASKET-EGR PIPE, A1	28491-2E920	1EA
GASKET-EGR PIPE, B	28492-2E900	1EA
O-RING WTC ASSY	25623-2E000	1EA
GASKET (FRT MUFFLER)	28751-2B300	1EA
NUT (FRT MUFFLER)	13183-12000	2EA
SWITCH ASSY-OIL PRESSURE	94750-37100	1EA

NOTES: During engine R&R, install the applicable Engine Long Block and Service Kit part numbers.

- Reuse other parts not listed under the Service Kit parts list.
- After installing the engine in the vehicle, fill the engine oil level to the top of "F" position.
 - (Engine Oil Fill Capacity: 4.5 liters with 5W20 engine oil)
