# Preliminary Information

## PIT5920 Buzz Rattle or Tick Noise From Right Fender Area

Brand:	Model:	Model Years:	VIN:		Engine	Transmissions:
			from	to	Engine:	Transmissions.
Chevrolet	Colorado	2020 - 2022	All	All	All	All
GMC	Canyon	2020 - 2022	All	All	All	All

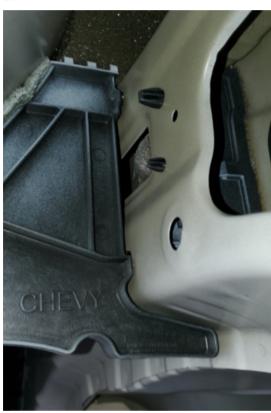
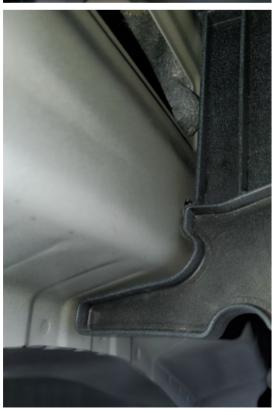
Involved Region or Country:	North America			
Additional RPO/s:	None			
Condition:	Buzz, rattle or tick noise from right fender area.			
Cause:	Fender support not secured to the fender.

Inspect the support shown below If it can be moved back and forth secure it to the fender with panel bonding adhesive and allow to set.
