GROUP	MODEL
Emissions Service	2020MY
Campaign	Sportage (QL)
	w/2.0L T-GDI
NUMBER	DATE
SC222 (Rev 1, 06/16/2022)	April 2022

VOLUNTARY EMISSIONS SERVICE CAMPAIGN

VEHICLE EMISSION CONTROL INFORMATION (VECI) LABEL REPLACEMENT (SC222)

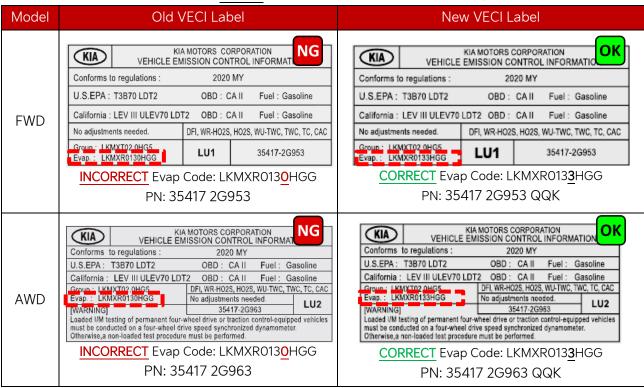
2. Select the new VECI label with the **correct** EVAP information for FWD or AWD, as shown below.

3. Clean the surface of the incorrect VECI label with an alcohol wipe or an equivalent cleaner.

4. Carefully affix the new provided VECI label over the old VECI label, ensuring complete coverage of the old label with the new one.

Ensure the correct label (FWD or AWD) is affixed to the vehicle. Refer to Parts Information for proper part number.
