# Aftertreatment Hydrocarbon Injector (AHI) Troubleshooting Guide - US10+OBD13 And Newer Emissions

## System Overview

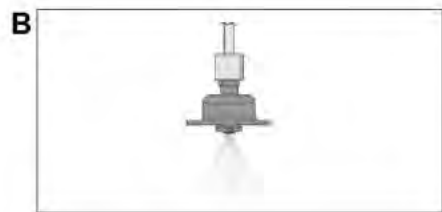
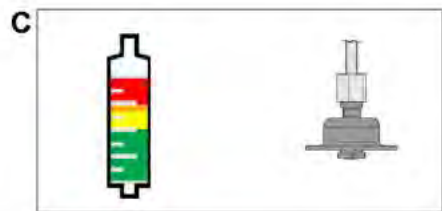
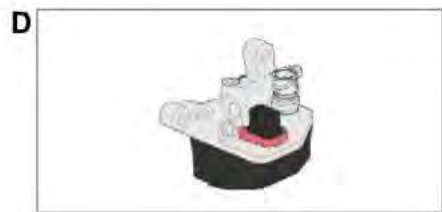
Select the illustration corresponding to the method or test to be performed

#### A

Sensor Values, Monitoring

#### B

Aftertreatment hydrocarbon doser air flow test

#### C

DPF System Reset

#### D

Active Diagnostics Test
