# Service Bulletin

Bulletin No.: 22-NA-126

**Subject: Automatic Emergency Braking (AEB) Forward Collision Icon Lamp On with No DTCs Present**

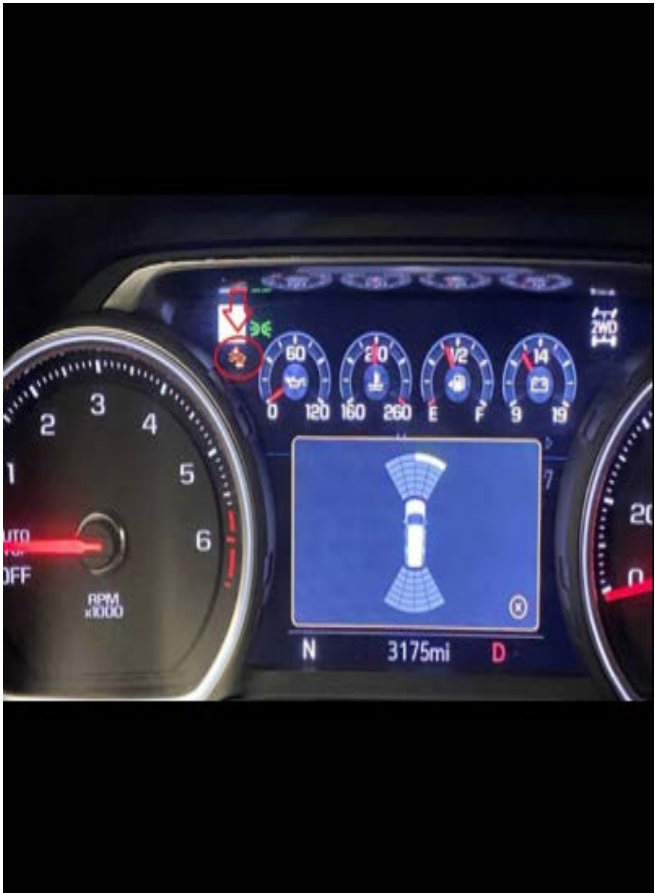
<p><b>Involved Region or Country</b></p>	<p>North America, Chile, Colombia, Ecuador, Peru, Europe, Uzbekistan, Russia, Middle East, Israel, Palestine, Japan, GM Korea Company, Cadillac Korea (South Korea), Thailand</p>
<p><b>Condition</b></p>	<p>Some customers may comment on an AEB forward collision icon lamp illuminated in the cluster. No DTCs are present as well as both lane keep assist and cruise are functional.</p>

<p style="text-align: right;">6100231</p>
<p><b>Cause</b></p>	<p>The cause of this condition may be due to the customers vehicle collision settings. The Pedestrian Detection or Forward Collision settings may be set to anything other than 'Alert and Brake.'</p>
<p><b>Correction</b></p>	<p>To correct this condition, set the Pedestrian Detection and Forward Collision settings to 'Alert and Brake.' If the customer does not want automatic braking enabled, then it is normal for this icon to be illuminated to inform the driver of reduced features.</p> <p>Go to the vehicle settings =&gt; collision detection systems =&gt; front pedestrian detection. Verify the setting is set to "alert and brake."</p> <p><b>Important:</b> If the setting is alert and brake and the AEB light is still on, restore the radio to factory settings.</p>
