## MIL Comes On with DTC P2422

Supersedes 20-002, dated March 3, 2020, to revise the information highlighted in **yellow**.

Year	Model	Trim	VIN Range
2017–22	Ridgeline	ALL	ALL

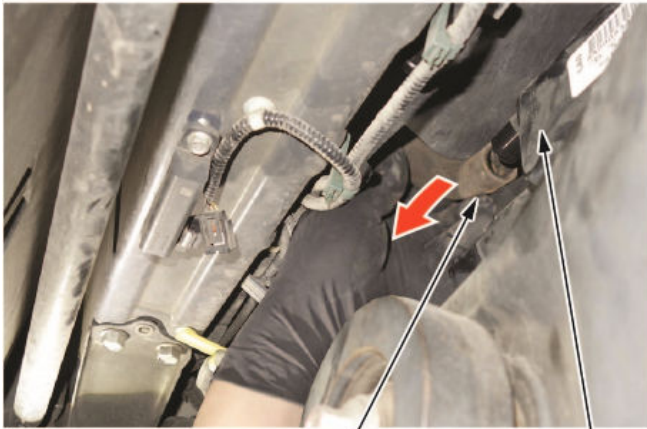
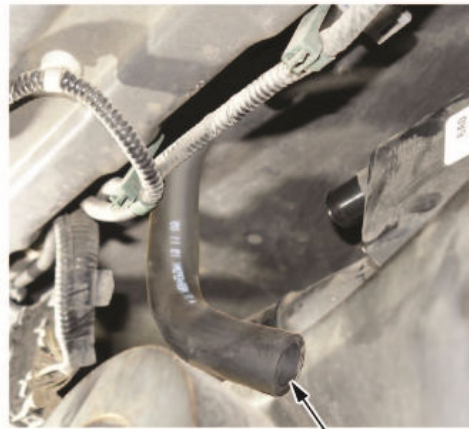
Disconnect the rubber drain tube. EVAP CANISTER

Inspect for dirt or dust.

- For 2WD vehicles, if the drain tube has any dust or dirt inside it, go to REPAIR PROCEDURE A.
- For AWD vehicles, if the drain tube has any dust or dirt inside it, go to REPAIR PROCEDURE B.

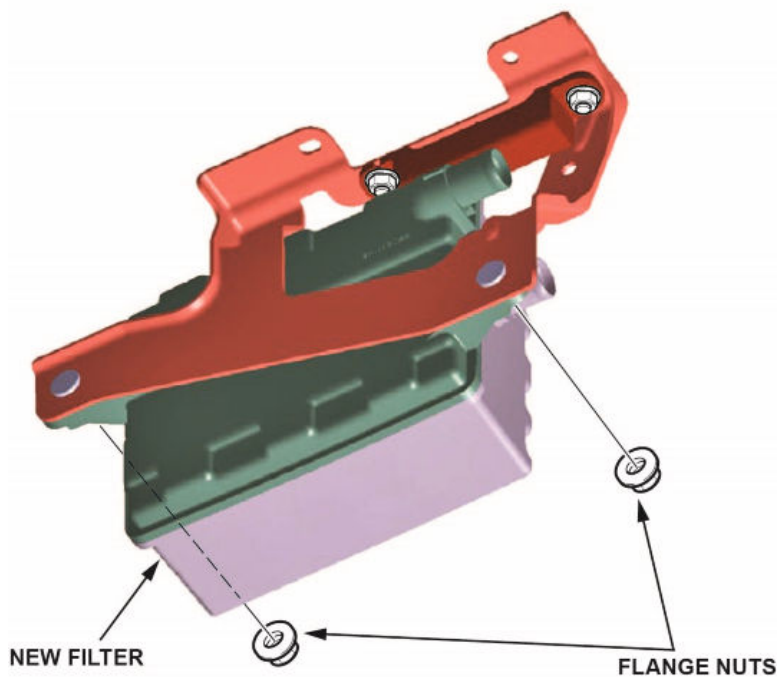
11. Install the new canister filter box to the bracket. Use the two flange nuts included in the kit, and torque them to **9.4 N•m (6.9 lb-ft)**.

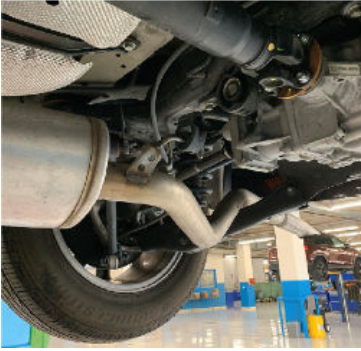
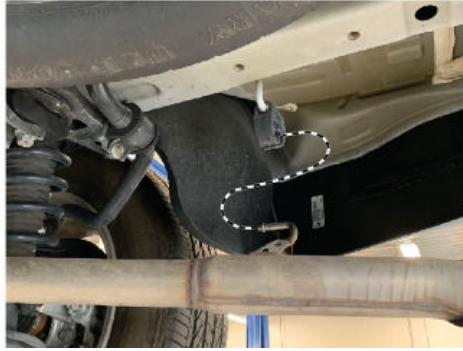
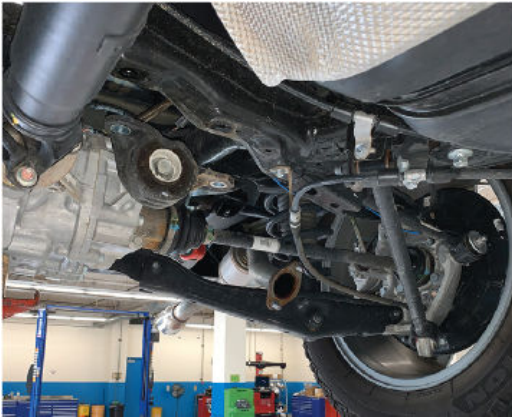
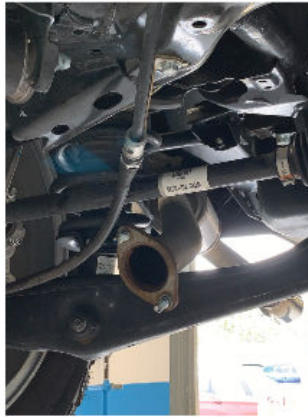
1. **2017–20 Models:** Unhook the mid-pipe and muffler from its hangers, the suspension will support it.

**2021–22 Models:** Remove the mid-pipe muffler.

NOTE: Do not reuse the exhaust nuts or gasket.
