JLRTB02102NAS1

**TECHNICAL BULLETIN**

Engine Oil Leak From Cylinder Head

MODEL:	MODEL YEAR:	VIN:	ASSEMBLY PLANT:	APPLICABILITY:
F-PACE (X761)	2021-2022	684486-693218	Solihull	V8 S/C 5.0L Petrol
F-TYPE (X152)	2021-2022	K76670- K79060	Castle Bromwich	V8 S/C 5.0L Petrol

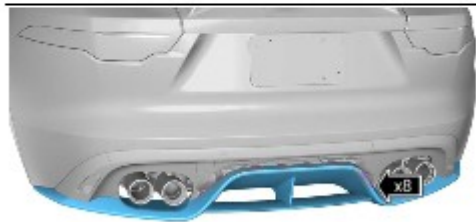
E256153

Remove the rear bumper panel.

- Remove the 6 screws.
  - Remove the 10 clips.
-

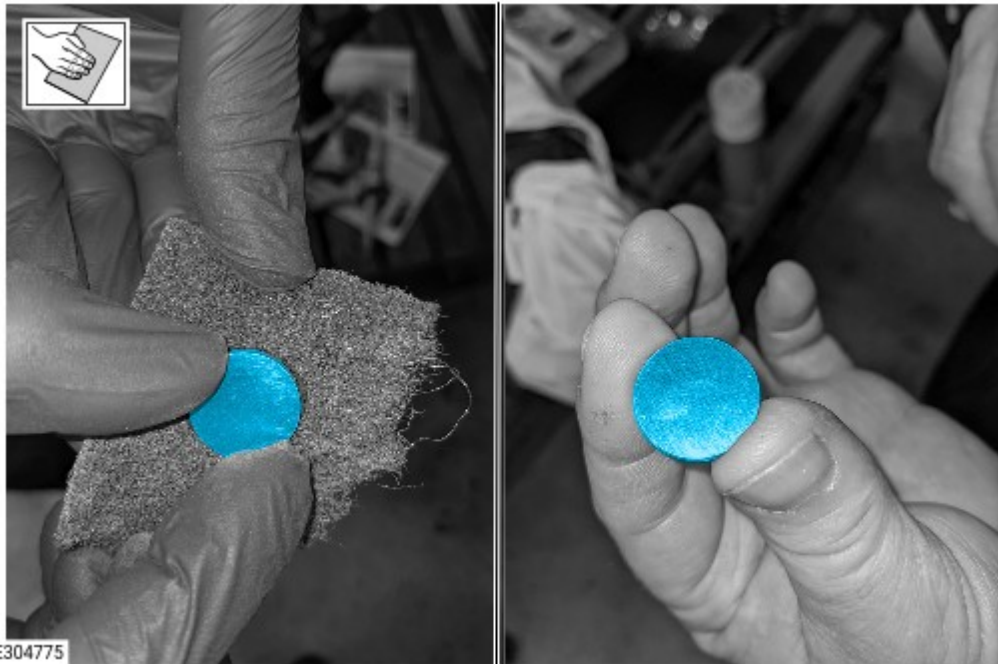
Prepare both sides of the aluminum disc using a Scotch-Brite™ pad to key the surfaces.

Clean the surface of the aluminum disc using brake cleaner.

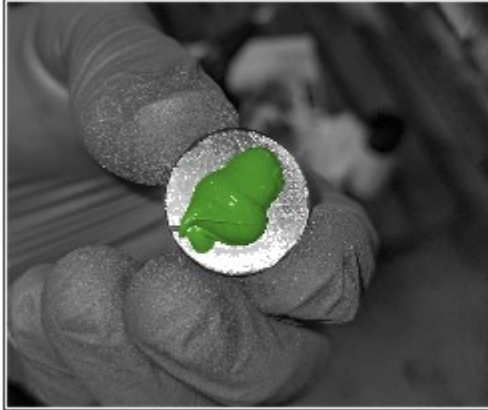
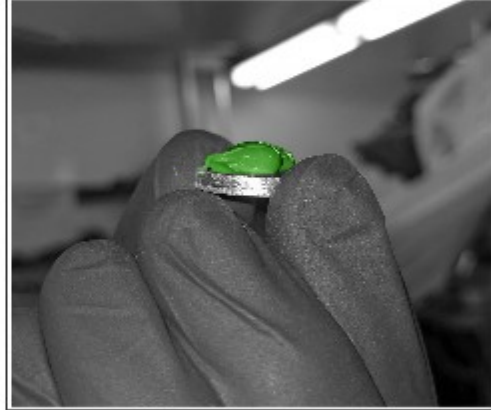
E304776

Make sure enough Loctite® adhesive is applied to the aluminum disc to allow the excess to be expelled around the outside of the aluminum disc during the next step.

Apply Loctite® adhesive to center of the aluminum disc.
