## Air Suspension Leaks In Difficult To Access Areas

| Topic number | LI32.22-P-075053 |
| Validity | All EQE - model series 295 |

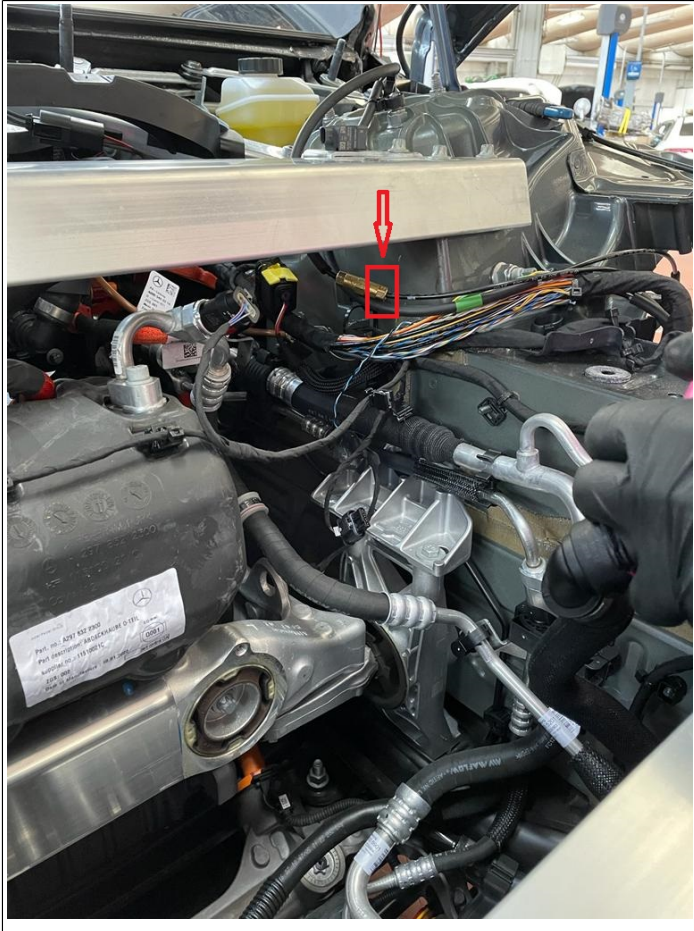
| Attachments | |
|---|---|
| <a href="#">Trennstelle Einbaulage (1).jpeg</a> | Example of a repair connector ex factory |

On some vehicles, repair connections have been implemented at the compressed-air lines as part of the factory re-work.

These are wrapped in the wiring harness and are therefore difficult to find and to access.

Check air suspension for leaks.

If no obvious leaks are found in the system, then prior to replacing the component part, first expose the air lines in the wiring harness and check these for leak tightness.

In some instances, a smoke machine can help with diagnosis.
