**9YA – Electric Parking Brake Warning in the Instrument Cluster**

**Vehicles Affected**

Models	Model Year	Model Type	VIN Range	Vehicle-Specific Equipment
Cayenne	2020 - 2021	9YA	n/a	All
Cayenne Coupe	2020 - 2021	9YB	n/a	All

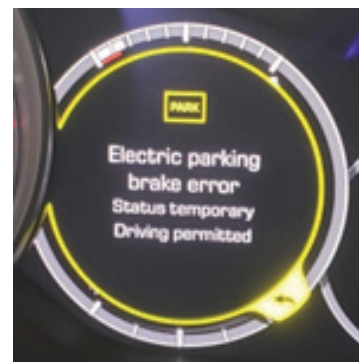
The customer complains of a yellow warning in the instrument cluster, stating that the electric parking brake is faulty.

- C10BCF6 – Left parking brake motor, Engine speed implausible
- C12E2F2 – Right parking brake motor, Engine speed implausible

**Figure 1: Yellow Warning in Instrument Cluster**

1. If the aforementioned fault codes exist, please verify the integrity the plug connections and all wiring for the parking brake motors.
2. If no faults are found with the wiring and plug connections of the parking brake motors, please replace the following parts:

- 9A790761500 and 9A790761600 – Electric motor
  - 9Y0614508PY – PSM control unit (Hydraulic unit)
3. Check the part numbers of the faulty parts. If the faulty part numbers are **9A790761500** (Electric motor, right) or **9A790761600** (Electric motor, left), and **9Y0614508HY** (PSM control unit), please contact Ben Leimkuehler with PCNA Quality Engineering at [ben.leimkuehler@porsche.us](mailto:ben.leimkuehler@porsche.us). These parts are currently desired for analysis to support the ongoing investigation mentioned earlier in the Technical Background section. Please use the subject "E3 Parking Brake Faults – Parts for Analysis" in your email.
