SIB 51 02 22

SERVICE ACTION: OPTIONAL ACCESSORY MIRRORS

2022-06-13

Model	Model Description
K63	S 1000 R

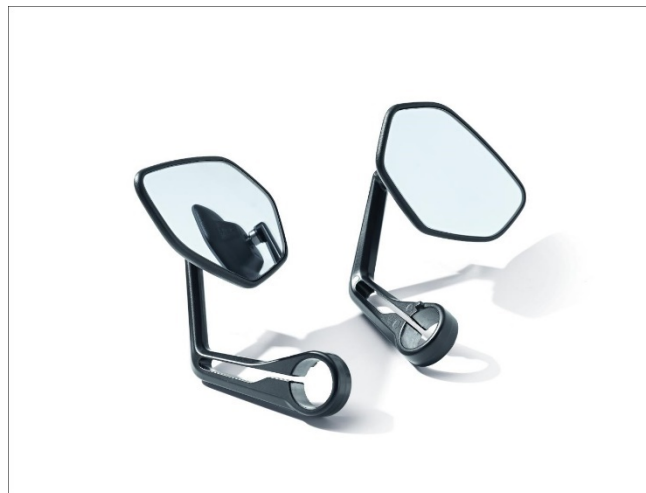
Bonding on the K63 handlebar accessory mirrors may fail, resulting in the loosening of the mirror-glass at the mirror assembly.

The following part numbers are affected:

- 51 16 1 542 963 – Handlebar end mirror, left
- 51 16 1 542 964 – Handlebar end mirror, right

If the handlebar-end optional accessory mirrors are found on K63 motorcycles, and they are not engraved with AI 04 or later, please replace them with new parts, numbers listed below, using installation instructions “77 22 028 – install mirror, right and left”.

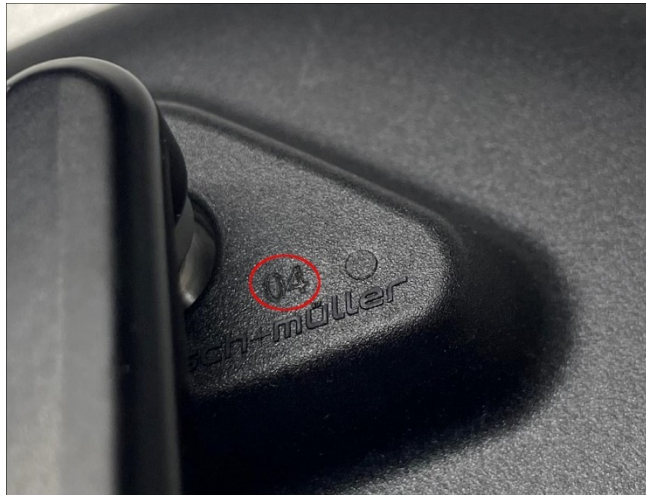
New revised accessory handlebar-end mirrors with markings AI 04 and later have improved bonding material and are offered as the replacement for the previous versions.

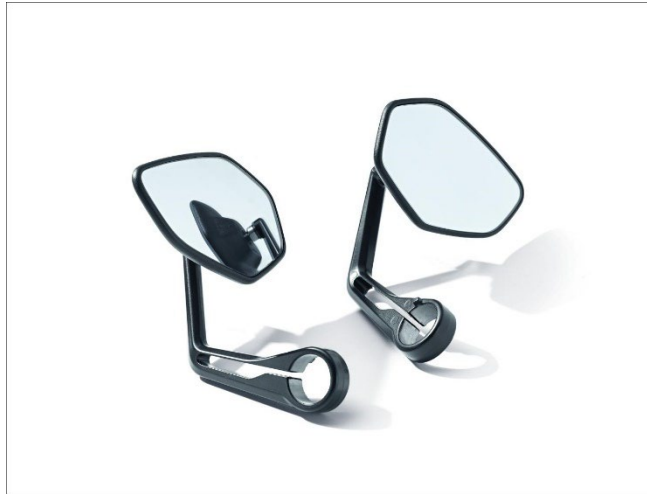
Bonding on the K63 handlebar accessory mirrors may fail, resulting in the loosening of the mirror-glass at the mirror assembly.

The following part numbers are affected:

- 51 16 1 542 963 – Handlebar end mirror, left
- 51 16 1 542 964 – Handlebar end mirror, right

If the handlebar-end optional accessory mirrors are found on K63 motorcycles, and they are not engraved with AI 04 or later, please replace them with new parts, numbers listed below, using installation instructions “77 22 028 – install mirror, right and left”.

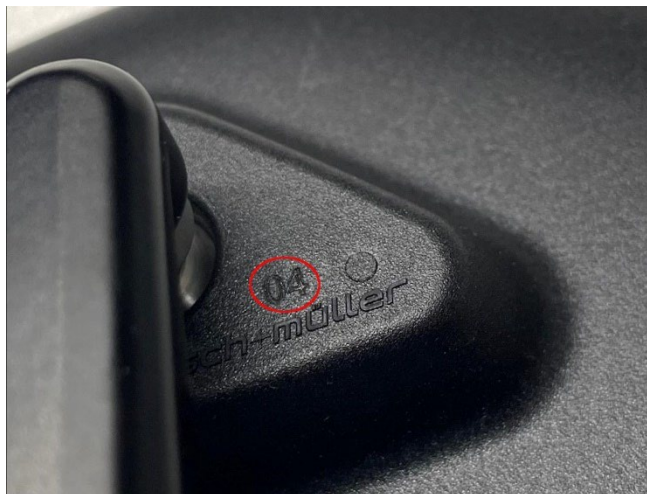
New revised accessory handlebar-end mirrors with markings AI 04 and later have improved bonding material and are offered as the replacement for the previous versions.
