Deployable Sidestep - No operation

22-23MY New Range Rover, New Range Rover Sport

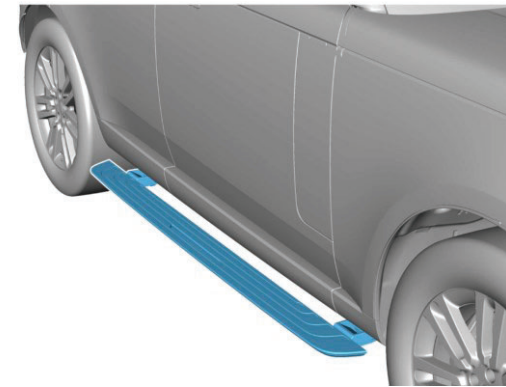
- Customer states that the deployable side steps are not operational

- This has occurred after CCF As-Built has been loaded into the vehicle. Loading the CCF as-built has removed the Deployable Sidestep option from the CCF

- Please follow step 8 completely in the accessory fitting instructions for Deployable Side Steps (Electrical Only) only after all other CCF work has been completed.
- SSM75802 has been released for this concern
