# Special Bulletin

# SP21-82

## FLOOR SIDE FLAT BAR

B13R (9700 us/can)

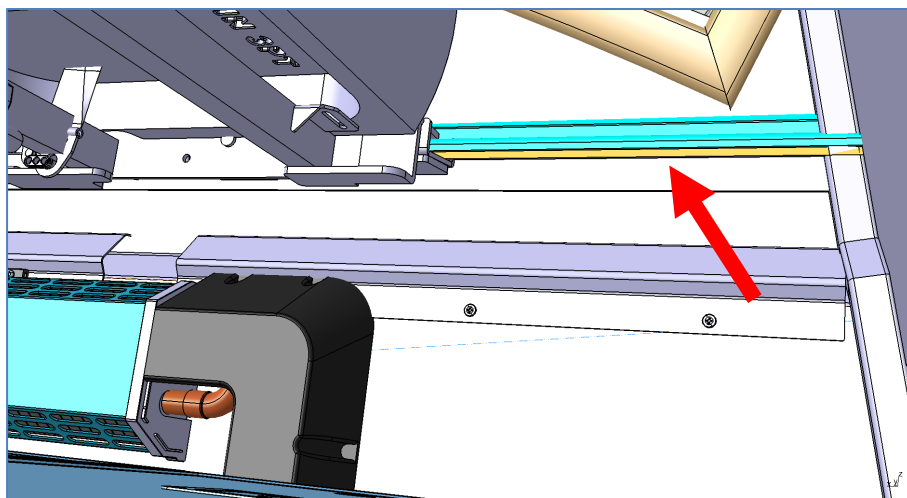
FIGURE 1

1. Install a flat bar (P/N: 24144641) on the linoleum top end.

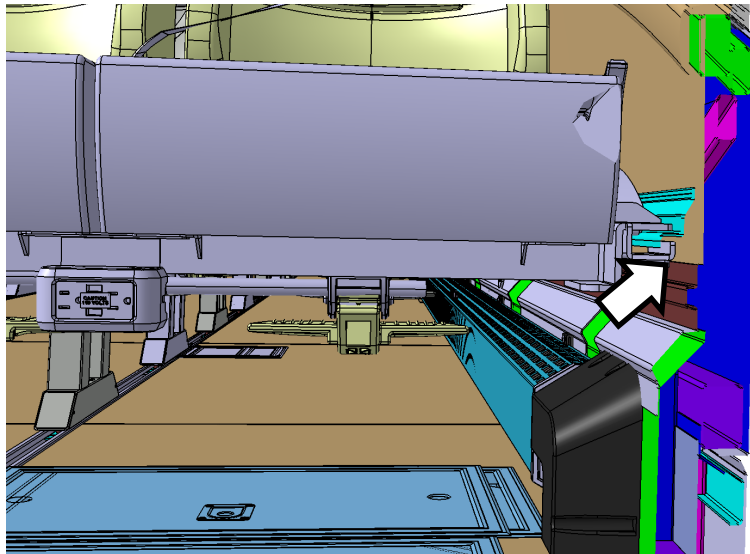
**FIGURE 2**

2. Location of the flat bars (P/N: 24144641) along the side wall is behind to seat rail aluminum profile.

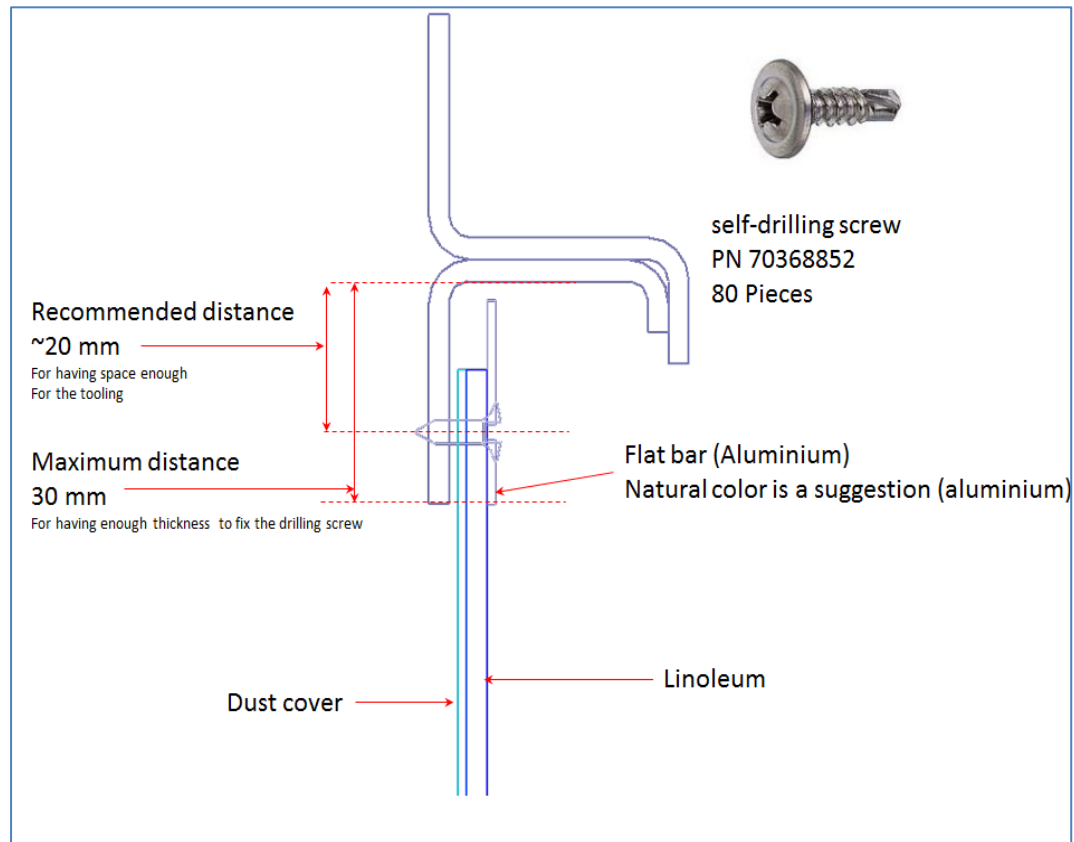
**FIGURE 3**

Each flat bar should be screwed using a CROSS RECESSED SUNK SCREW (*P/N: 70368852*) according to dimensions recommended at **FIGURE 3**.

Each flat bar contains 4 drilling guides. Secure the flat bar with 4 CROSS RECESSED SUNK SCREW.

Note: It not necessary to drill the upholstery to put the sunk screws.

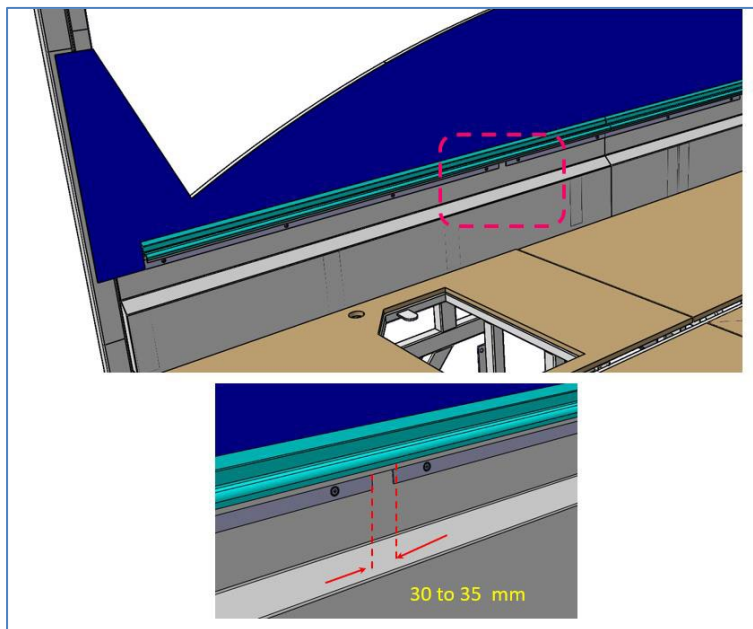
For the right side, the separation between each flat bar should be **30 - 35 mm** (Figure 5).

The reason for these suggested separations is to span the entire length under the side rail.

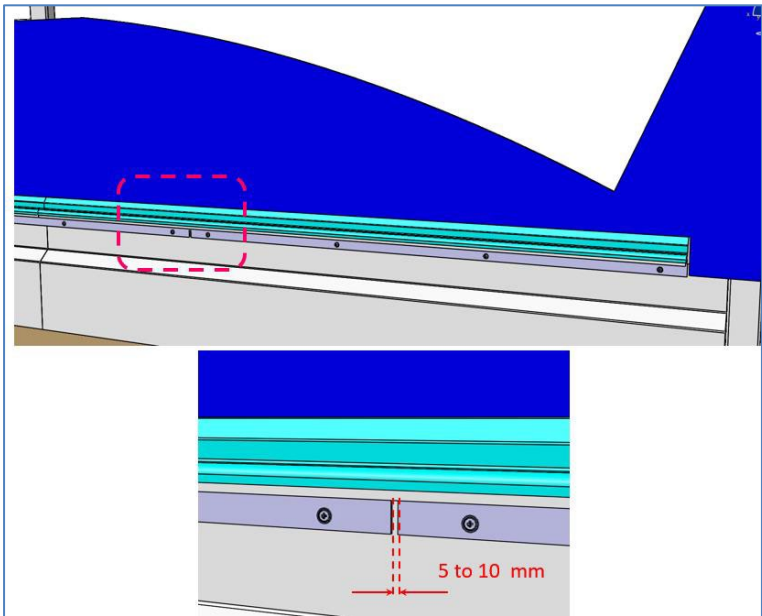
Note: Consider a separation of **5-10 mm** (Figure 6) between them of on the left side for a better distribution of the supports along the bus.

FIGURE 6 FLAT BARS INSTALLATION AT THE LEFT-HAND SIDE.

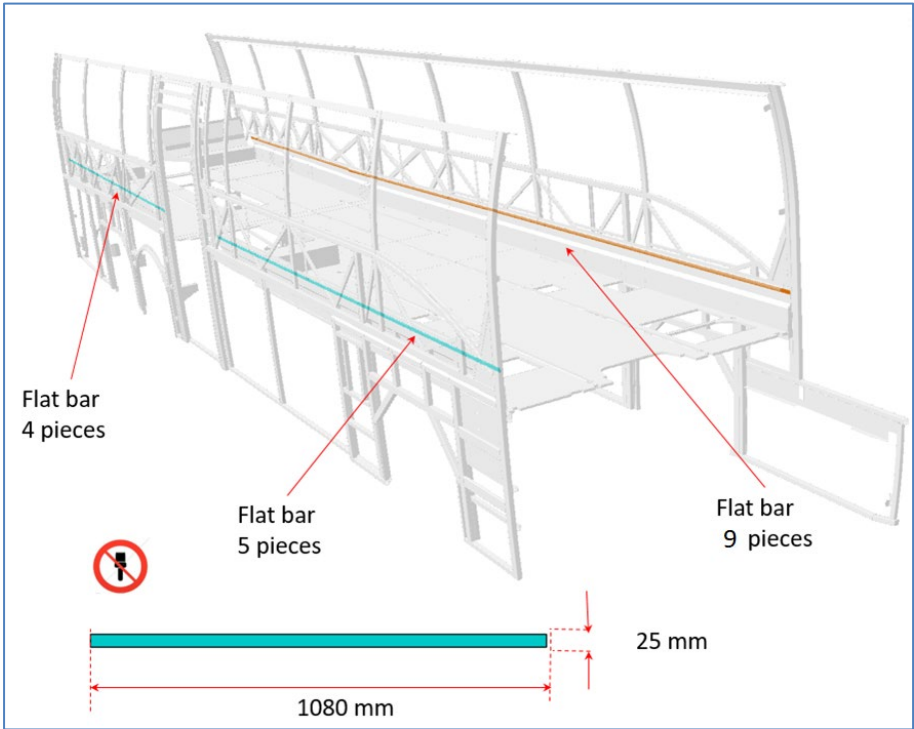
FIGURE 7 FLAT BARS INSTALLATION ALONG THE INTERIOR SIDE WALLS ON WCL COACH VERSION.

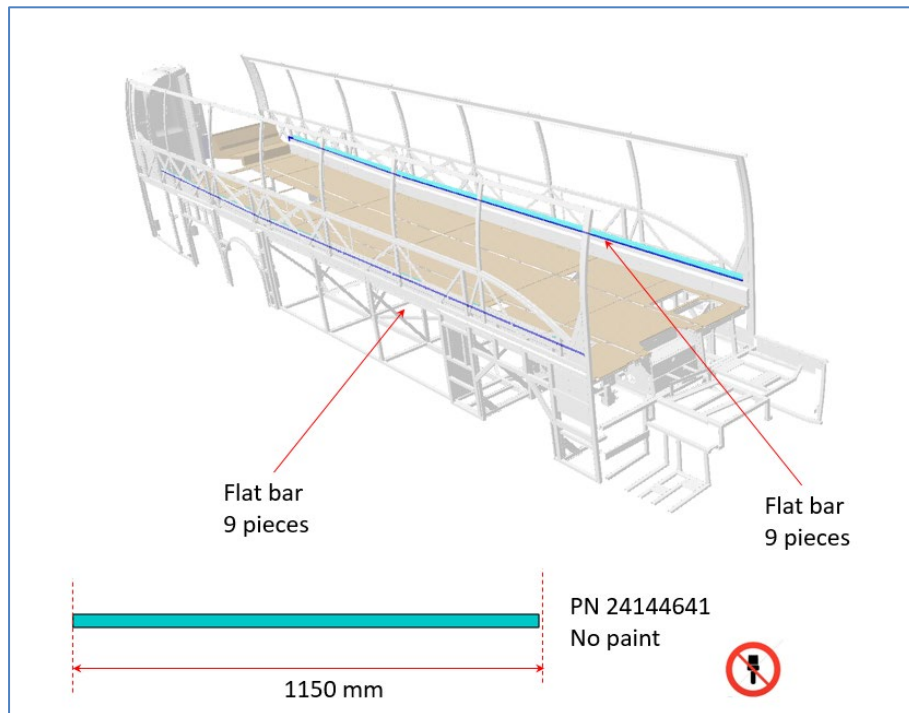
**FIGURE 8 FLAT BARS INSTALLATION ALONG THE INTERIOR SIDE WALLS ON UWCL COACH VERSION.**

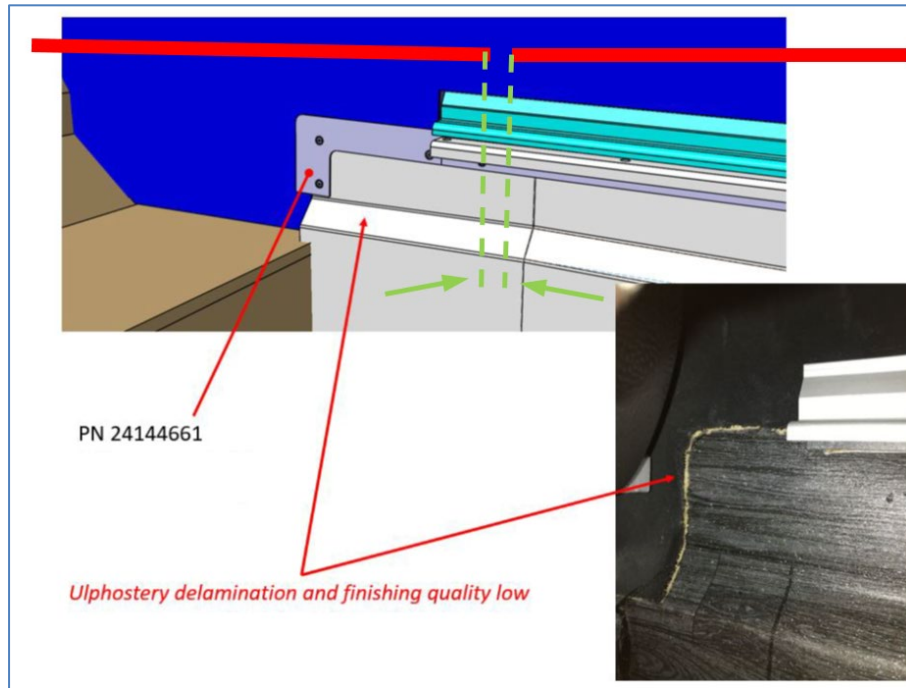
**Figure 9**

4. An additional molding (*P/N: 24144661*) will be added (*only for the back corner, on the left side*) to improve the quality of the finish.

The additional molding should be screwed as shown at the **FIGURE 9** using 4 CROSS RECESSED SUNK SCREW (*P/N: 70368852*).
