Check Engine Warning Light Activated/Fault Memory Entry "P222700 - Ambient Pressure Implausible" in the DME Control Unit (139/22)

Vehicle Type: **Cayenne (9YA/9YB) / Cayenne E-Hybrid (9YA/9YB) / Cayenne S (9YA/9YB) / Cayenne GTS (9YA/9YB) / Cayenne Turbo (9YA/9YB) / Cayenne Turbo S E-Hybrid (9YA/9YB) / Cayenne Turbo GT (9YB)**

Concerns: **DME control unit**

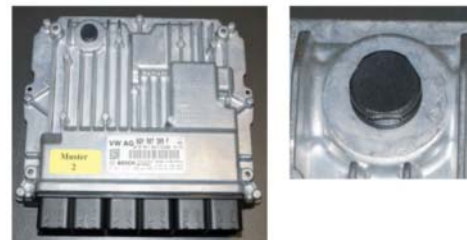
Pressure compensation element on DME control unit

Component analyses of DME control units replaced due to the fault type specified above have shown that dirt on the pressure compensation element of the DME control unit was the ⇒ *Pressure compensation element on DME control unit* cause of the fault type described. The dirt could be identified as silicone oil, which may have been caused by cleaning the engine or engine compartment using silicone-containing cleaning agents or care products.

Action required: If the fault occurs because the pressure compensation element diaphragm on the DME control unit is contaminated, the control unit is defective and must be replaced.

To prevent this from happening, please note that basically **no cleaning agents or care products** containing silicone may be used when cleaning the engine or engine compartment or when performing visual finishing of peripheral components in the engine compartment, e.g. the engine compartment cover.
