**WLD1 - Supplying Wheel Spacer (Workshop Campaign)**

Vehicle Type: **911 GT2 RS (991)/911 GT3 RS (991)**

Subject: **Spacer**

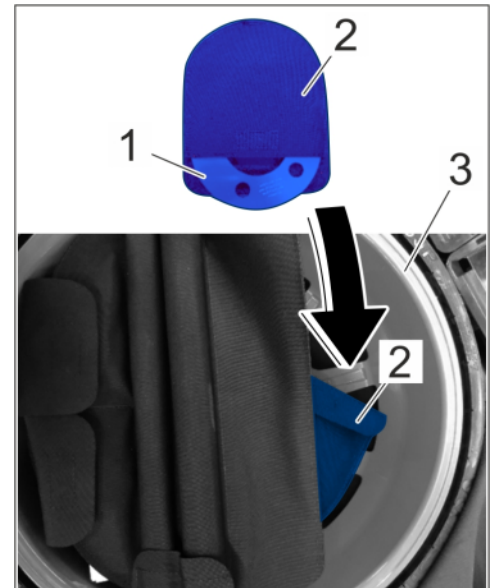
*Placing the wheel spacer in the vehicle*

- 2 Stow the wheel spacer ⇒ *Placing the wheel spacer in the vehicle -1-* in the bag ⇒ *Placing the wheel spacer in the vehicle -2-* as shown in the illustration behind the tool bag on the inside of the rim of the spare wheel ⇒ *Placing the wheel spacer in the vehicle -3-*.
- 3 After placing the wheel spacer in the vehicle, close the spare wheel bag and strap the spare wheel with the holder to the passenger seat.
- 4 Enter the campaign in the Warranty and Maintenance booklet.

Remedial Action: Place the wheel spacer in the vehicle to ensure that the front wheel can be installed on the rear axle in the event of a flat tire.
