## SERVICE BULLETIN

**NUMBER:** 09-74-21R

**SUBJECT:** Cleaning Procedure for Carbon Deposit Removal to Address Engine Misfire DTCs, Black Smoke from the Exhaust, Lack of Power, Knocking (Ping) and / or Rough Idle Concerns

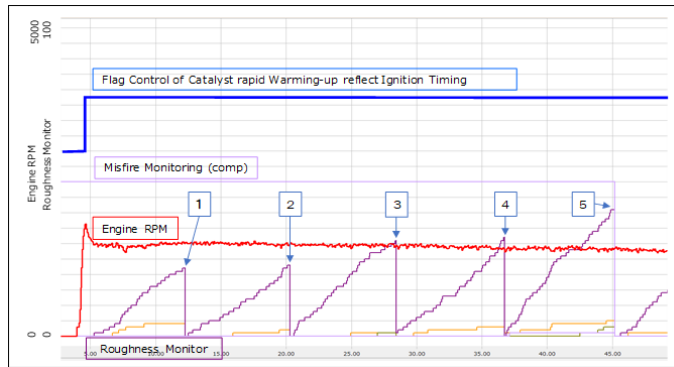
**EXAMPLE 1:**

Cylinder:	Peak 1	Peak 2	Peak 3	Peak 4	Peak 5	Total:
#1 (Orange)	4	2	1	3	5	169
#2 (Blue)	0	0	1	0	3	
#3 (Purple)	22	23	31	32	41	
#4 (Green)	0	0	0	0	1

- Flag control of Catalyst Rapid Warming-up reflect Ignition Timing
- Misfire Monitoring (comp)
- Engine RPM
- Roughness Counters #1, #2, #3 and #4.
- The roughness counter rises and resets (drops sharply) repeatedly which is the reason the signals form triangles. Read the peak values of each triangle on all cylinders until the “Misfire Monitoring (comp)” changes to “0” then, add all the values to get a “total” value. A **TOTAL** count of **34 or less** is to be considered acceptable.

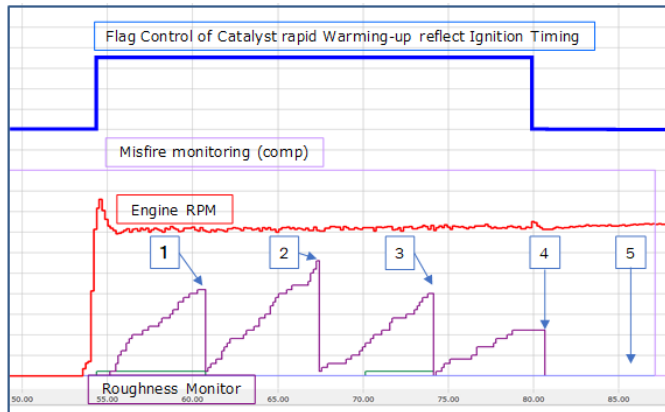
**EXAMPLE 2:**

Cylinder:	Peak 1	Peak 2	Peak 3	Peak 4	Peak 5	Total:
#1 (Orange)	0	0	0	0	0	82
#2 (Blue)	1	0	1	0	1	
#3 (purple)	21	28	20	11	0	
#4 (Green)	0	0	0	0	0

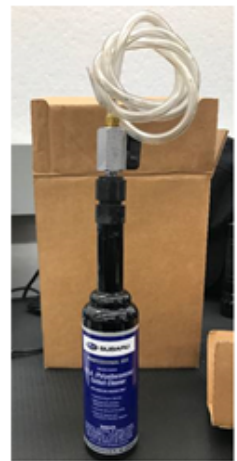
- **STEP 3 (all models):** Pour **ONE** full bottle of P.E.A. carbon cleaner into the vehicle's **FULL** fuel tank. **REMINDER:** The fuel tank **MUST** be **FULL**.
- **STEP 4:** With the valve **CLOSED** as shown below, remove the cap and thread the applicator tool onto the P.E.A. bottle. During use, try to keep the bottle vertical to insure all the contents are consumed.

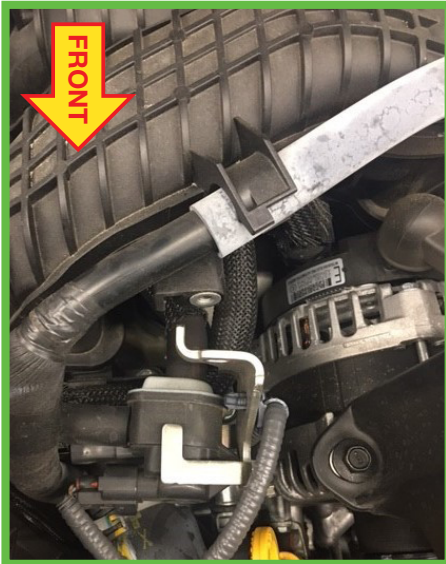
#### 2.4 DIT

- **STEP 6:** Remove the purge hose and connect the hose from the applicator tool. Refer to the images below for the hose locations.
