## Audio Unit Software Update

Supersedes 17-048, dated June 29, 2017, to revise the information highlighted in **yellow**.

Year	Model	Trim	VIN Range
2016	Civic Sedan	EX, EX-T, Touring	ALL

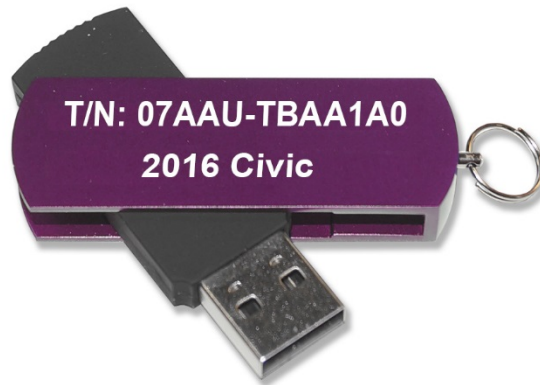
Tool Name	Part Number
Audio-Navigation System Update Device (purple USB update tool)	07AAU-TBAA1A0

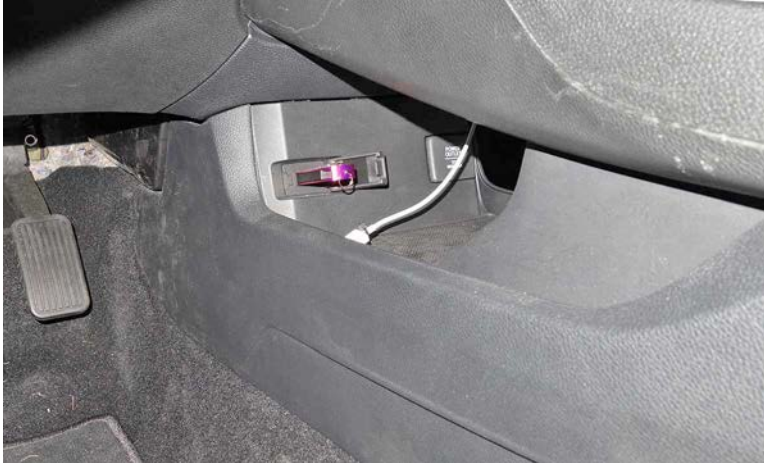
6. Plug the purple USB update device into the USB port below and behind the audio unit near the driver's knee area.

**NOTE: The previous orange USB tool (p/n 07AAZ-TBAA100) is to be destroyed and replaced by the new purple tool.**

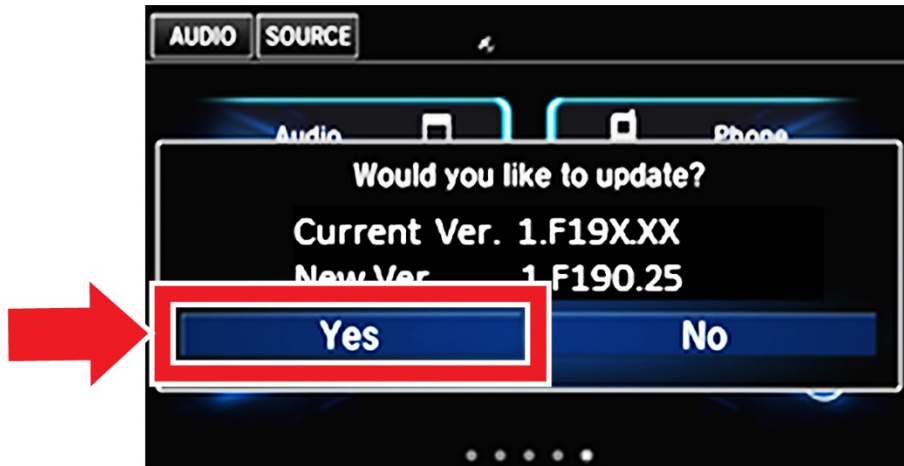
7. Depending on the current audio software and after **50 seconds**, you will either see a blank display and the system will reboot or you will see the following update message, Select **Yes**.

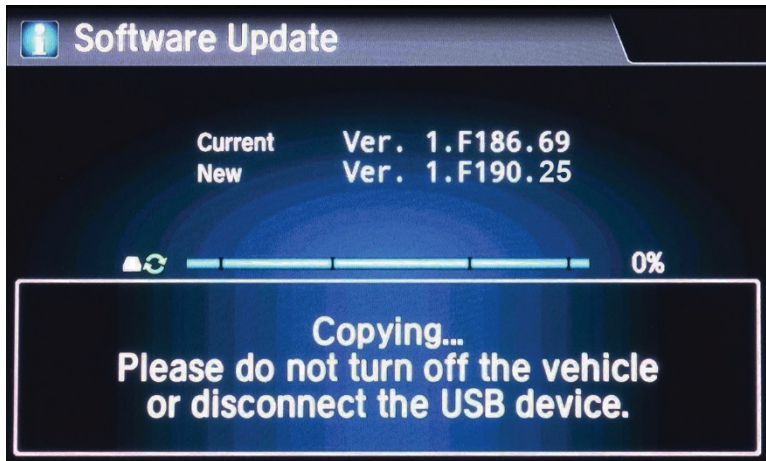
8. After the system reboots, the software update should start. It takes up to **20 minutes** to complete the update. Once you start the update, you do not have to stay with the vehicle.

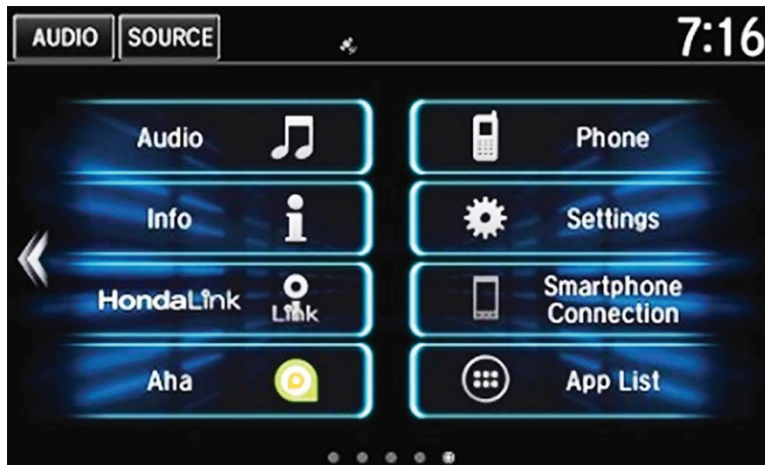
NOTE: After the update has completed, the system will reboot automatically. If the Lost Power message appears, press and hold the power button for **2 seconds** to enable the system. The GPS screen may appear and will disappear once the GPS is received.

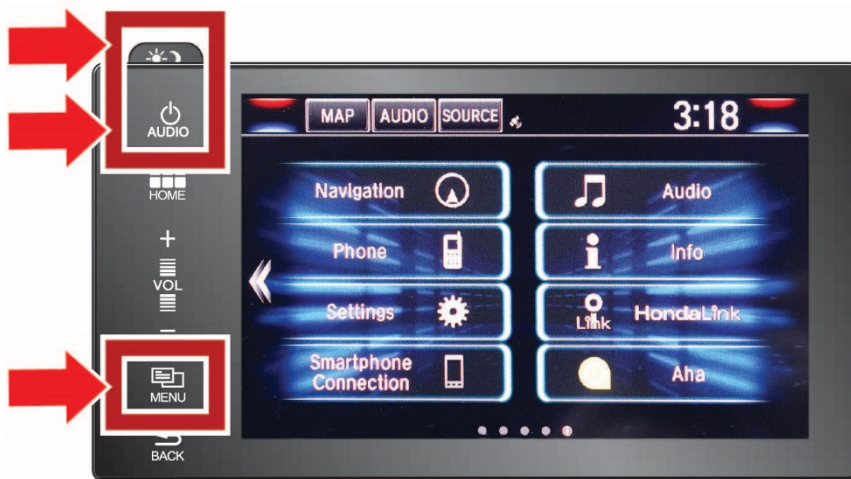
9. Press and hold the **Day/Night**, **Audio Power**, and **MENU** buttons at the same time.

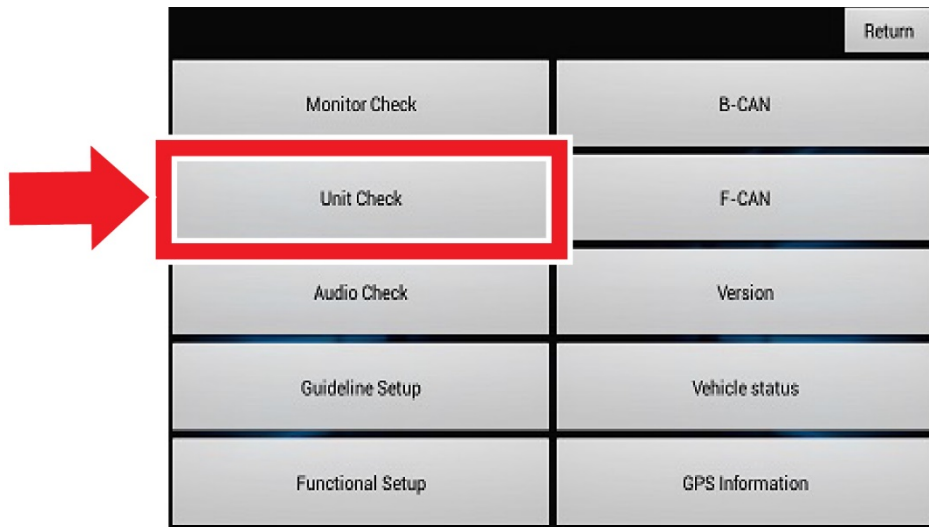
14. Select **Unit Check**.

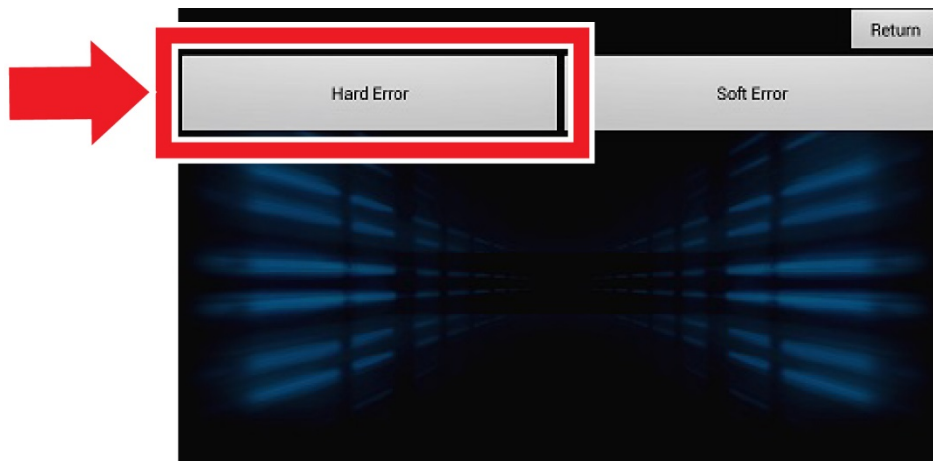
16. Select **Hard Error**.

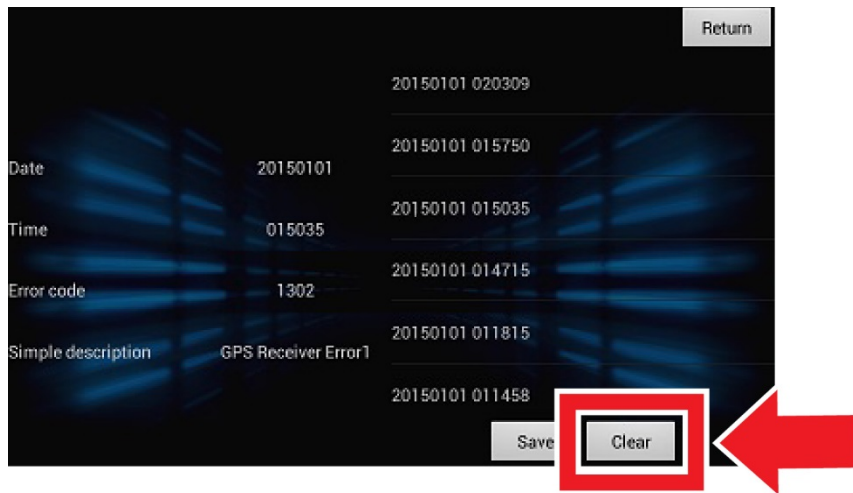
17. Select **Clear**.

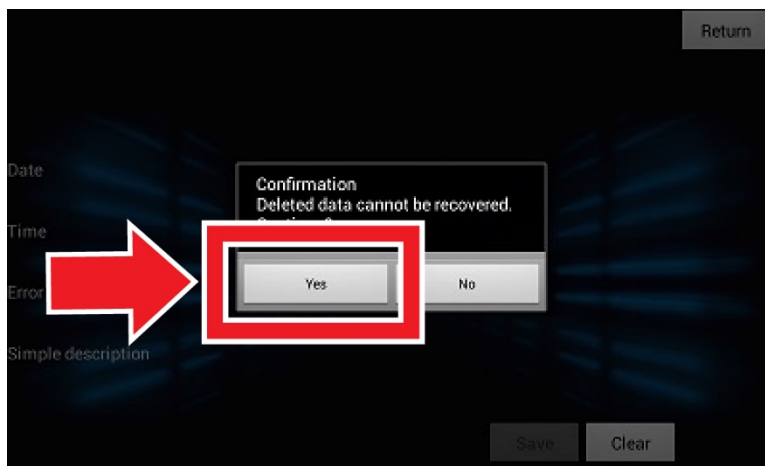
18. Select **Yes**.
