TECHNICAL INSTRUCTIONS

SPECIAL SERVICE CAMPAIGN 22LC02

Crankcase Case Vent

**Certain 2022 Model Year ES300h
Certain 2022 Model Year ES250**

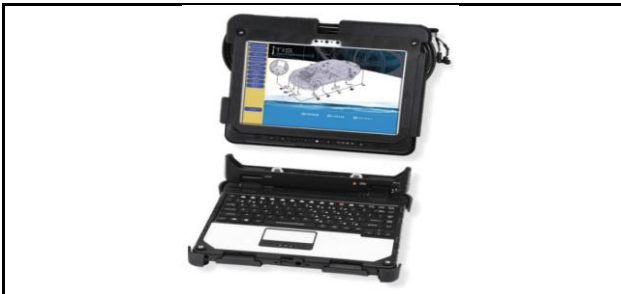
VII. REMOVE NO. 1 VENTILATION CASE

1. CHECK FOR DTC'S

- a) Perform a Health Check to check for Diagnostic Trouble Codes.

NOTE: This campaign covers only the replacement of No. 1 ventilation case and associated parts. It does not cover the diagnosis or replacement of any other parts on the vehicle.

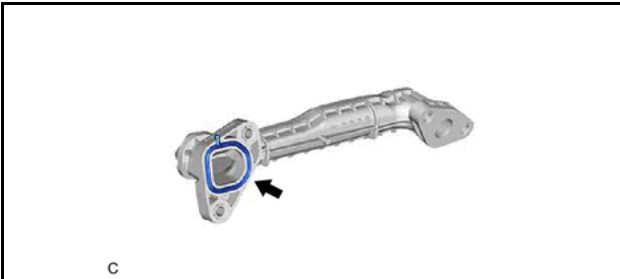
12. REMOVE NO. 1 EGR PIPE SUB-ASSEMBLY

- a) Using an 8 mm socket wrench, remove the 4 bolts and No. 1 EGR pipe assembly from the intake manifold and EGR valve.

- b) Remove the EGR valve adapter gasket from the No. 1 EGR pipe assembly.

- c) Cut the removed EGR valve adapter gasket to avoid confusion with new part and or reinstallation on the vehicle.
