## STAR ONLINE PUBLICATION

**Case Number:** S2208000121

**Symptom/Vehicle Issue:** Check Engine Lamp (CEL) On, DEF Reductant Quality Sensor Circuit

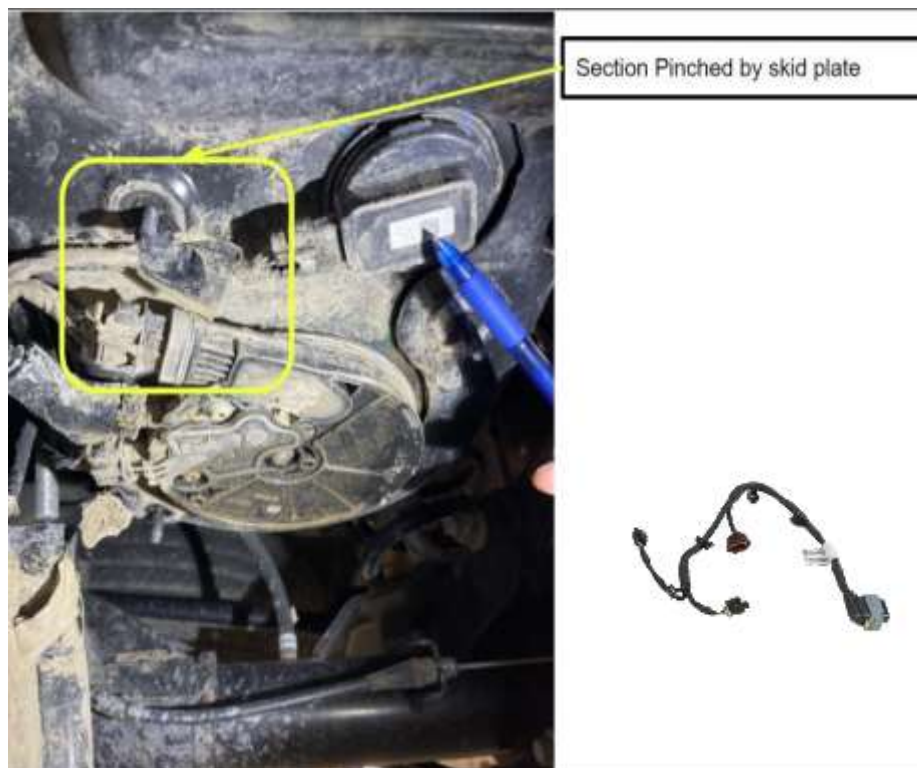
**Repair Procedure:** Inspect the harness routing of the DEF reductant quality sensor that is routed under the vehicle's underbody skid plate. Example: Skid plate was pinching the harness for the reductant quality sensor circuit. Repair or replace the involved harness as needed  
Part# 68409264AA.
