Case Number: S2208000130 REV. A

Symptom/Vehicle Issue: 1ST Row Power Seat Forward Or Rearward Adjustments Do Not

Operate, Heated Seat Back Does Not Turn On

Discussion: Inspect the following highlighted areas prior to any component replacement.

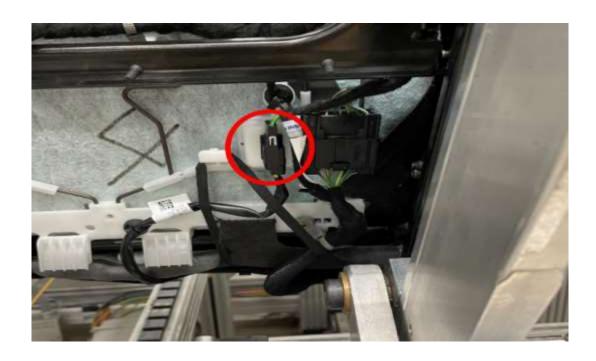
1. Check connection underneath bottom cushion circled below. Location is rear, outboard portion of seat.

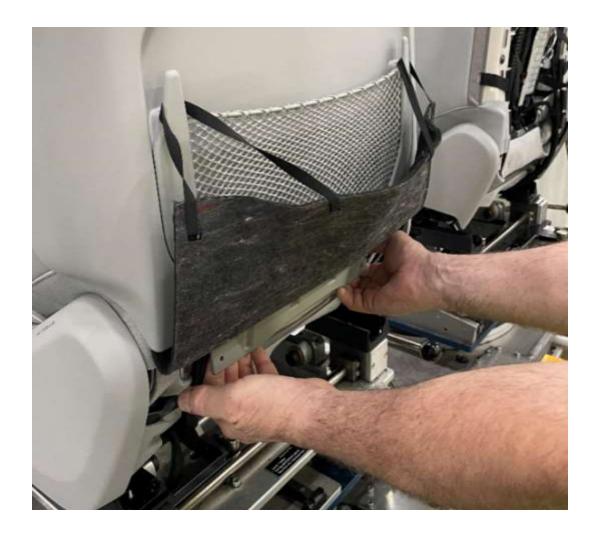
- 1. Remove straps from under seat.
- 2. Grab Bottom of back panel shown below to remove it from seat.

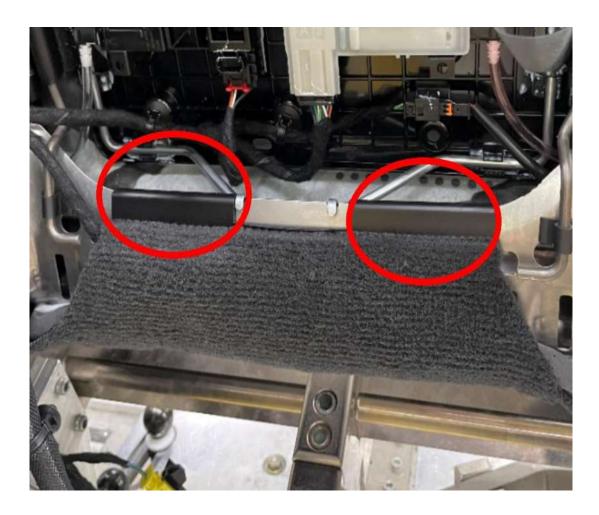
3. Remove carpet clips from seat circled below.

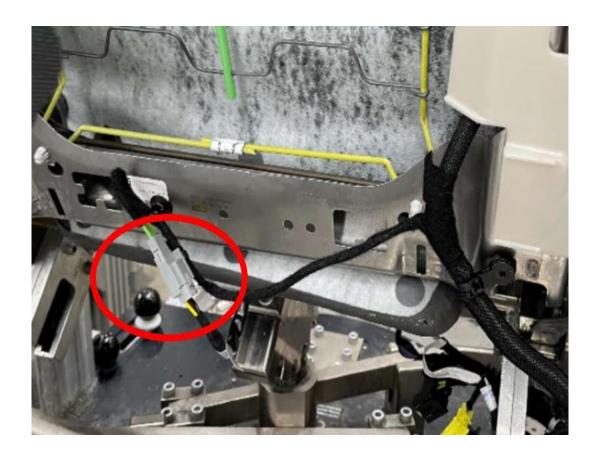
4. Check connection circled below.

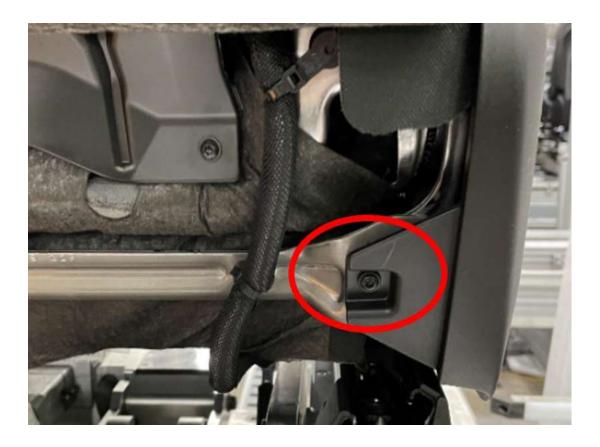
- 1. Remove straps for rear back panel and flip up carpet.
- 2. Remove screw in rear of side shield shown below.

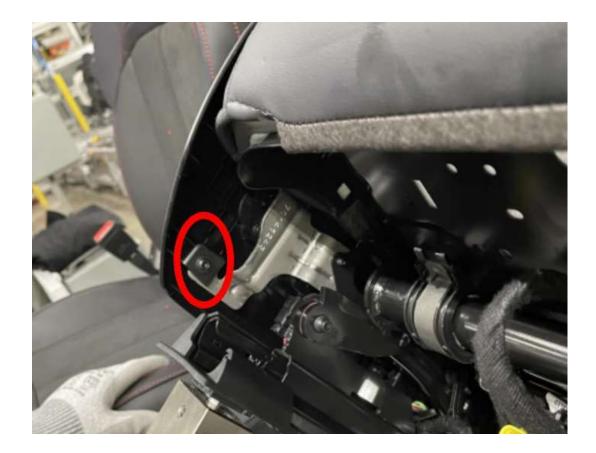
3. Remove screw in front of side shield.

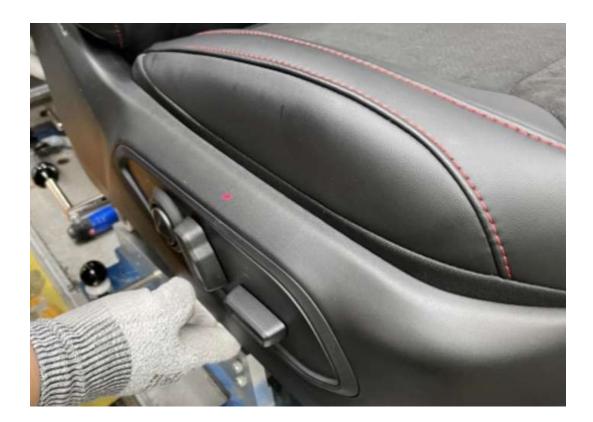
4. Grab from bottom and back of side panel to remove.

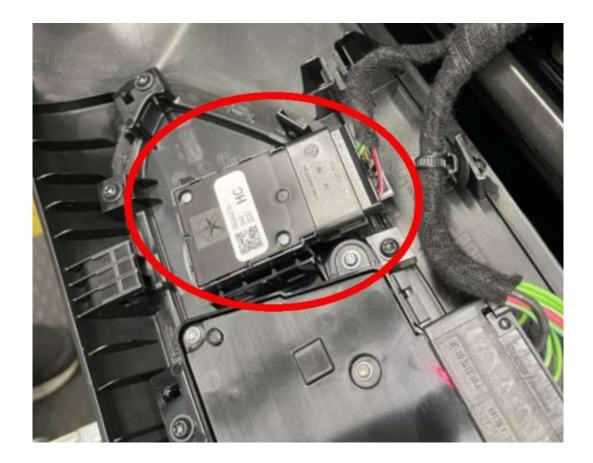
5. Check connection shown below.
