Technical product information

Topic	Fitment of rear brake caliper carriers for complaints relating to 3.4 KHz rear brake squeal
Market area	Bentley; worldwide (2WBE)
Brand	Bentley
Transaction No.	2066143/4
Level	EH
Status	Approval
Release date

Bentayga series

Rear brake squeal (3.4 KHz) during brake application at low speed

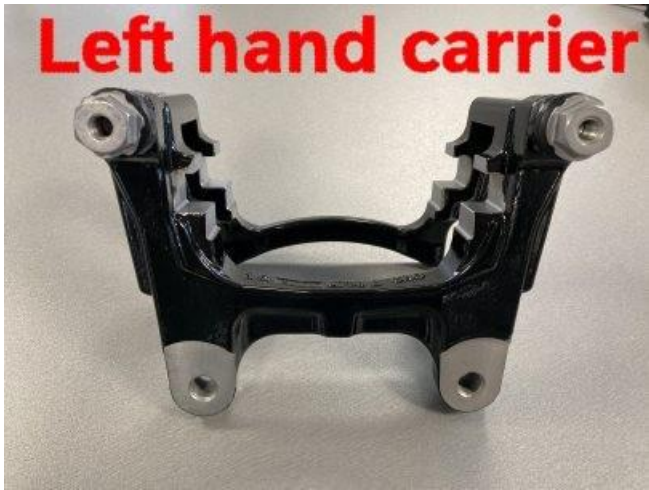
Figure 1

- 36A698425 - Left hand side (Figures 1 and 2)
- 36A698426 - Right hand side (Figures 3 and 4)

- 36A698425A - Left hand side (Figures 1 and 2)
- 36A698426A - Right hand side (Figures 3 and 4)

3) Referring to Rep.Gr 46 - Fit the left and right hand rear carriers as follows:

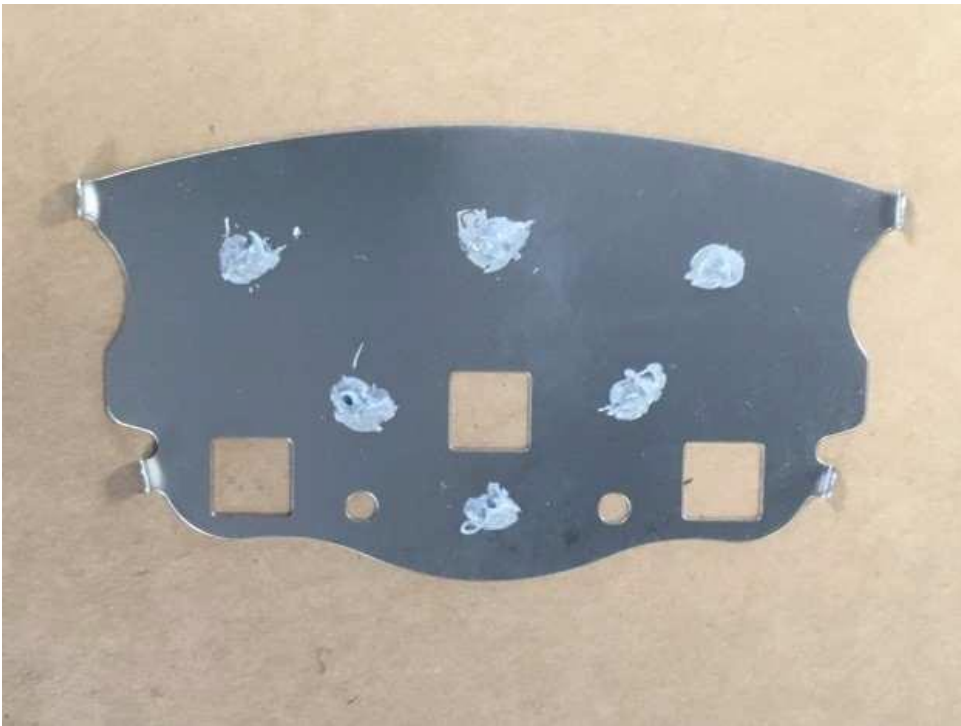
5) Referring to Figure 8 - Apply 6 dots of grease (<1.0g in total) to the inside face of the clip on each shim (x4 in total)

TIP: Grease application is the same process regardless of shim design

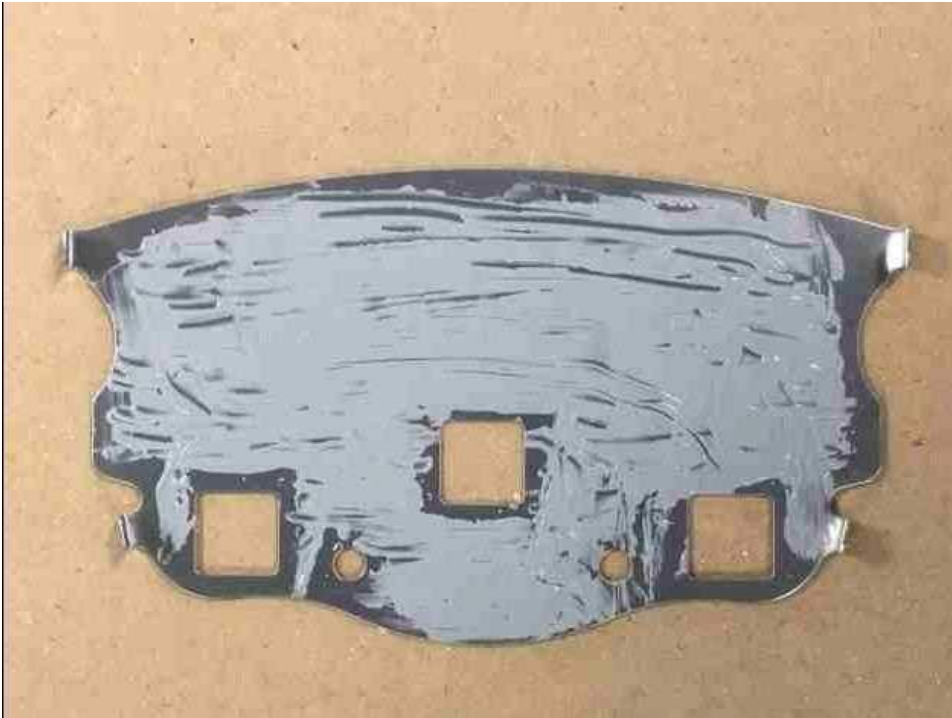
- Referring to Figure 9 - Using a suitable spatula spread the grease to an even layer condition (x4 shims in total)

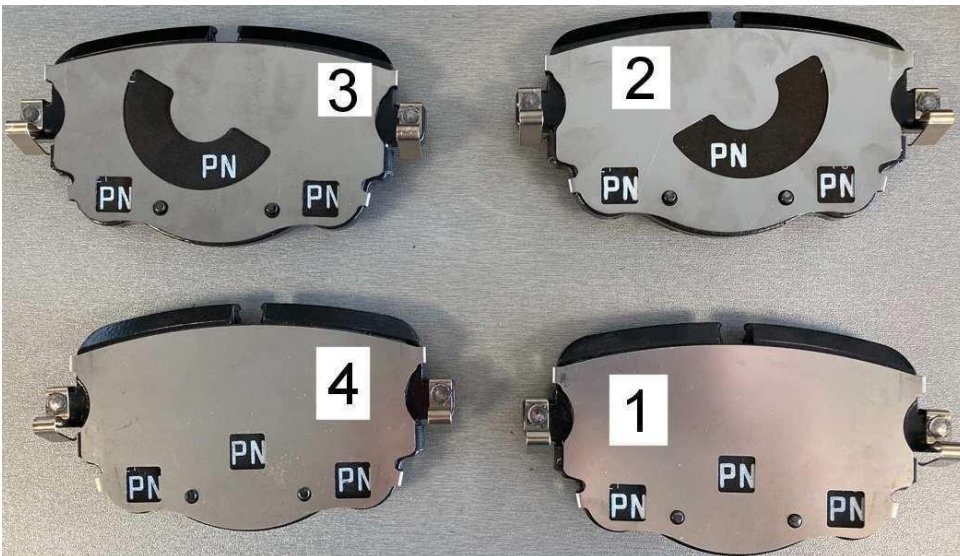
6) Referring to Figure 10 - Assemble the clip-on shim onto each pad, the pads **MUST** be fitted in the positions as detailed:

- 1 - Lefthand outer pad
- 2 - Left hand inner pad
- 3 - Righthand inner pad
- 4 - Righthand outer pad

For clarity once fitted the brake pads MUST be positioned as shown in Figure 13 (with reference to Figure 10)

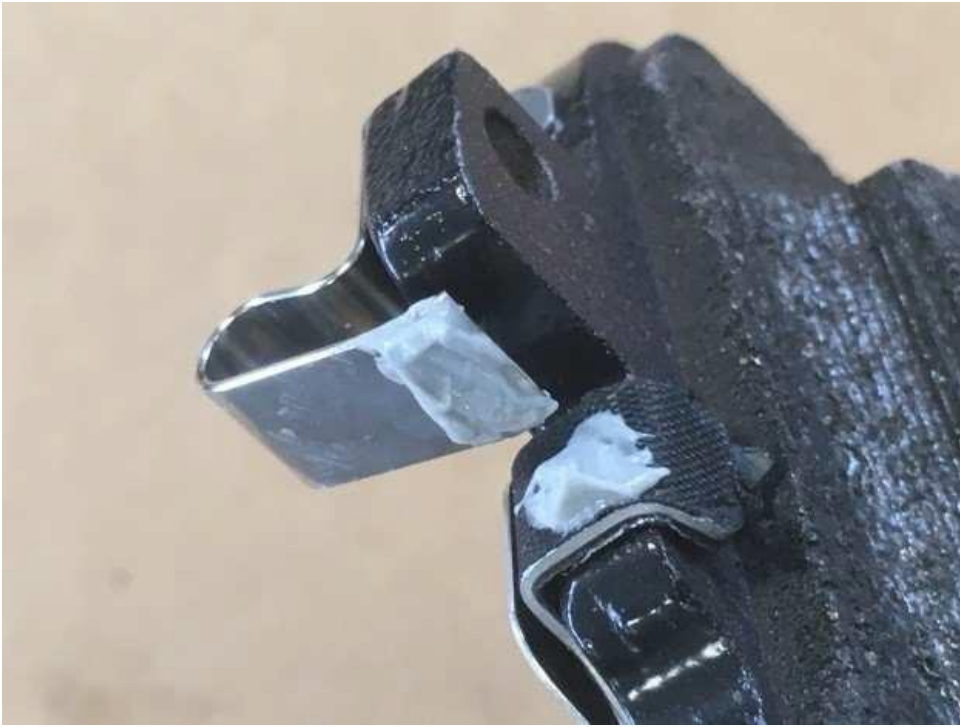
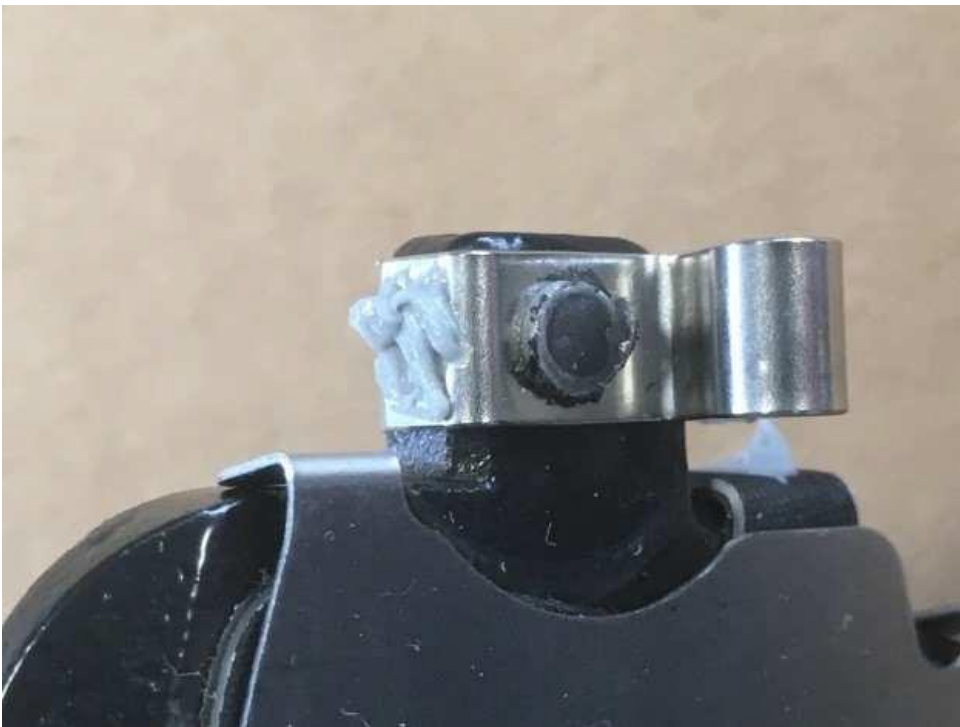
8) Referring to Figures 11 and 12 - Apply a small dot of grease to the pad abutments and the springs of each pad

CAUTION: if visibility of the shim from the exterior is as shown in Figure 12 the shims are NOT positioned correctly, in this scenario please refer back to the previous instructions to ensure the shims are fitted correctly
