Technical Service Bulletin

Topic	Continental GT Convertible - Front seat belt webbing twisted
Market area	Bentley: worldwide (2WBE)
Brand	Bentley
Transaction No.	2038562/5
Level	EH
Status	Released for publishing
Release date	Sep 15, 2022

Front seat belt webbing twisted

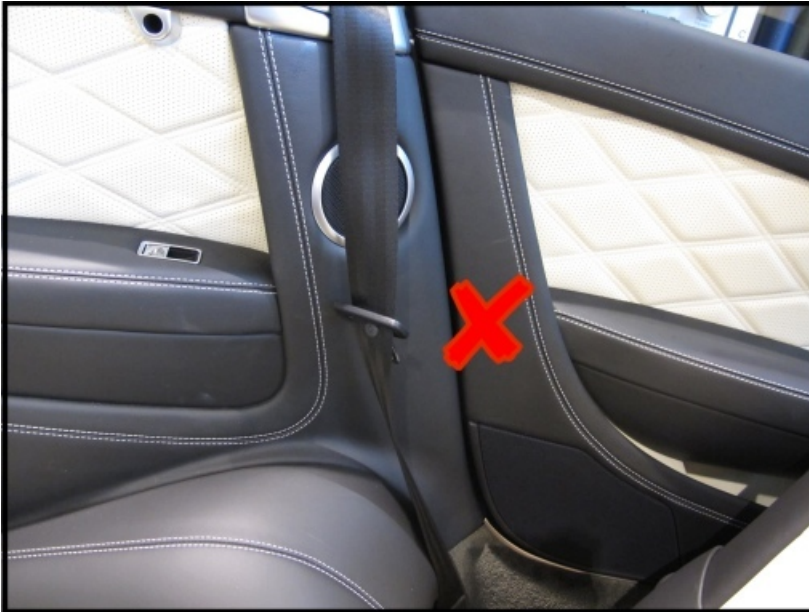
The front seat belt webbing is twisted this is evident in both the stowed position and also when the seat belt is worn see Figure 1

The plastic seat belt webbing guide, a plastic moulding incorporated in the seat belt upper 'D' loop assembly, may not have been fully clipped onto the metal 'D' loop. When this is the case a twist in the seat belt webbing is possible

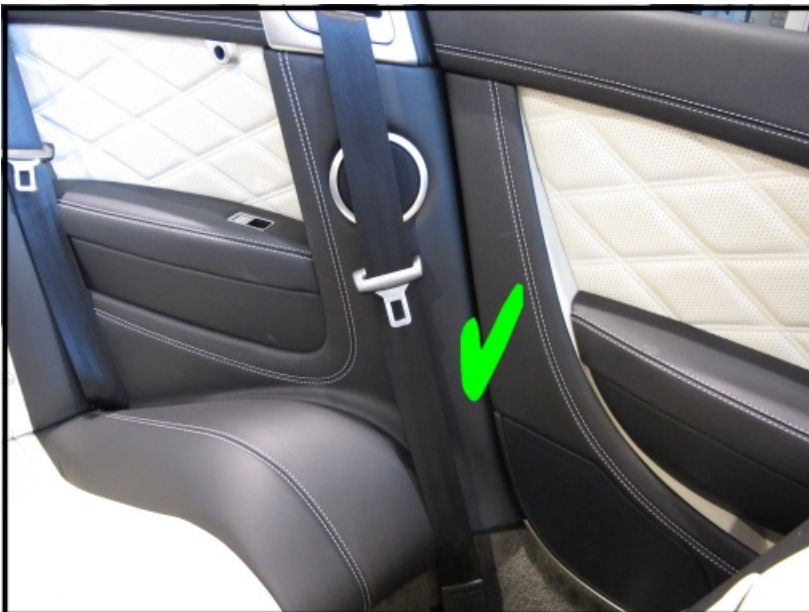
Figure 2

The front seat belt in the stowed position should be as shown in figure 2

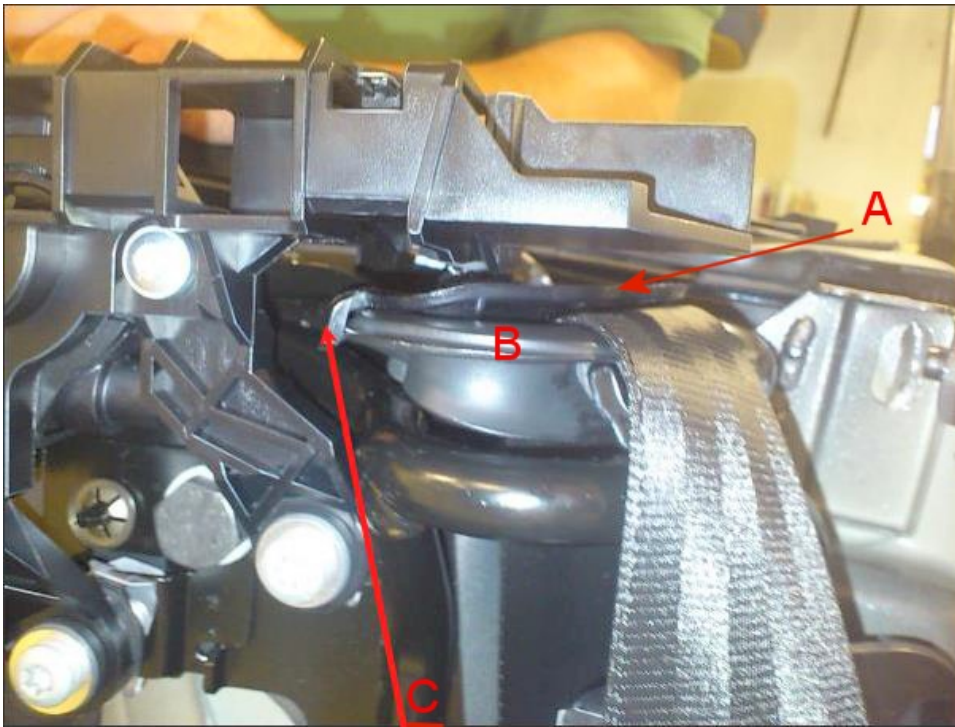
Figure 3

2. Referencing figure 3 and 4 inspect the seat belt webbing plastic guide (A). Ensure the three clipping points (C) are securely clipped to the 'D' ring (B).
3. If the guide is not securely clipped then remove and discard the guide and fit a new replacement guide.
4. On completion the guide must be correctly secured to the 'D' ring paying close attention to both outer clipping features (C)
