BULLETIN NUMBER:
IB16-F-001C

GROUP:
DRIVELINE/AXLE

LIMITED SLIP DIFFERENTIAL CHATTERING NOISE

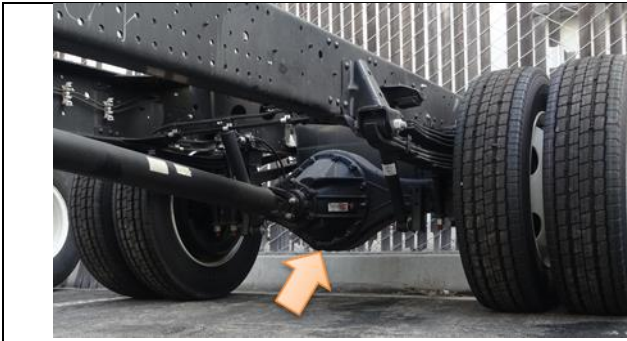
Figure 1 – Code Location

See Figures 1 and 2 below in this bulletin to identify a limited slip differential or check the vehicle build in IVIS (Isuzu Vehicle Information System) for Option Code IV0.

1. Replace the differential gear oil with a commercially-available gear oil (SAE90 GL-5) and add 20oz of limited slip differential lubricant additive (P/N 8-01052-358-0 (quantity of five (5), 4oz bottles).
2. Road test the vehicle for at least 10 miles by making eight to ten tight left and right turns, such as going around a corner, to ensure the limited slip is activated and to determine if there is no longer any audible clicking or chattering noise coming from the rear of the vehicle during tight turns.
3. If the condition persists, technicians are to call the Technical Assistance Center (TAC) at 1-877-ISUZUCV (1-877-478-9828), Select a language, at Prompt press "3" to speak directly to a TAC Specialist for further assistance.
